FINAL INVESTIGATION REPORT
ON
ACCIDENT INVOLVING CESSNA 172 R AIRCRAFT VT-CAF
OPERATED BY M/S CHIMES AVIATION ACADEMY
AT DHANA ON 3RD JANUARY 2020.

AIRCRAFT ACCIDENT INVESTIGATION BUREAU
MINISTRY OF CIVIL AVIATION
GOVERNMENT OF INDIA

**FINAL INVESTIGATION REPORT ON ACCIDENT AT DHANA
ON 3RD JAN 2020 INVOLVING CESSNA 172 R AIRCRAFT VT-CAF OPERATED
BY CHIMES AVIATION ACADEMY**

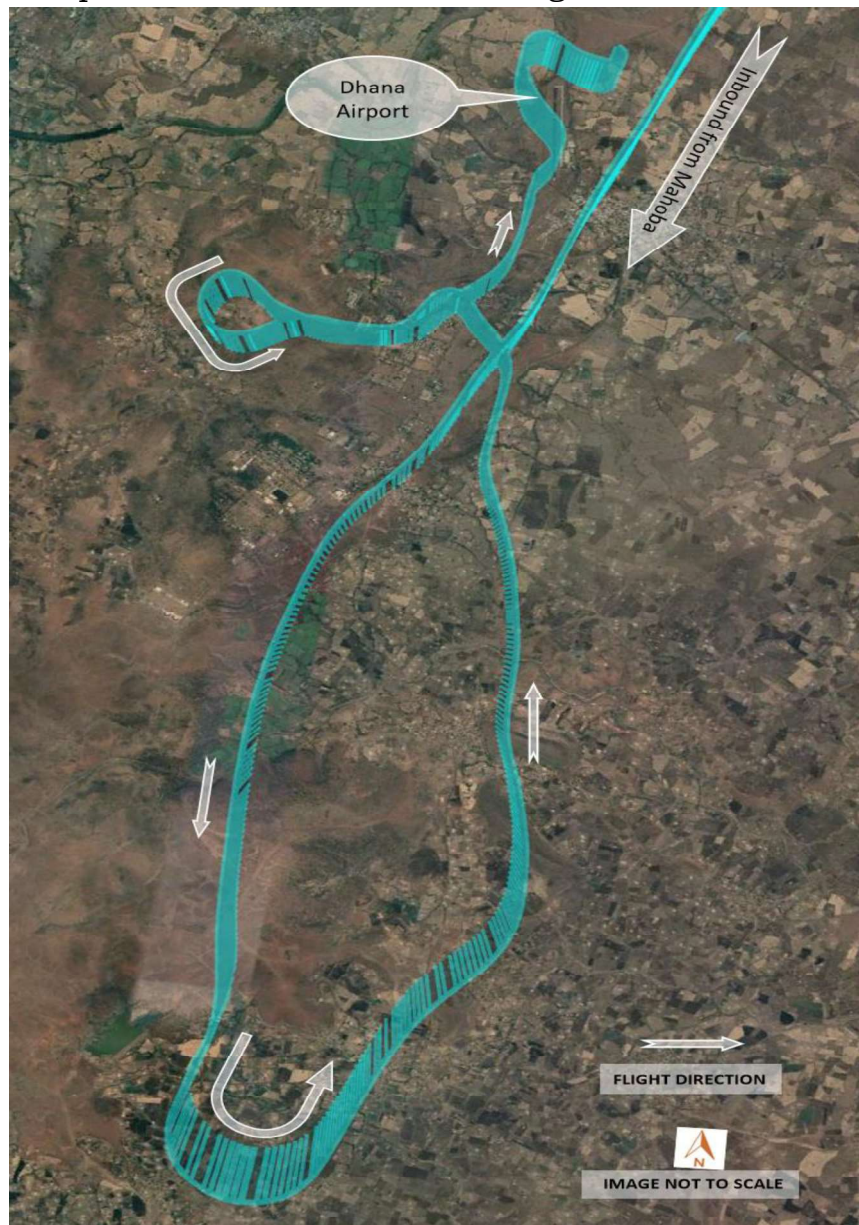
Figure 16 : Flight Path taken by VT-CAF created from Garmin recording

As the aircraft came inbound to Dhana from Mahoba it went about 6 NM south of Dhana Airport before turning back to join approach for Runway 35 at an altitude
