FINAL REPORT ON ACCIDENT INVOLVING BEECHCRAFT KING AIR C90A AIRCRAFT VT-JIL OPERATED BY M/s JET SERVE AVIATION PVT LTD AT MUMBAI ON 06TH MAY 2021

Government of India Ministry of Civil Aviation Aircraft Accident Investigation Bureau

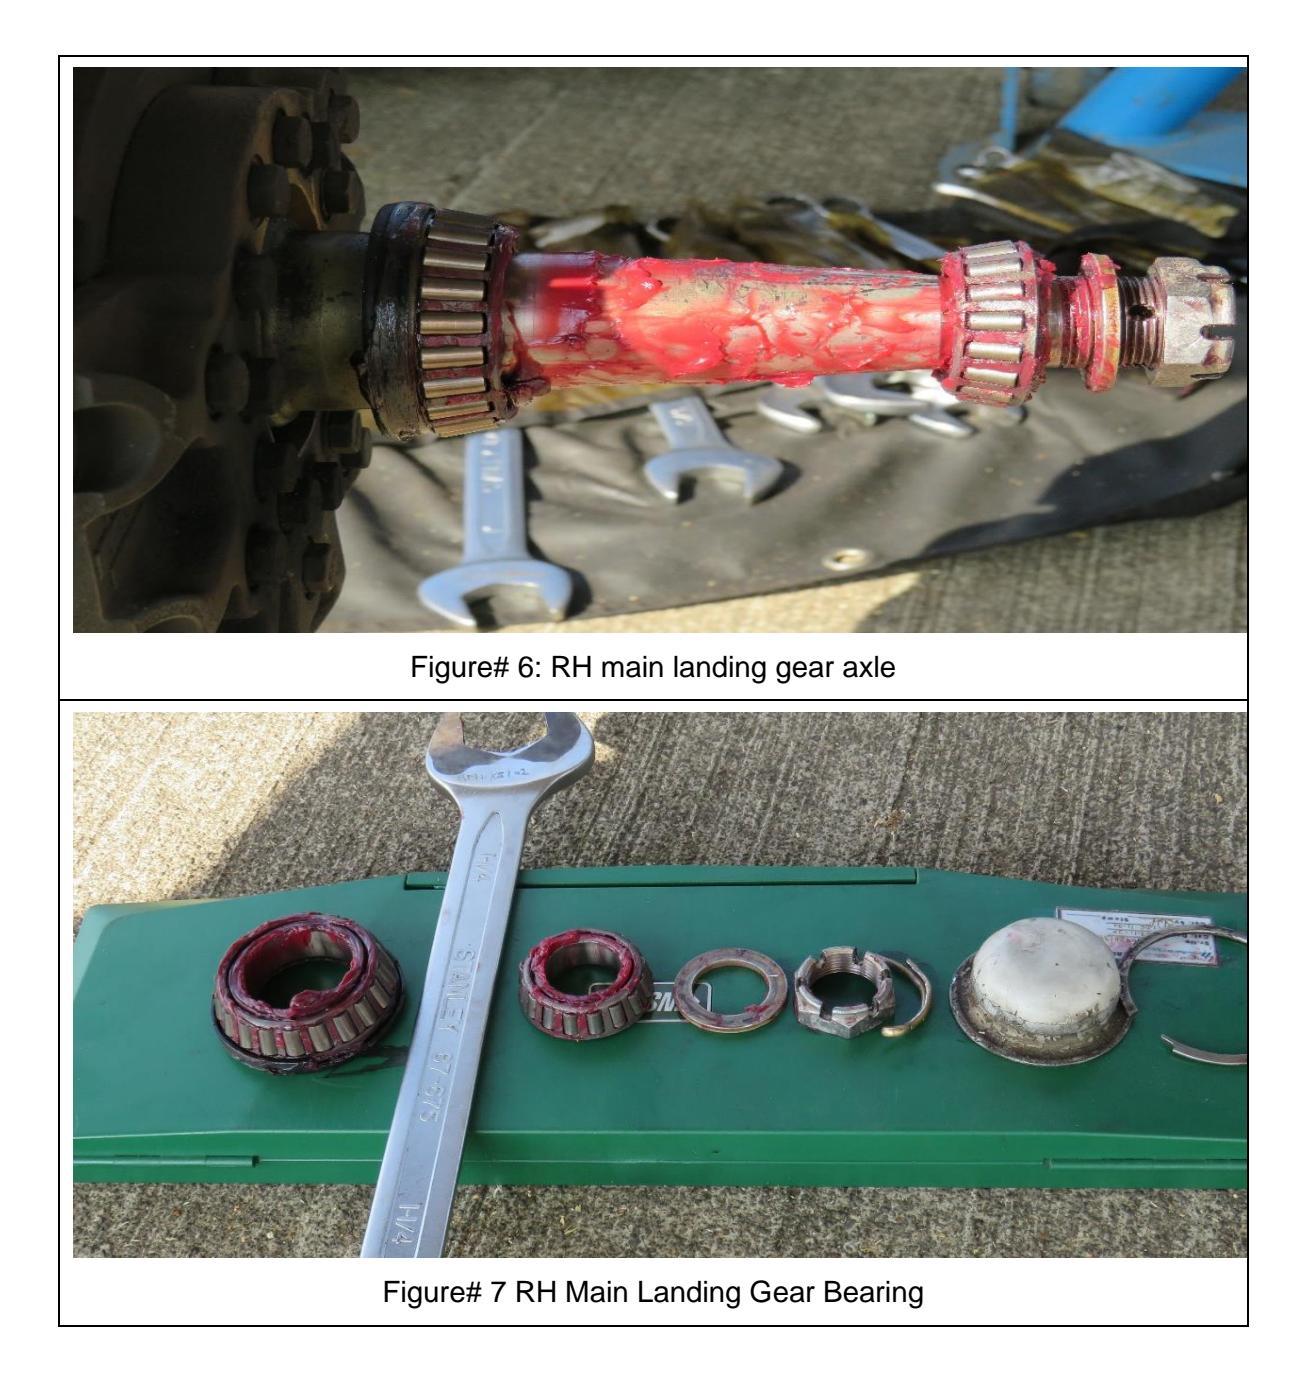
RH main wheel assembly and bearings were inspected by the investigation team post-accident. The wheel assembly was found to be as per IPC and adequately greased.

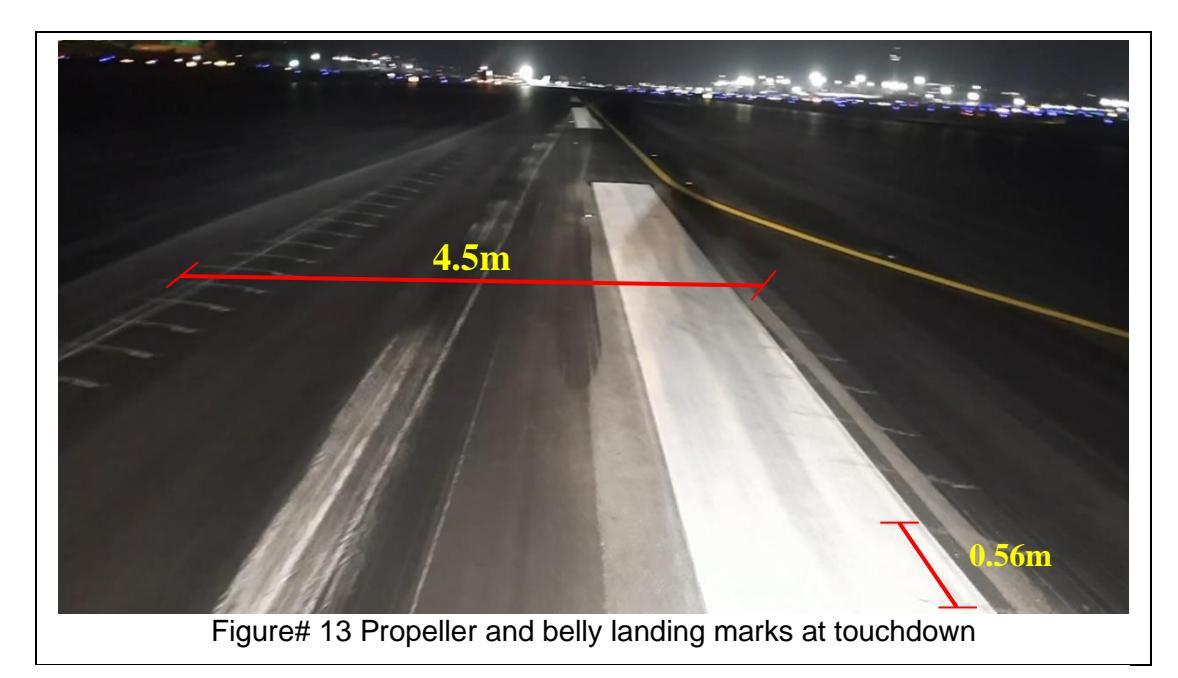
- a. Aircraft touched down on runway centerline at approximately 177m from the displaced threshold of runway 27.
- b. Initially, right propeller & belly touched runway surface followed by left propeller.
- c. The distance between left and right propeller strike markings were measured to be approximately 4.5m. (Ref. Figure# 13)
- d. The distance between two consecutive propeller strike marks at touchdown point was measured to be 0.56m. (Ref. Figure# 13)

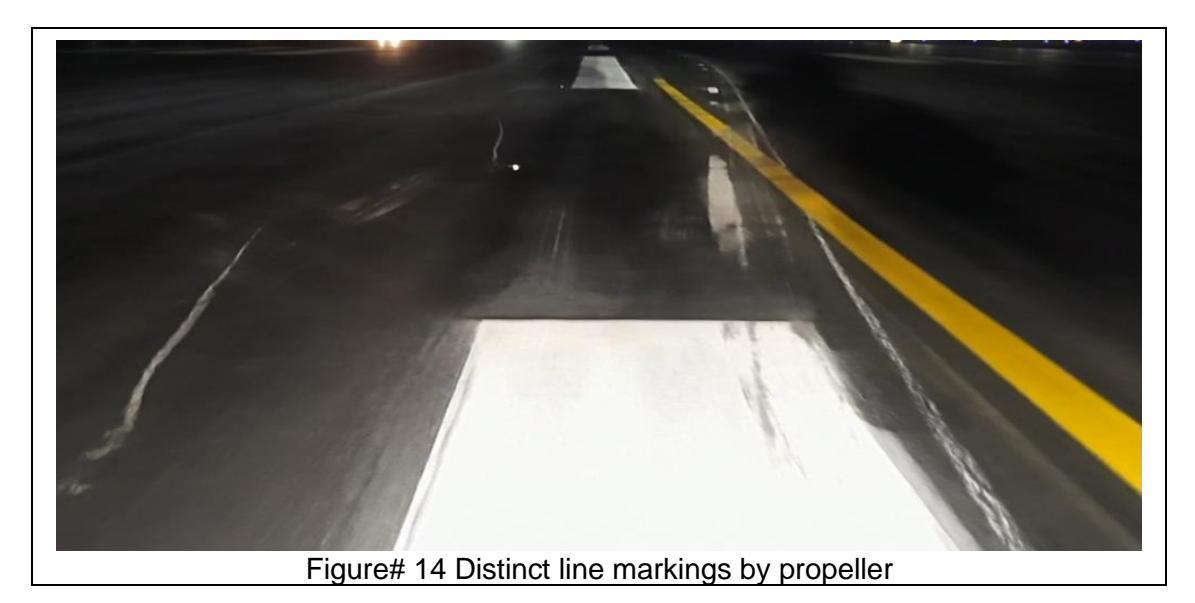
e. The propeller strike marks were visible for 116m from touchdown point which later became intermittent with distinct line marking. (Ref. Figure# 14)

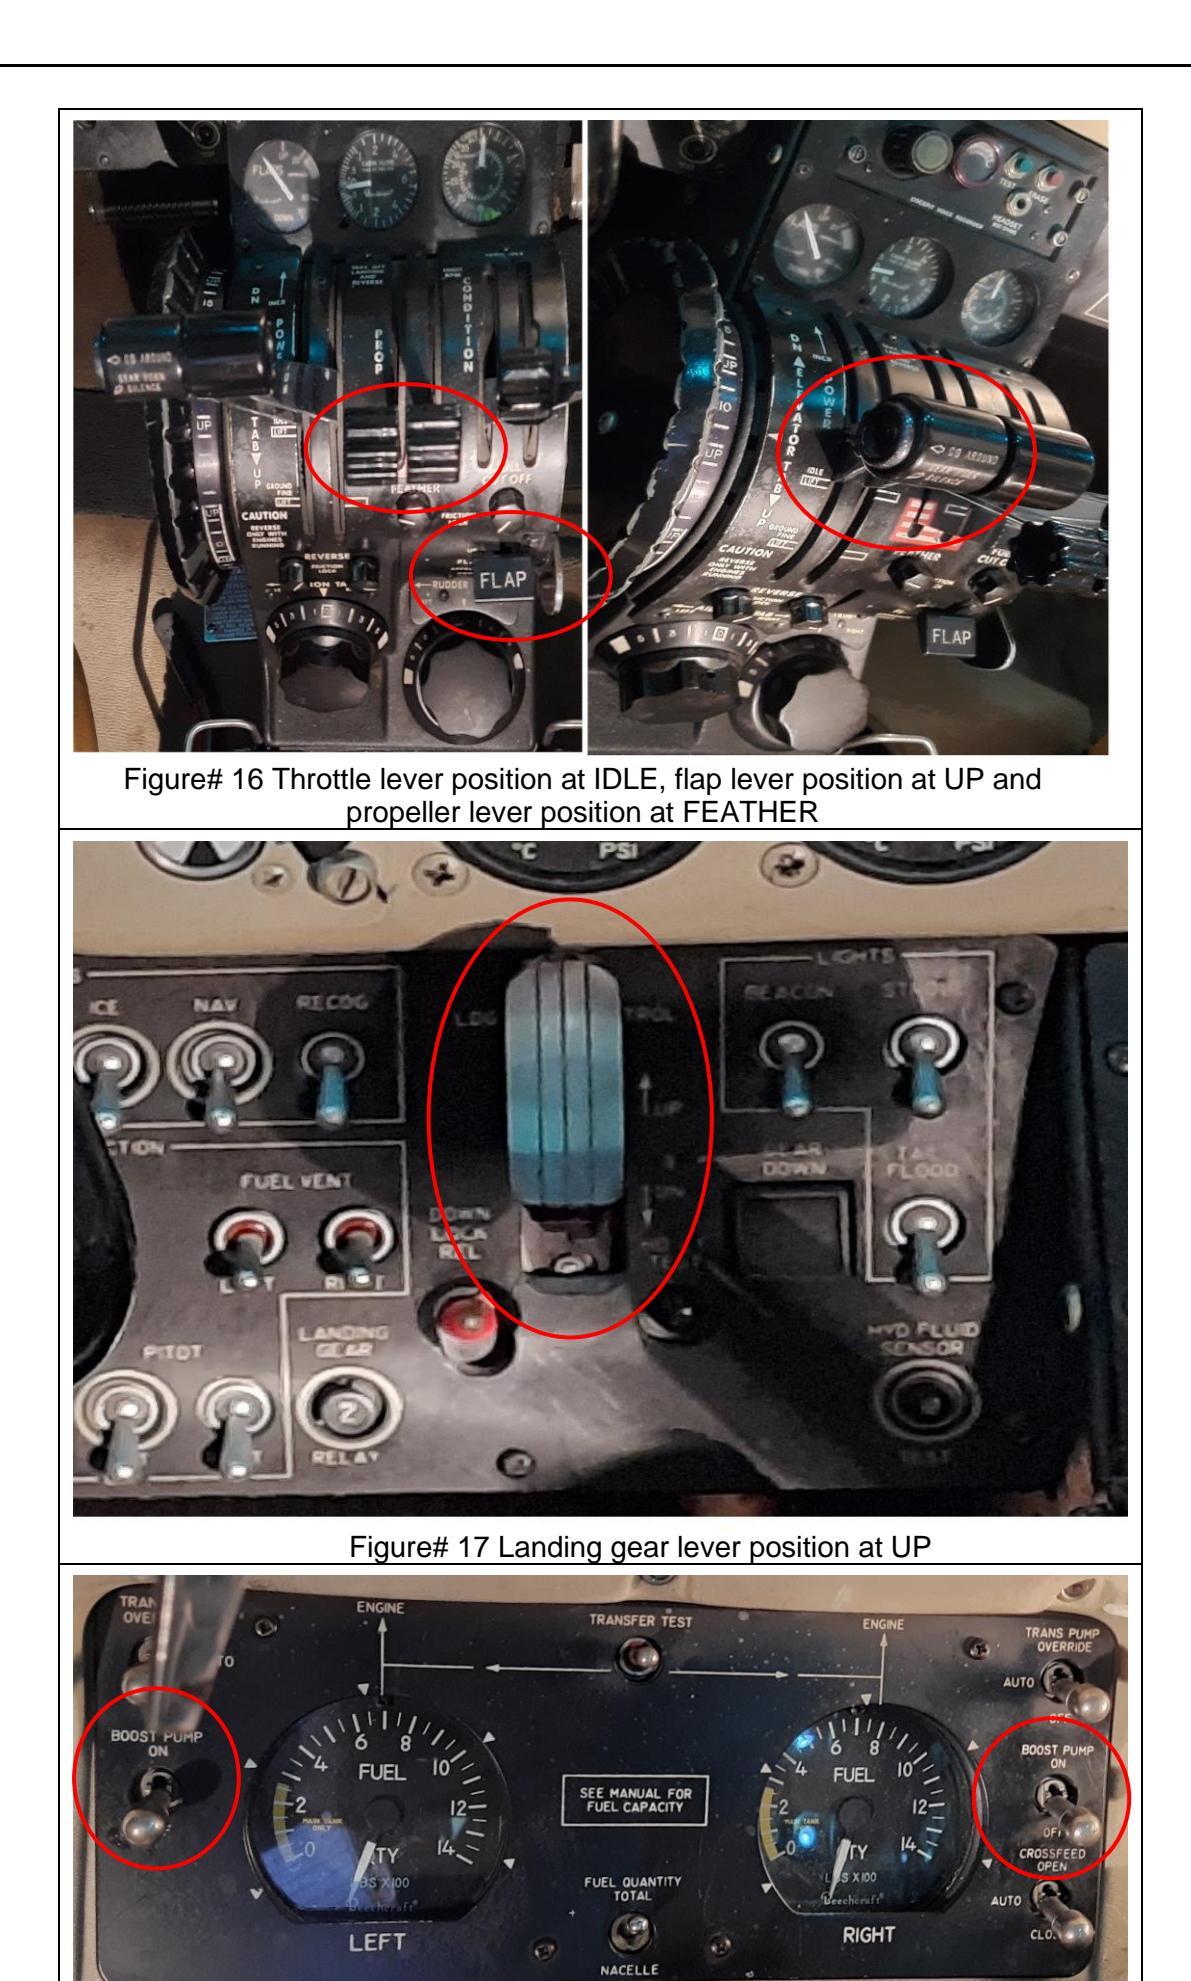
Figure# 18 Left and right fuel boost pumps at OFF

- f. Both fuel boost pumps were in OFF position. (Ref. Figure# 18)
- g. Flap lever was observed in UP position and flaps were physically observed to be in retracted position. (Ref. Figure# 16,19 & 20)

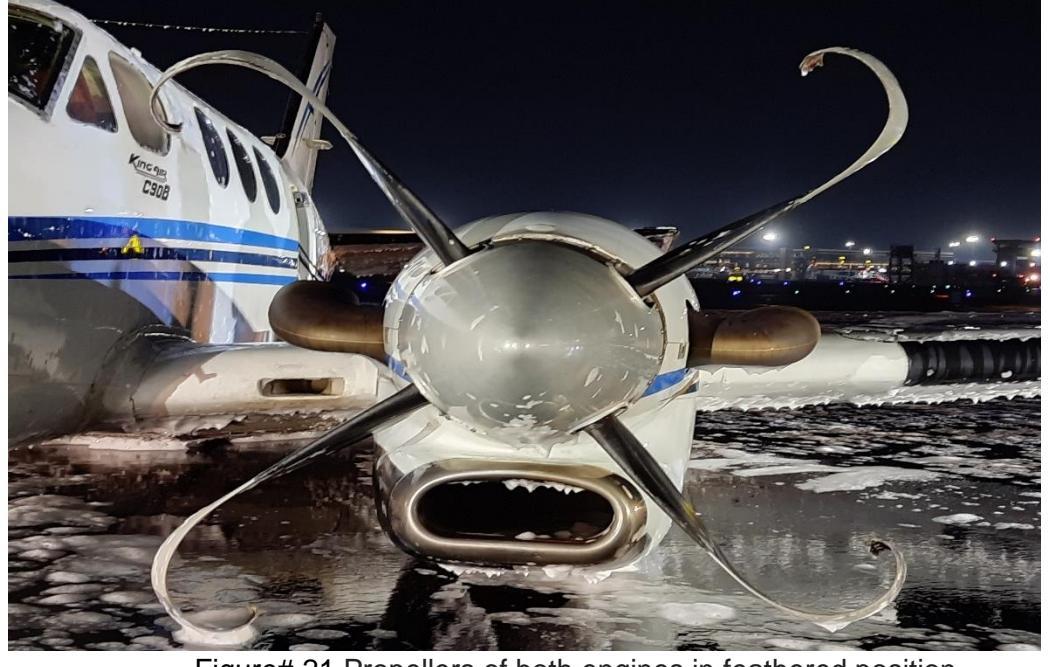
Figure# 21 Propellers of both engines in feathered position

- Propellers of both engines were physically observed & identified to be in feathered position; however, the bent blades depicts that the propellers were rotating during the aircraft contact with the runway surface. (Ref. Figure# 21 & Figure# 22)

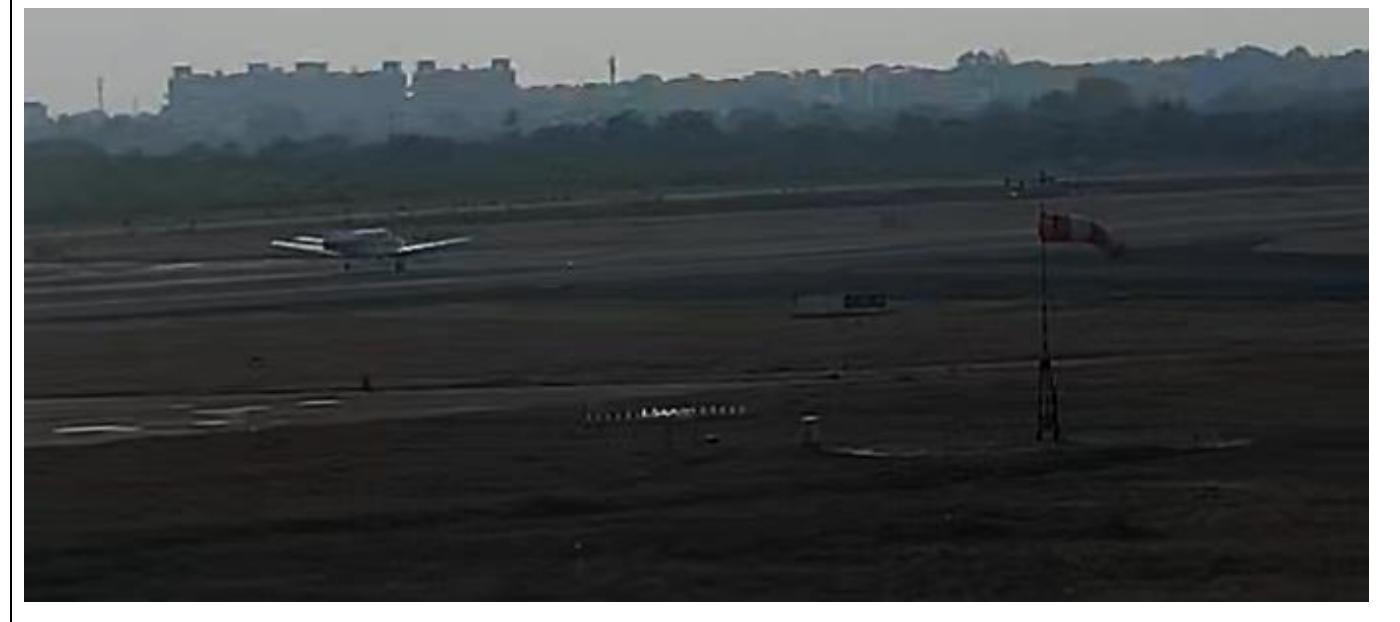
Figure#35 CCTV image of VT-JIL on initial Take-off roll. All undercarriage extended and wheels visible

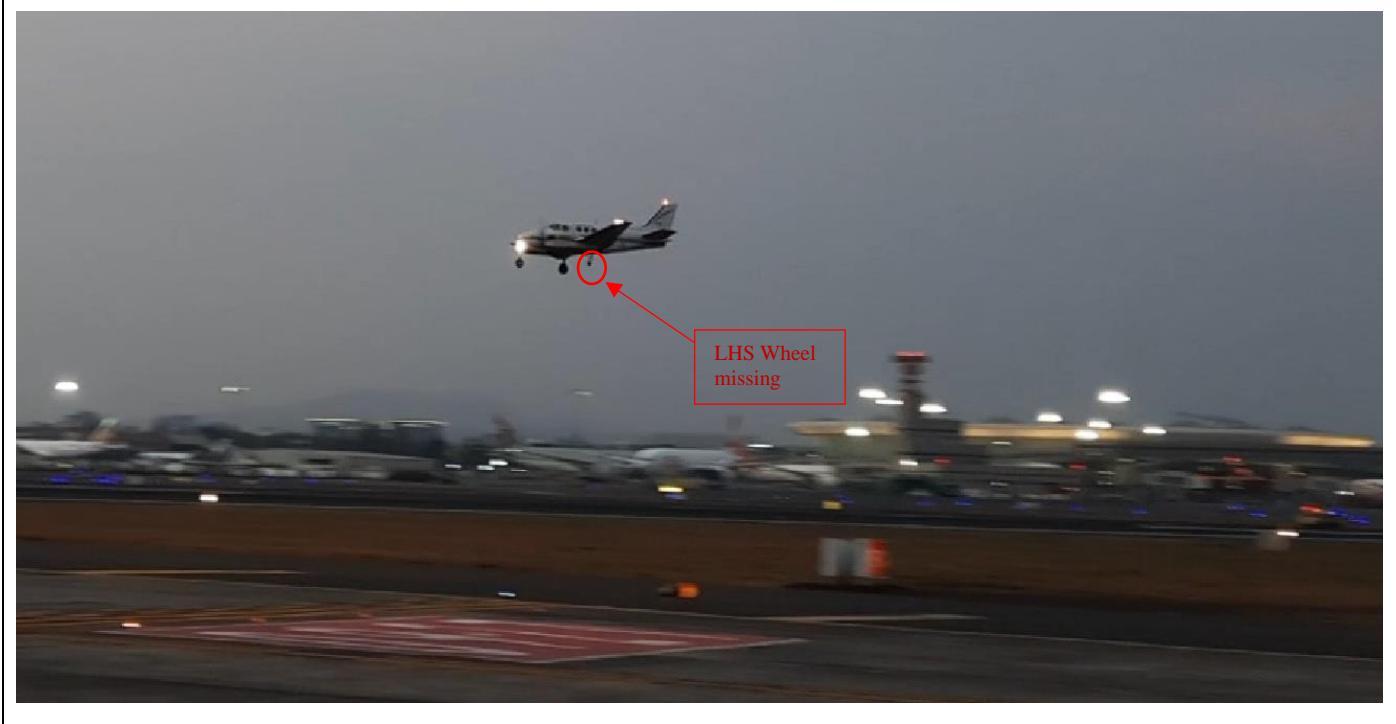
Figure# 38 VT-JIL performing low pass at RWY 27 at 13:43UTC

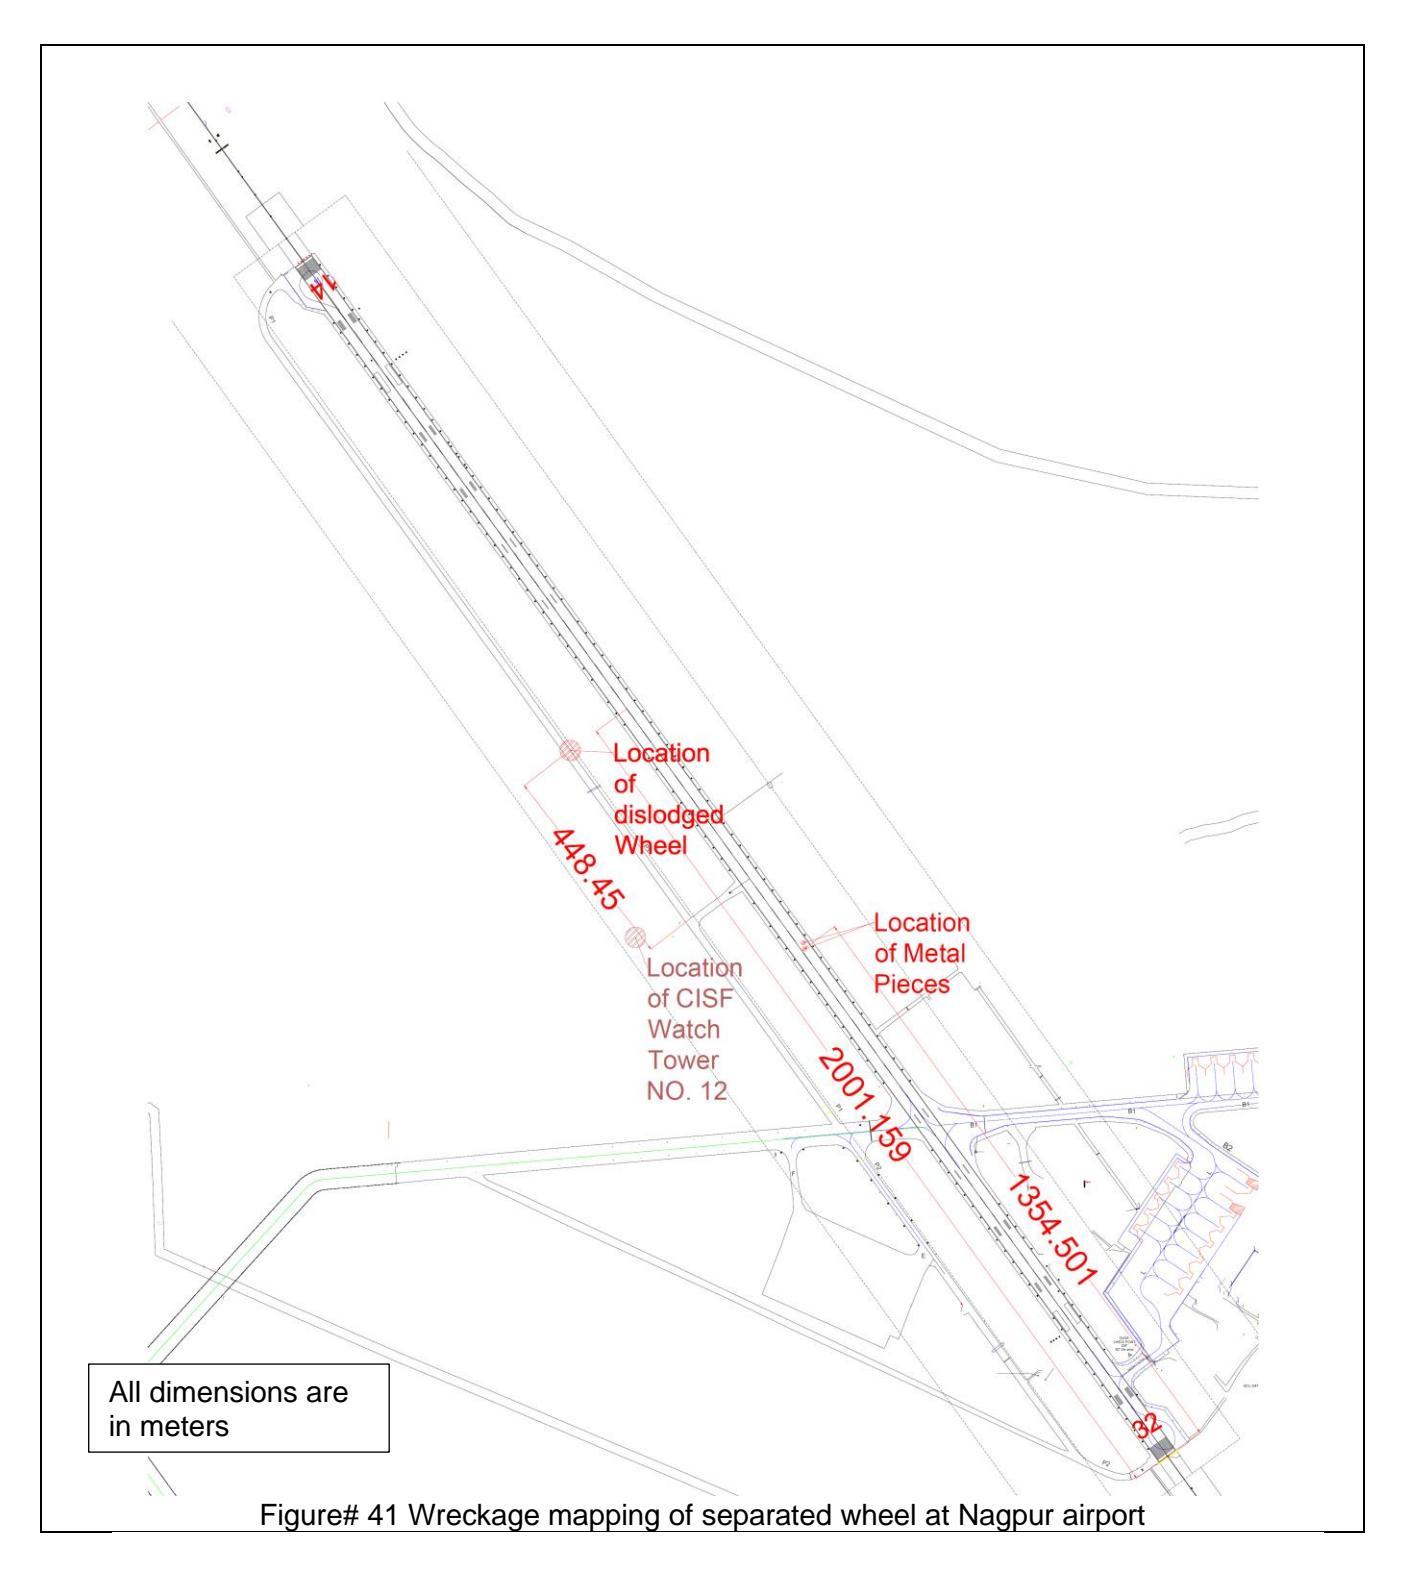
The above grid map image shows the location of the LH Main wheel and its metal pieces after separation from aircraft.

In order to find out other missing parts of the LH main wheel assembly, an extensive search operation was carried out at Nagpur airport in coordination with aerodrome safety team. The missing parts of the LH main wheel assembly could not be recovered during search operation.

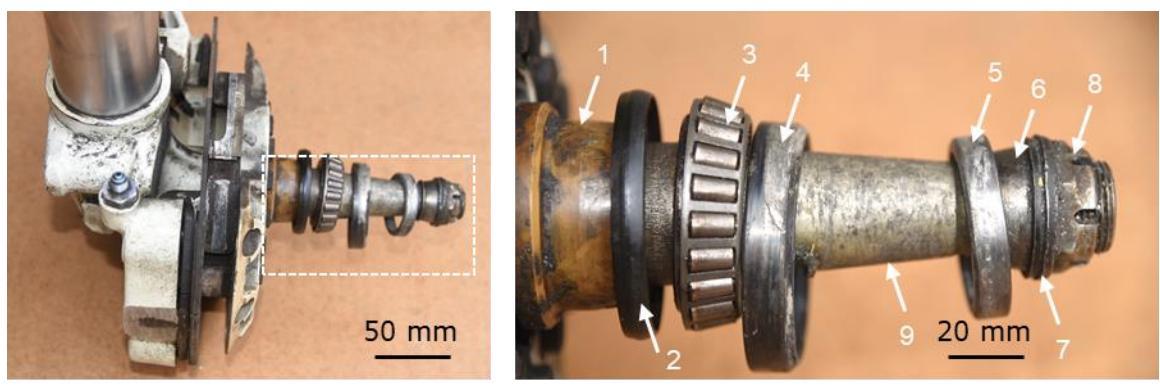
Examination revealed that all parts/components of the wheel hub assembly on the axle of the port MLG were in order and as per the IPC of the OEM (refer Fig.3).

Figure 3: (a) Axle assembly, and (b) magnified view of the region marked in (a); (1) retainer, (2) seal, (3) inner bearing cone assembly, (4) inner bearing cup, (5) outer bearing cup, (6) outer bearing cone, (7) washer, (8) nut, (9) axle

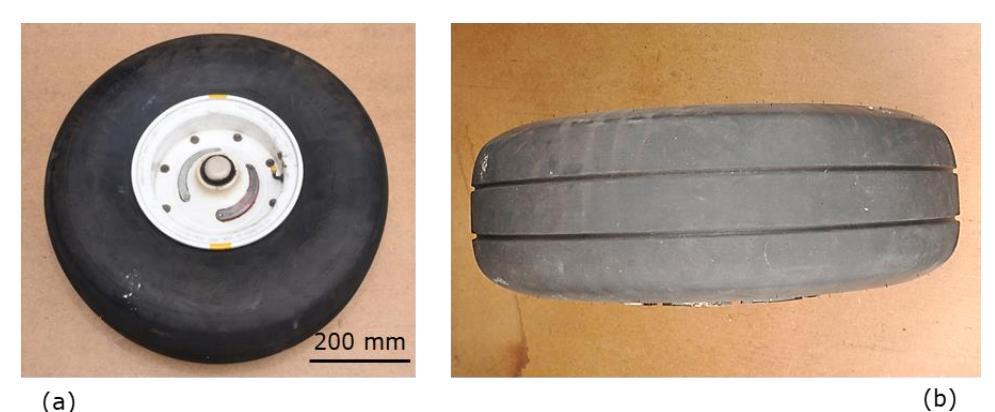
(a) (b) **Figure 4:** (a) Inboard surface of the wheel, and (b) tyre showing no damages

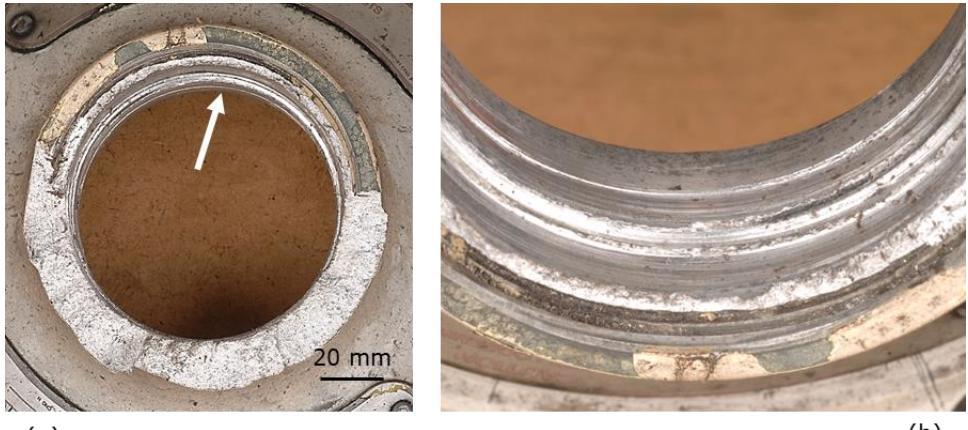
Figure 6: (a) Close-up view of the half hub bore marked 'A' in Fig.5 showing fracture along the circumference, and (b) bore surface in the region marked by an arrow in (a); note circular groove on the bore surface

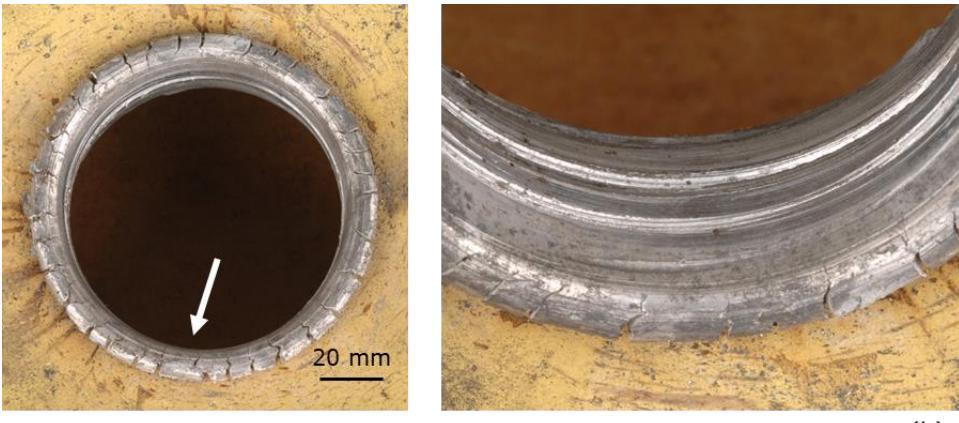
Figure 8: (a) Close-up view of the half hub bore marked 'B' in Fig.5, and (b) bore surface in the region marked by an arrow in (a); note deep circular groove and outward flow of material

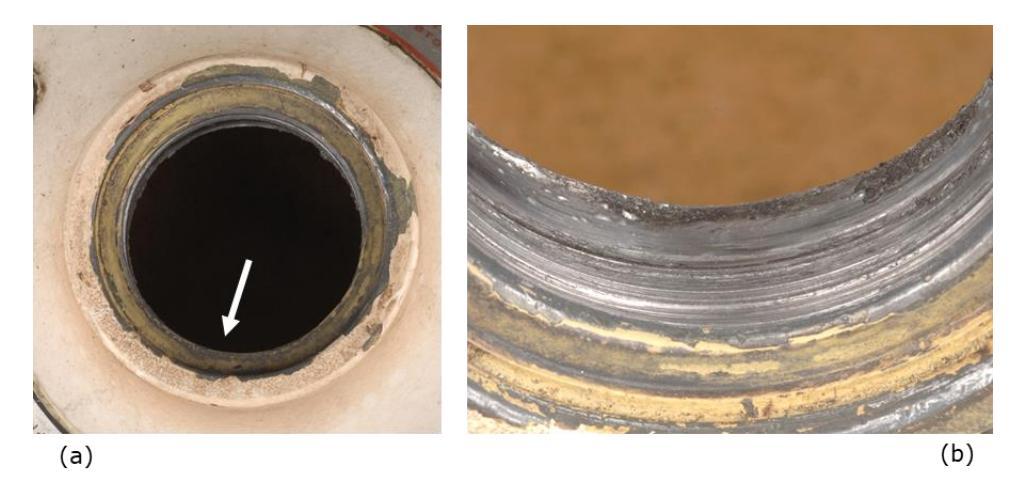
Figure 9: (a) Close-up view of the half hub bore marked 'C' in Fig.5, and (b) bore surface in the region marked by an arrow in (a)

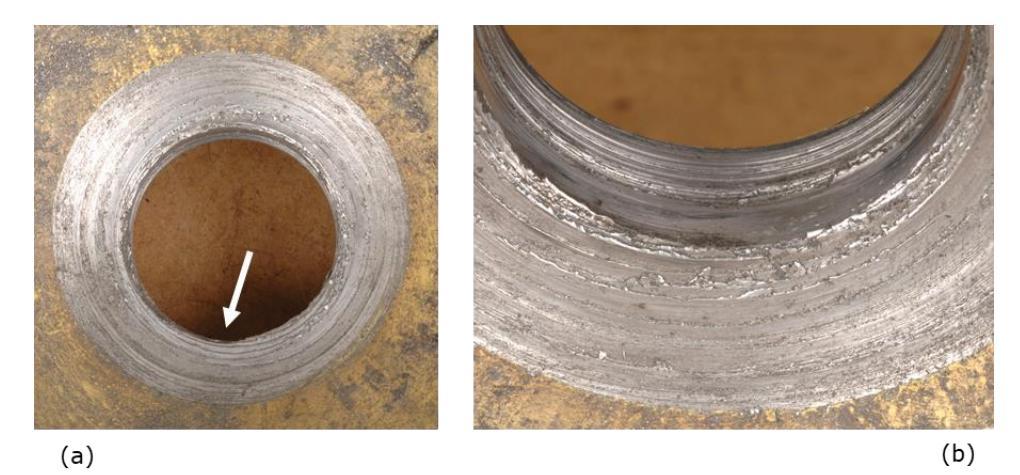
Figure 10: (a) Close-up view of the half hub bore marked `D' in Fig.5, and (b) bore surface in the region marked by an arrow in (a); note deep circular groove on the bore surface

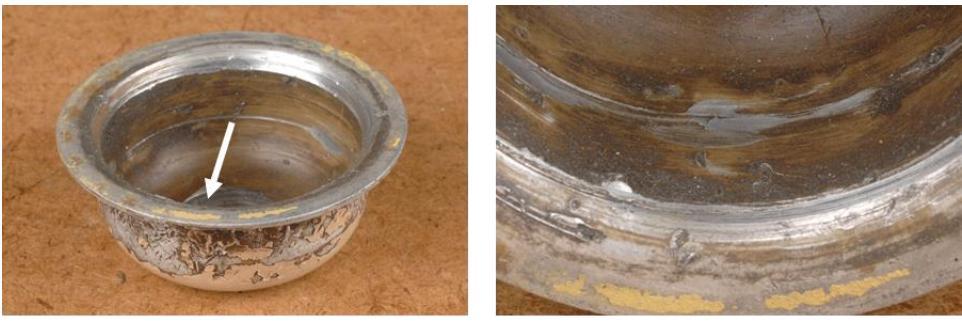
Figure 11: (a) Dust cap of the wheel hub assembly, and (b) close-up view of the region marked by arrow in (a) showing rubbing marks

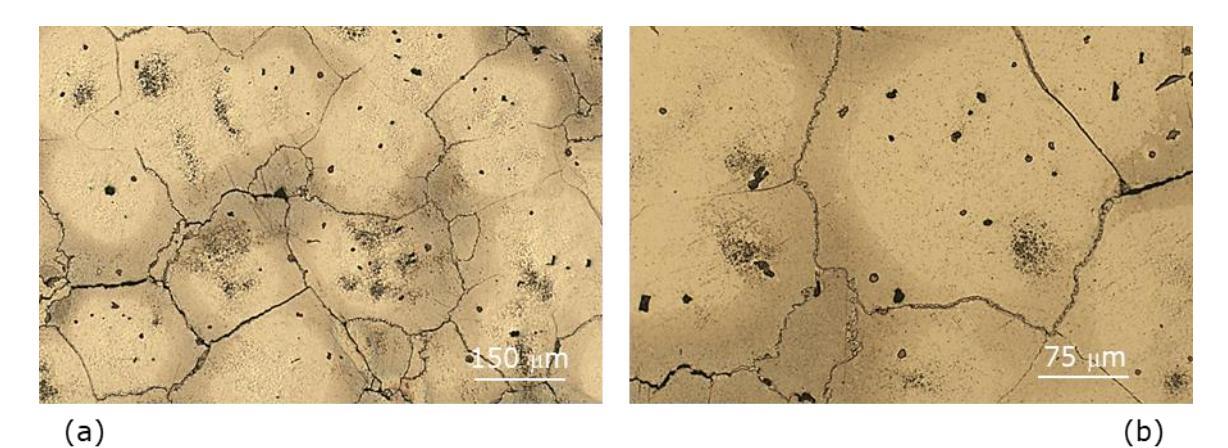
Figure 12: (a-b) Optical microstructure of wheel hub material consisting of α Mg-rich grains with β -phase at the grain boundaries

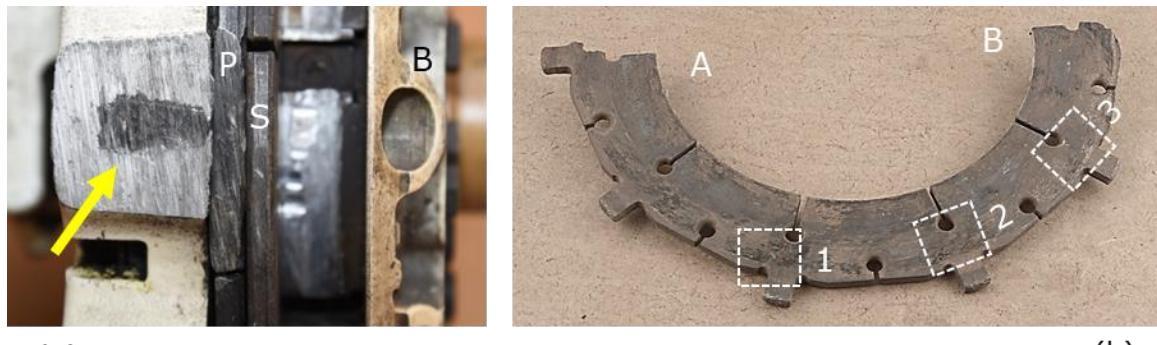
The brake assembly was found damaged and both the rotor plates were found missing (refer Fig.13(a)). It is reported that during post-accident check on the MLG extension and retraction, one-half of a rotor plate had fallen off from the assembly (refer Fig.13(b)). The other fragments of the rotor plates could not be retrieved and they appeared to have fallen off in air. While the pressure and the stator plates were available with all the shoes in place, shoes of the backing plate were found missing.

Figure 13: (a) Brake assembly with pressure plate (P), stator (S) and backing plate (B), and (b) one-half of fractured rotor plate that had fallen off during post-accident extension-retraction check; note damage on the structure due to friction with the runway surface shown by an arrow in (a)

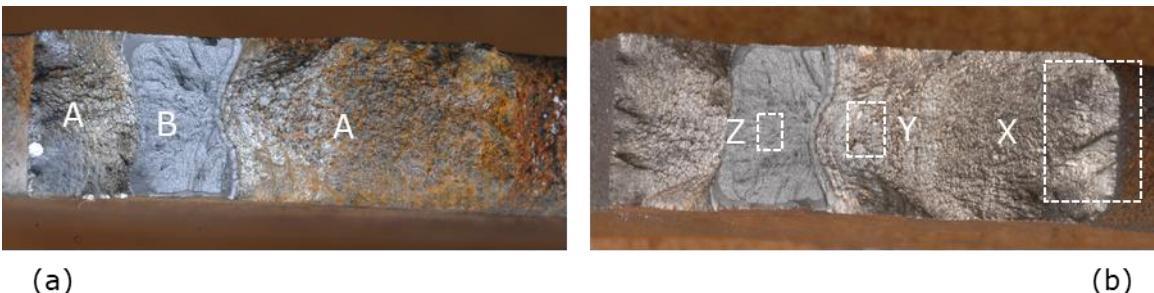
Further examination of the rotor plate showed presence of incipient cracks at three locations (refer Fig.15). Two of these cracks were pull opened for identification of the mechanism of crack initiation and propagation. The resulting fracture surfaces of a typical crack are shown in Fig.16. The fracture surfaces showed clearly delineated crack arrest marks or beach marks with wavy crack fronts, typical of fatigue mode of crack propagation. This was further confirmed through scanning electron fractography study wherein fatigue striations were observed in the progressive crack propagation zones (refer Fig.17(c)). In the freshly opened region, the fracture surface showed cleavage fracture features (refer Fig.17(d)).

Figure 16: (a) One of the mating crack surfaces of the incipient crack shown in Fig.15(a) showing existing crack surface (marked 'A') and freshly opened surface (marked 'B'), and (b) the fracture surface after cleaning by repetitive use of replicating tape

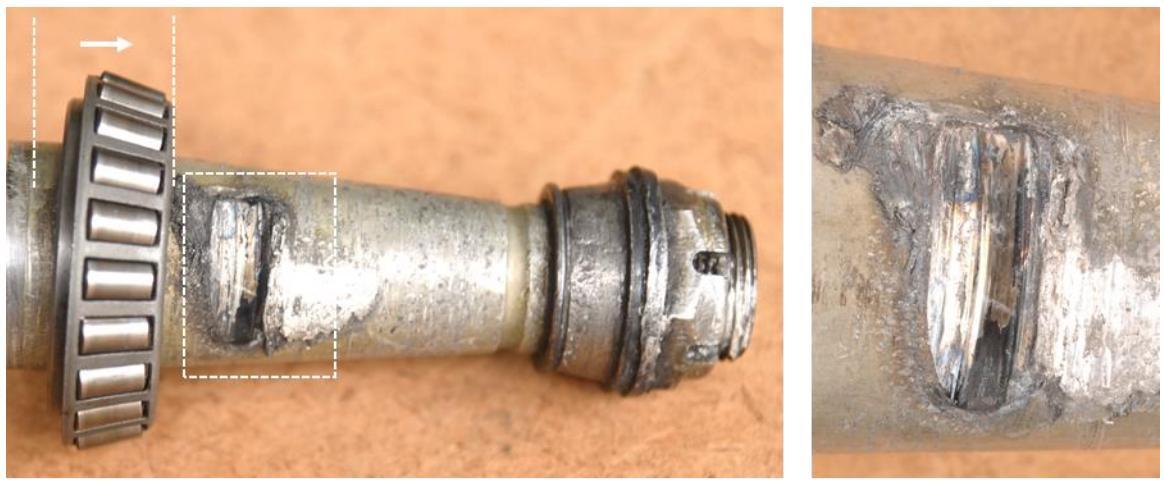
The axle of the MLG was sectioned from a location ahead of the inner bearing seal and removed from the assembly for detailed examination. It can be seen that the inner bearing had moved inboard from its position on the axle (refer Fig.18(a)). The deep dent mark seen on the axle was the result of impact of the wheel hub bore with the axle (refer Fig.18(b)). The dent location was on the bottom surface of the axle in fully extended position of the MLG. The impression was created by the cup of the inner bearing as shown in Fig.19(a-b). Discolouration of the dent surface shows that the cup along with the wheel rotated at this location for some time prior to its dislodgement from the wheel hub bore. On the rest of the axle, there were circular marks resulting from smearing of material from the wheel hub bore while the wheel was moving out of the axle during detachment. The locking assembly was found firmly stuck on the axle and hence, could not be removed by unwinding.

Figure 18: (a) Axle assembly in as-received condition, and (b) magnified view of the region marked in (a) showing dent on the axle; note discolouration on the dent surface due to frictional heat generation during rotation of the inner bearing cup along with the wheel hub on the axle

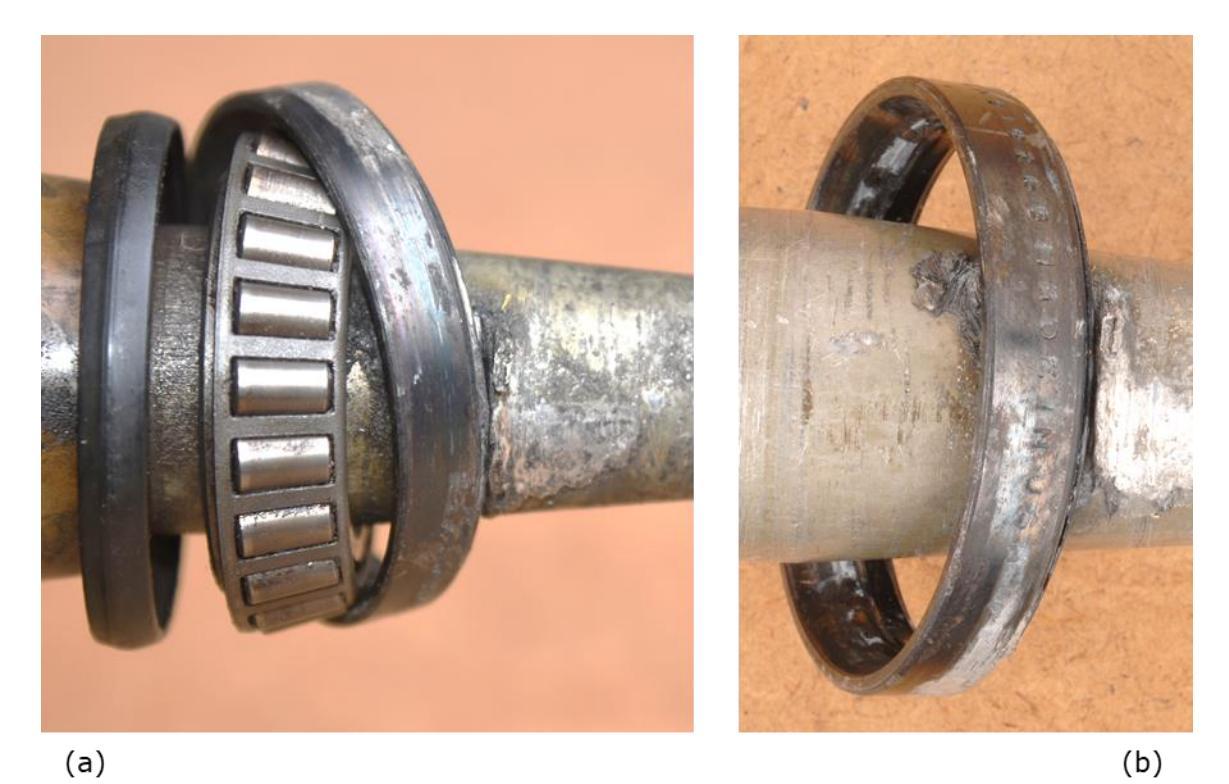
Figure 19: (a-b) Photographs showing the orientation of wheel hub while impacting on the axle

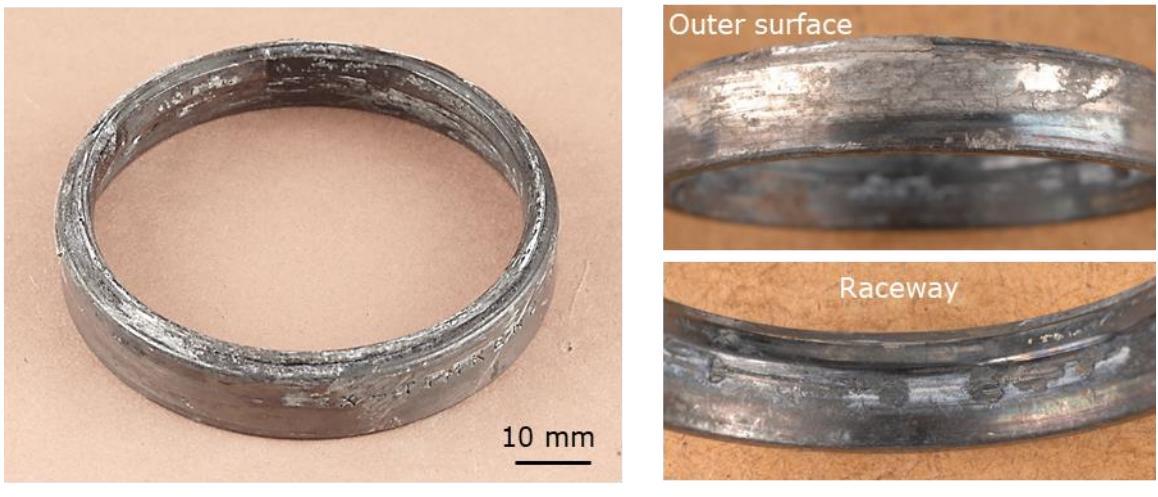
The cup was found to be severely damaged with flow of material on the raceway and severe heat effects (refer Fig.20). The nature of damages on the cup suggests that they occurred when the wheel came out of the cone assembly and was rotating on the axle during detachment. The damages, therefore, were secondary in nature.

Figure 20: (a) Damaged cup of the inner bearing, and (b) outer surface and raceway of the cup showing smeared wheel hub material on the outer surface and damages on the raceway

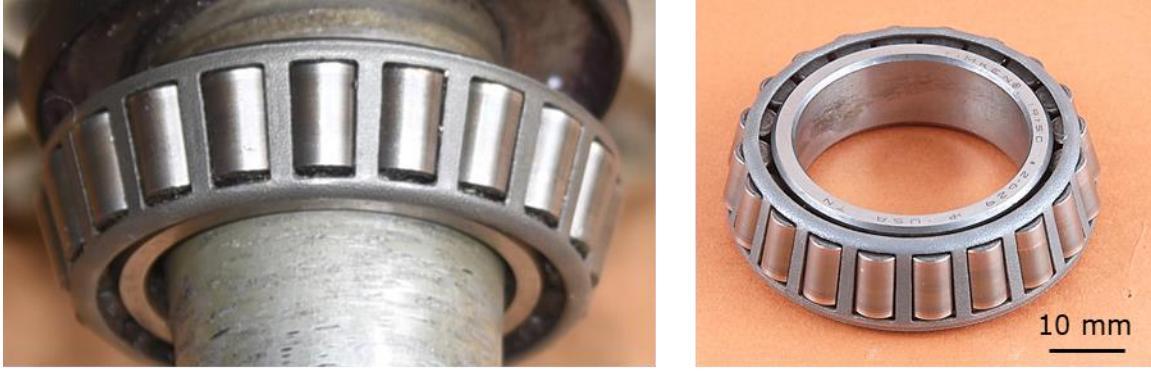
Figure 21(a-b) show the cone assembly on the axle, and after removal from the axle. The bearing was found freely rotating without any restriction. For further study, the bearing was disassembled by sectioning (refer Fig.22(a)). The surface of the rolling elements (rollers) presented a golden yellow to light blue colouration (refer Fig.22(b)). The discolouration of the rolling surface was due to heat generation during service. Examination of the rolling surfaces did not show any major mechanical damages (refer Fig.22(b-c)). The inner surface of the cone did not show any damage indicating that there was no relative movement between the bearing cone and the axle during service (refer Fig.22(d)).

Figure 21: Cone assembly of the inner bearing (a) in as-received condition on the axle, and (b) after removal from the axle

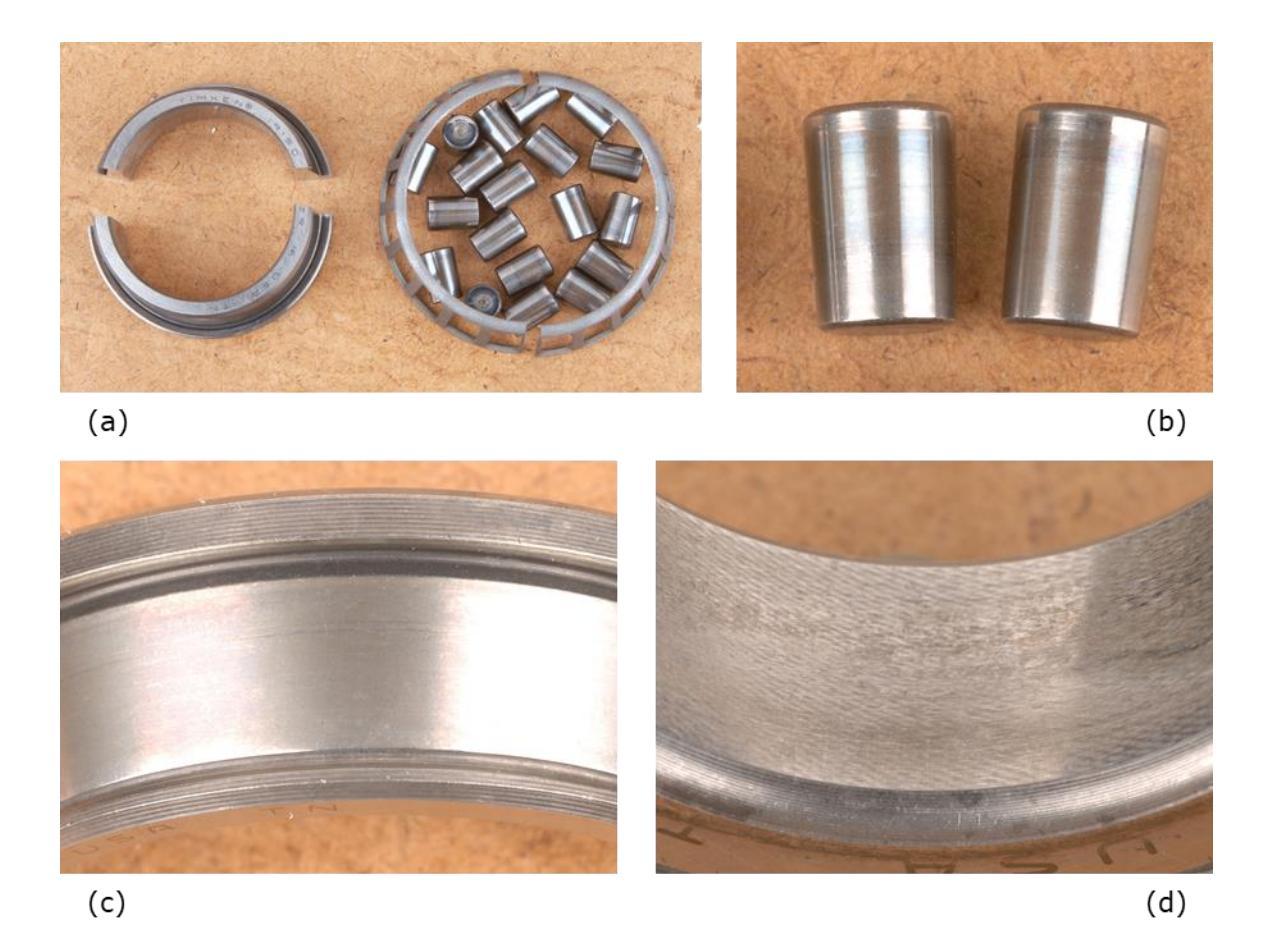
Figure 22: (a) Cone assembly of the inner bearing after dis-assembly, (b) rollers' surface, (c) raceway, and (d) inner surface of the cone fitted onto the axle

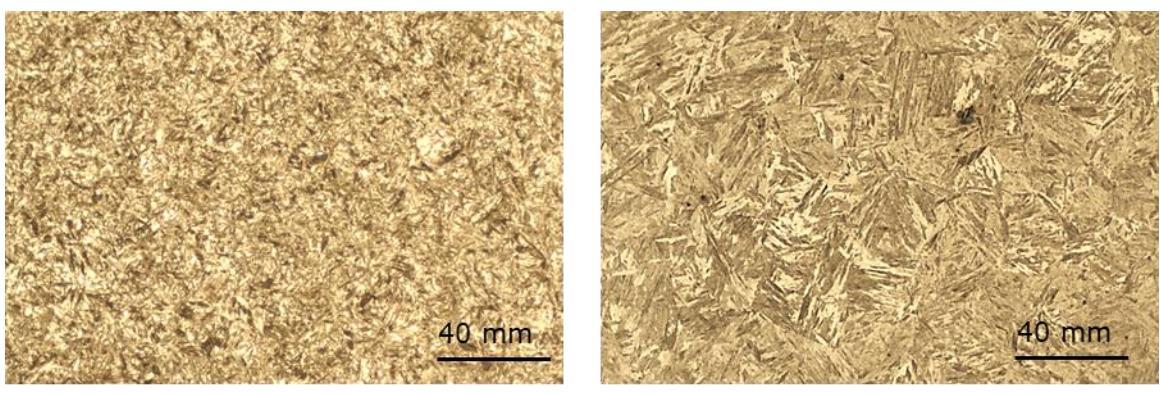
Metallurgical examination confirmed that the rolling elements of the bearing were made of case-hardened steel (refer Fig.23, Table 1). The surface hardness of the bearing elements was achieved through carburizing treatment. Examination revealed that there were no metallurgical abnormalities in the cone and rollers in terms of microstructure or hardness profile. (refer Fig.23-24). However, the cup of the bearing showed substantial decrease in hardness due to heat effects (refer Fig.24). Metallography study showed that as a result of rotation of the cup on the axle under load, not only there was heat generation but also deformation and flow of material (refer Fig.25).

Figure 23: Optical microstructure of (a) case, and (b) core of rollers, typical of case-hardening microstructures; similar microstructures were observed on the cone of the bearing as well

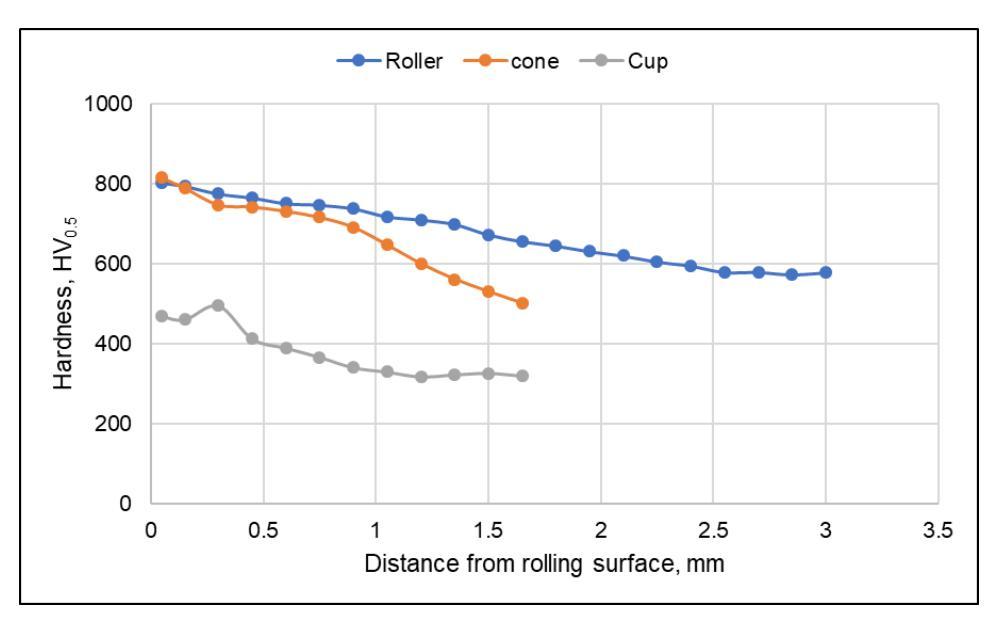
Figure 24: Hardness as a function of distance from the rolling surface of rollers, cone and cup of the inner bearing

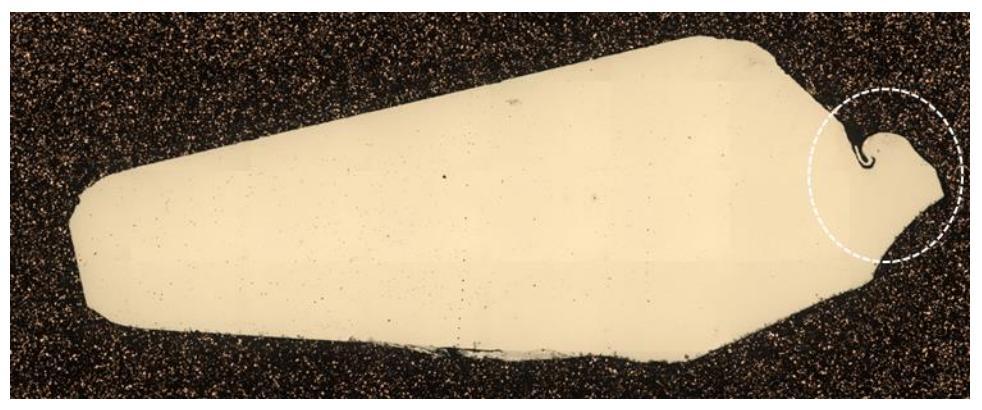
Figure 25: Cross section of the inner bearing cup showing deformation and flow of material at the region of contact with the axle during rotation under load

Results of semi-quantitative composition analysis of cup and cone of the outer bearing are given in Table 2. Results of hardness survey conducted on the cone and cup are shown in Fig.30. Comparative study with the inner bearing showed that the hardness of the cone and cup of the outer bearing decreased substantially because of severe heat effects. However, examination did not reveal any gross deformation in the cup as seen in the case of inner bearing cup (refer Fig.25 and Fig.31).

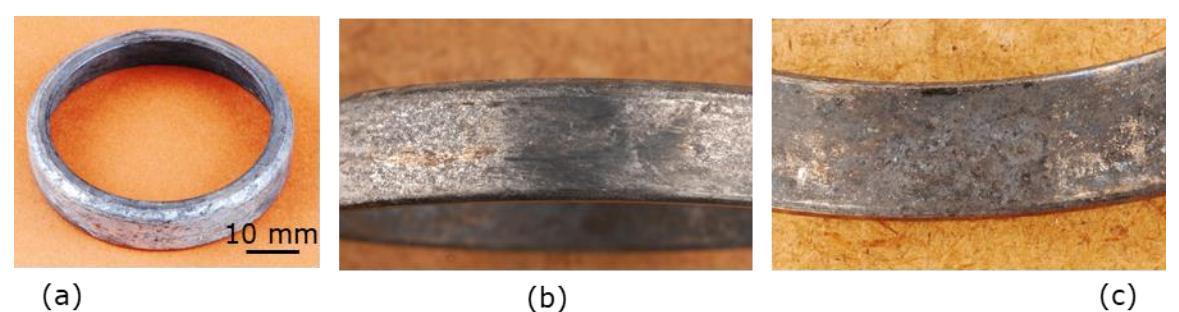
the surface accompanied by plastic flow of material (refer Fig.27(a)). Inner surface of the cone showed signatures of adhesion with the axle (refer Fig.27(b)).

Figure 27: (a) Raceway of the cone of outer bearing showing damages, and (b) inner surface of the cone showing adherence of material
