FINAL REPORT ON ACCIDENT INVOLVING BEECHCRAFT KING AIR C90A AIRCRAFT VT-JIL OPERATED BY M/s JET SERVE AVIATION PVT LTD AT MUMBAI ON 06TH MAY 2021

Government of India Ministry of Civil Aviation Aircraft Accident Investigation Bureau

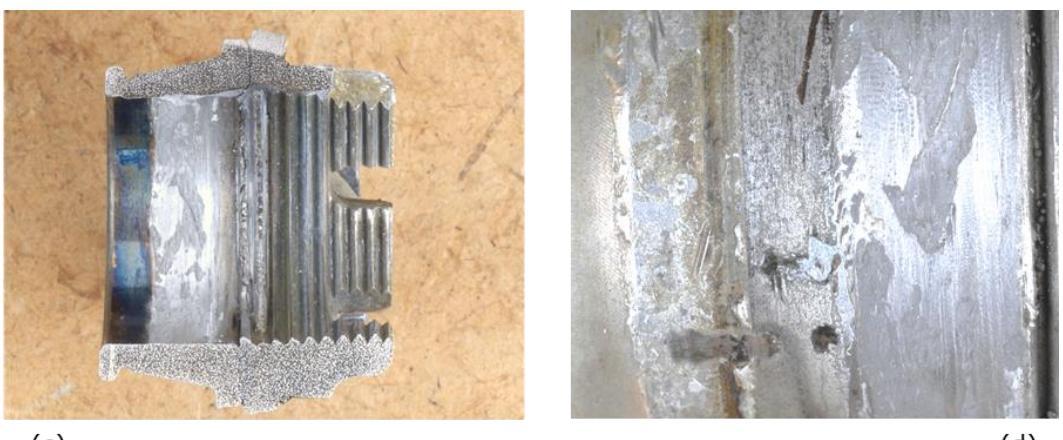
For further study, one-half of the lock assembly was removed from the axle by sectioning using electro discharge machining (EDM) (refer Fig.28(a-c)). The exposed bearing seating area on the axle is shown in Fig.28(d)). Adhesion of bearing cone material on the axle surface can be seen. The axle surface also showed deep scoring marks due to relative rotational movement between the cone and the axle.

Figure 28: (a) Lock assembly with cone of the outer bearing, and (b) exposed surface of the axle at the bearing seating after removal of half of the assembly by EDM shown in (c), and (d) close-up view of the region marked in (b) showing adhesion of material

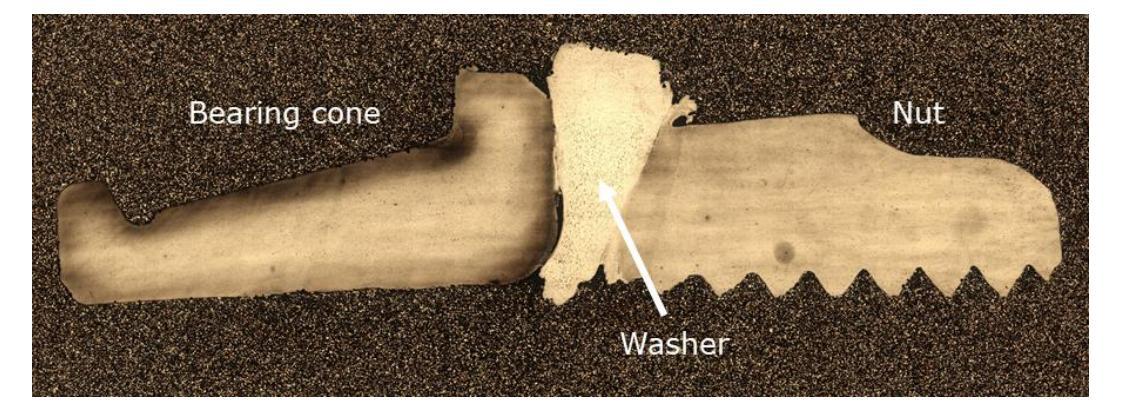
Figure 29 shows the longitudinal section of the bearing cone along with the washer and the nut. Examination revealed that all these components fused together and formed a single body. It can be seen that the temperature in the bearing was so high that the washer got deformed and firmly bonded with the nut and the cone under the load that acted in the axial direction. The deformation in the washer and the nut also facilitated movement of the bearing cone in inboard direction.

Figure 29: Longitudinal section of the outer bearing cone with washer and nut

The damages to the outer bearing, however, were very severe. The frictional heat generation in the bearing was so high that the cone, washer and nut got fused together. Also, there was adhesion between the cone and the axle. Generation of significant fraction of the debris with particle size less than 50 μ m indicated that there was progressive deterioration on the rolling surfaces of the bearing. The deterioration of the rolling surfaces resulted in frictional heat generation leading to substantial decrease in hardness of both cone and the cup. Considering the severity of damages on the outer bearing elements as a whole, it appears that the bearing was running in distressed condition for a prolonged period of time.

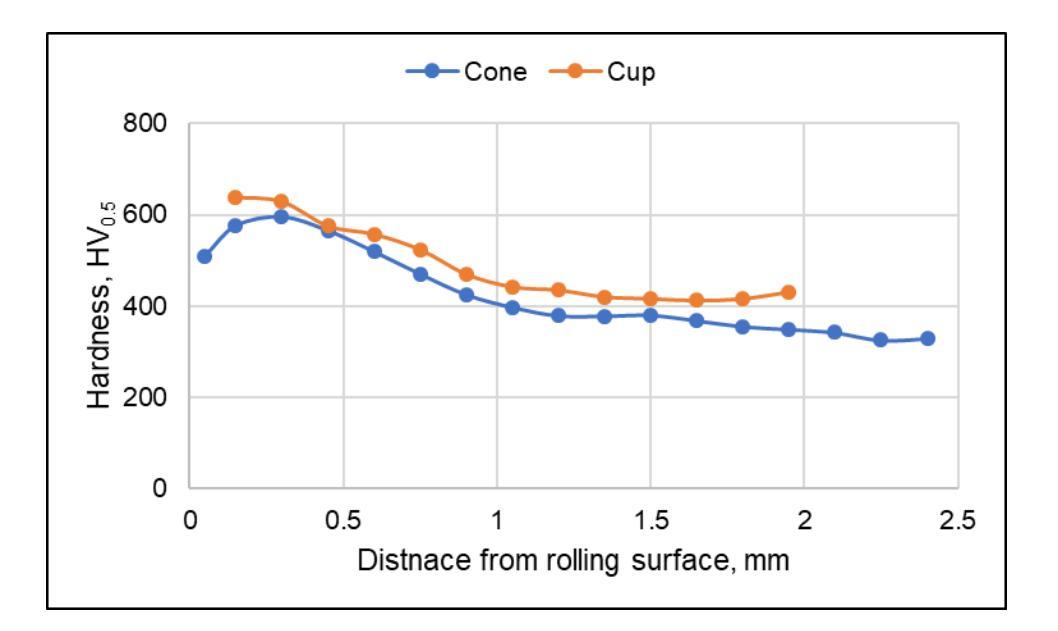
Results of semi-quantitative composition analysis of cup and cone of the outer bearing are given in Table 2. Results of hardness survey conducted on the cone and cup are shown in Fig.30. Comparative study with the inner bearing showed that the hardness of the cone and cup of the outer bearing decreased substantially because of severe heat effects. However, examination did not reveal any gross deformation in the cup as seen in the case of inner bearing cup (refer Fig.25 and Fig.31).

Figure 30: Hardness as a function of distance from rolling surface of cone and cup of the outer bearing

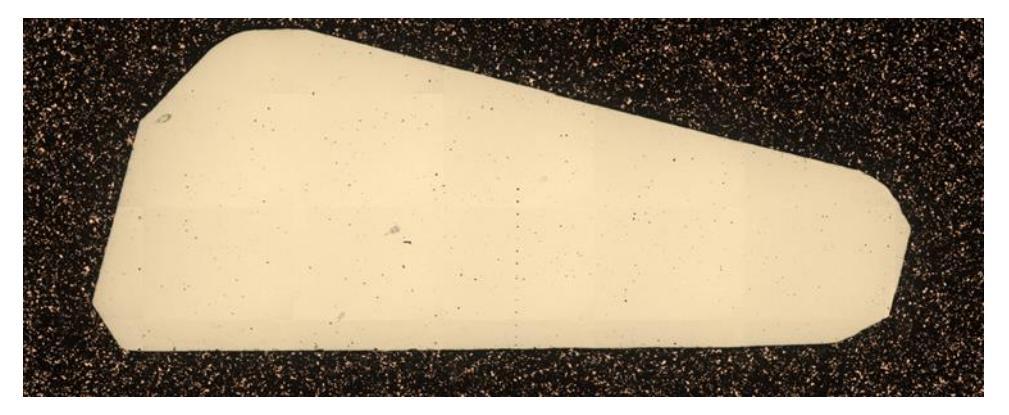
Figure 31: Cross section of the outer bearing cup; note no gross deformation or change in the shape

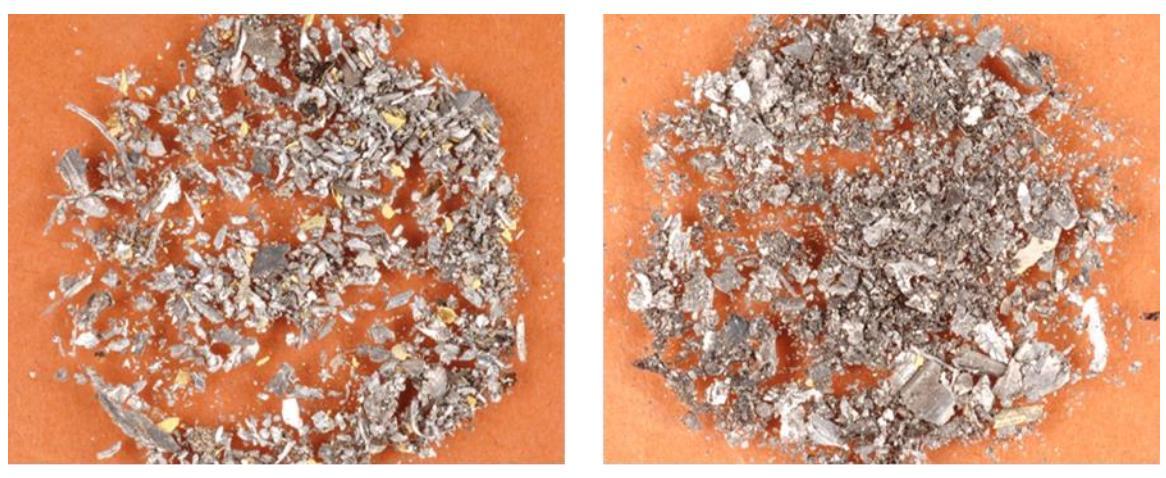
To remove greasy material, the debris collected from inside the dust cap was dissolved in acetone. By decanting the solution, the sediment was collected and examined. Examination revealed that the sediment contained fine particles and chips. The particles and chips collected were nothing but the debris generated from the wheel hub and/or the outer bearing. This is stated based on the fact that except for the wheel hub, the outer bearing, and the sheared parts of locking pin, there was no loss of material from any of the components of the axle assembly.

By using a magnet, the magnetic and non-magnetic particles/chips in the debris were separated (refer Fig.34). However, composition analysis revealed that most of the chips, irrespective of whether magnetic or non-magnetic, showed predominantly magnesium (Mg) on the surface (refer Table 3). Since Mg or Mg-alloy is non-magnetic in nature, the magnetic behaviour of the chips could be explained only if magnetic material was smeared with a layer of Mg on the surface. To examine this, a sample was prepared wherein a few chips were mounted in bakelite and polished metallographically. Examination of this sample confirmed that the debris which were magnetic in nature, contained chips from the bearing elements with smeared layer of Mg-alloy on the surface (refer Fig.35 and Table 4). Examination also confirmed that substantial fraction of the fine particles in debris contained iron (Fe) indicating that they got generated from the bearing elements (refer Fig.36 and Table 5).

Figure 34: Debris collected from the dust cap after cleaning in acetone, and separation using a magnet: (a) non-magnetic, and (b) magnetic

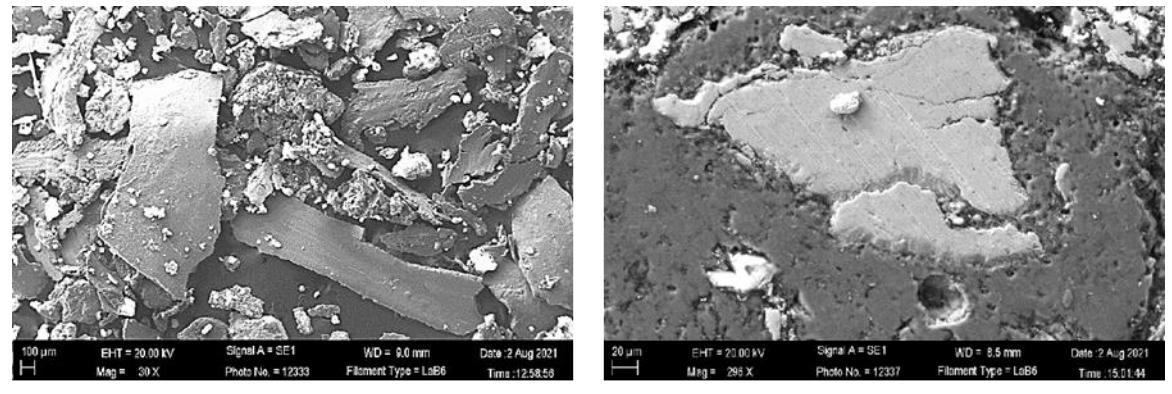
Figure 35: (a) Secondary electron (SE) image of magnetic chips, (b) metallographic section of a typical chip, and (c-d) X-ray dot mapping for elements Fe and Mg respectively on the region shown in (b); dark region in (c) and (d) represents absence of the element mapped

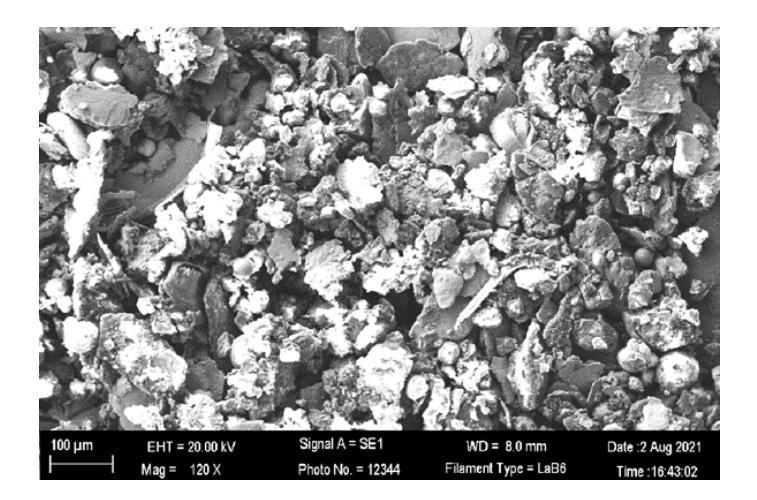
Figure 36: SE image of fine particles in the debris collected from the dust cap

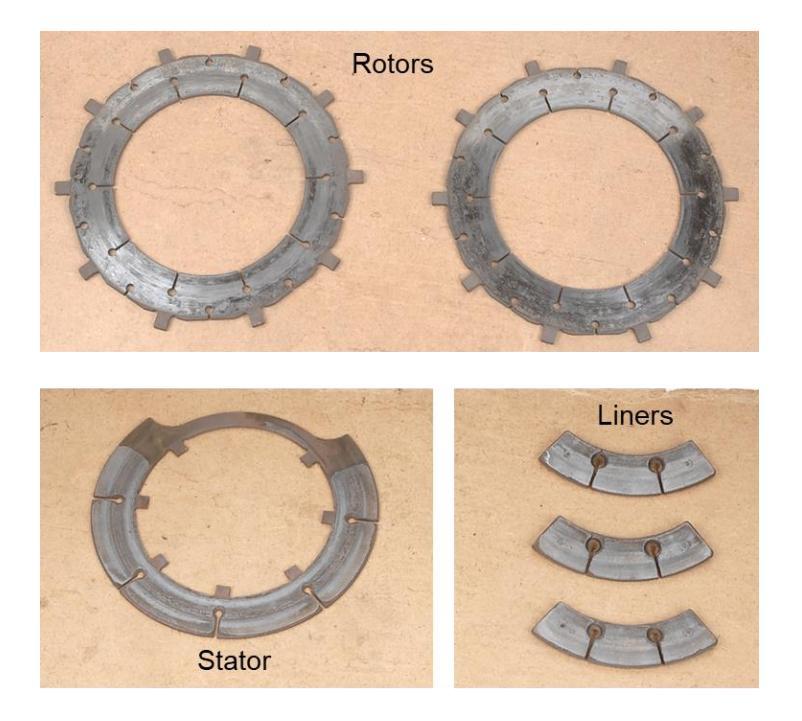
Figure 37 shows the brake assembly components received for investigation. Examination revealed no incipient cracks in any of the rotor or stator plates. No abnormalities were observed in any of the components except for normal wear and tear.

Figure 37: Components of the starboard axle brake assembly received for examination

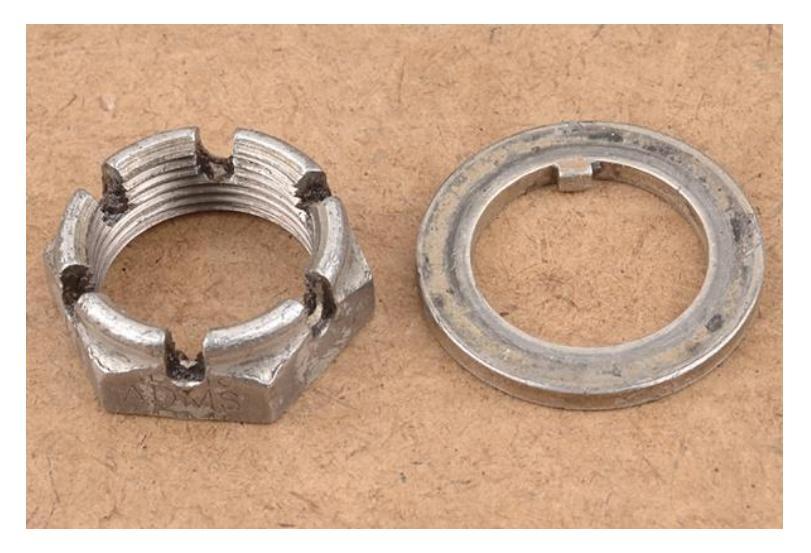
Figure 38 shows the washer and the nut of the starboard MLG axle lock assembly. Examination did not show any abnormalities in any of these components. The threads on the nut were found in good condition.

Figure 38: Washer and nut of the starboard axle lock assembly

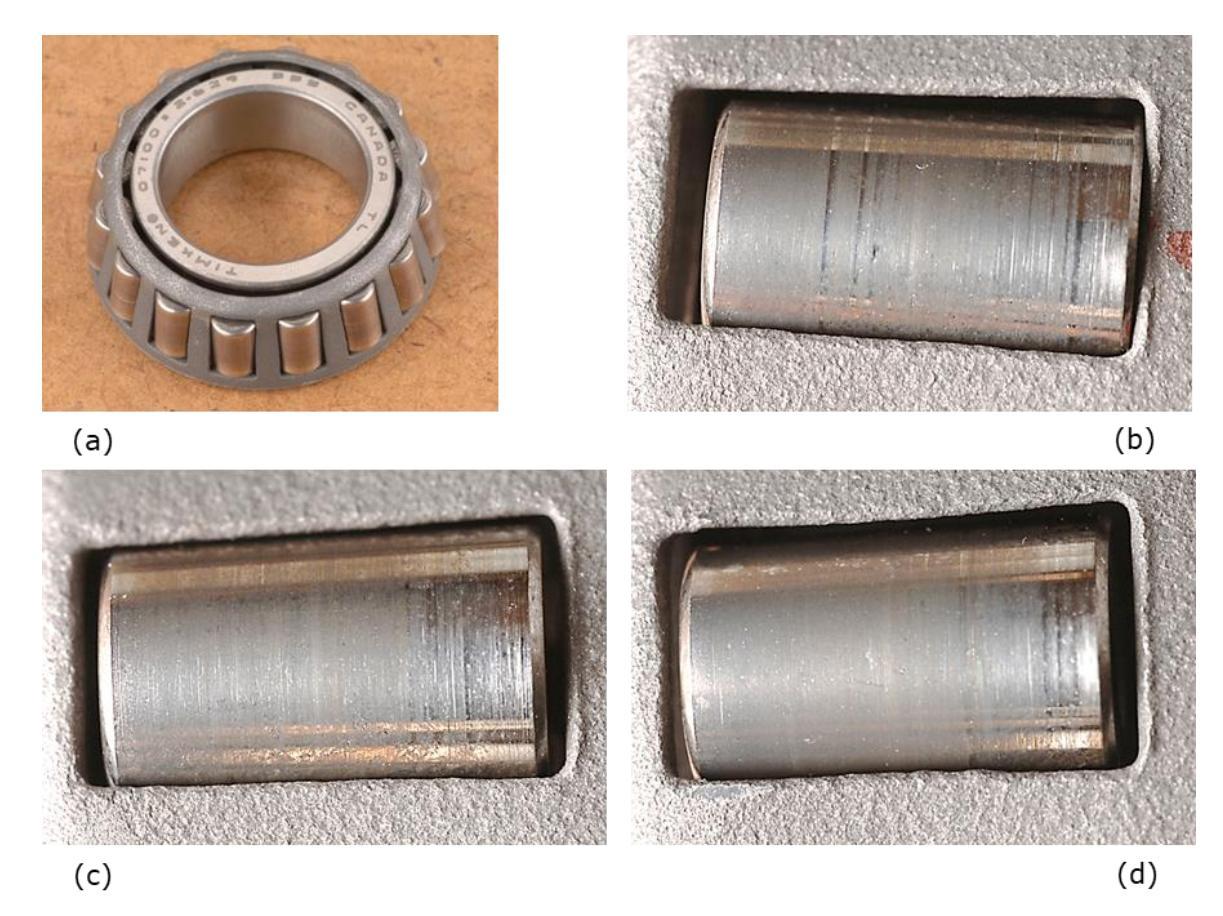
Figure 39(a) shows the outer bearing of the starboard MLG wheel assembly. Visual and stereo-binocular examinations revealed that the roller surfaces had dull appearance and deep scoring marks, indicative of overall deterioration of the rolling surfaces (refer Fig.39(b-d)). Further examination of the roller surfaces in SEM showed widespread pitting and spalling. The typical damages observed on the rollers are summarized in Fig.40-42.

Figure 39: (a) Cone assembly of the outer bearing, and (b-d) appearance of surface of three typical rollers
