# Final Investigation Report on Serious Incident to M/s SpiceJet Ltd. Aircraft VT-SYZ (Boeing 737-800) in PATNA Airspace on 17 November 2021

**Gp Capt Rajendra Pratap Singh VSM (Retd.)**  
**Investigator-in-Charge**

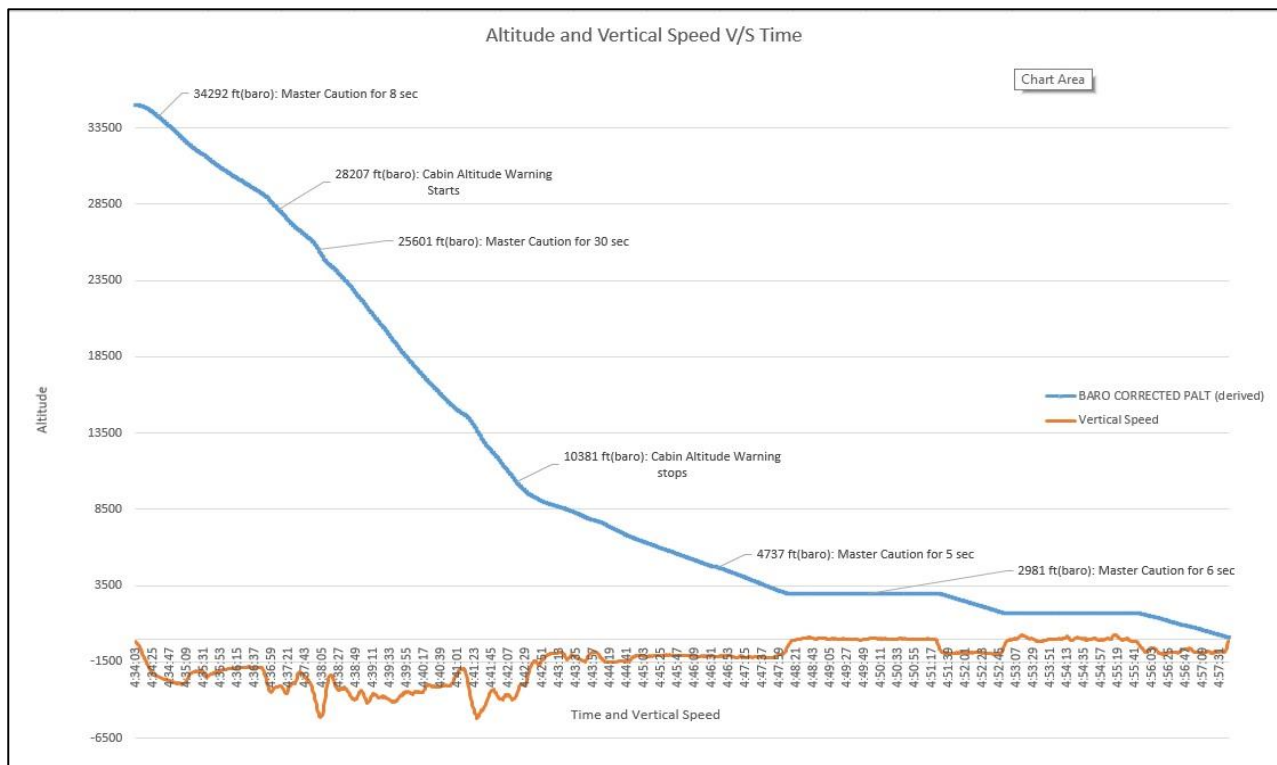
**Fig 7: Graph Altitude and Vertical Speed v/s Time**

The aircraft rate of descent from top of the climb (35004 ft at 04:34:01UTC) to the point of annunciation of Master Caution and Auto Fail light on (34292 ft at 04:34:32UTC) was approx. 1378 Ft/min.
