**FINAL INVESTIGATION REPORT
ON
SERIOUS INCIDENT INVOLVING
M/s SPICE JET'S B737-800 AIRCRAFT VT-SZN
AT SEYCHELLES ON 14 SEPTEMBER 2021**

**GOVERNMENT OF INDIA
MINISTRY OF CIVIL AVIATION
AIRCRAFT ACCIDENT INVESTIGATION BUREAU**

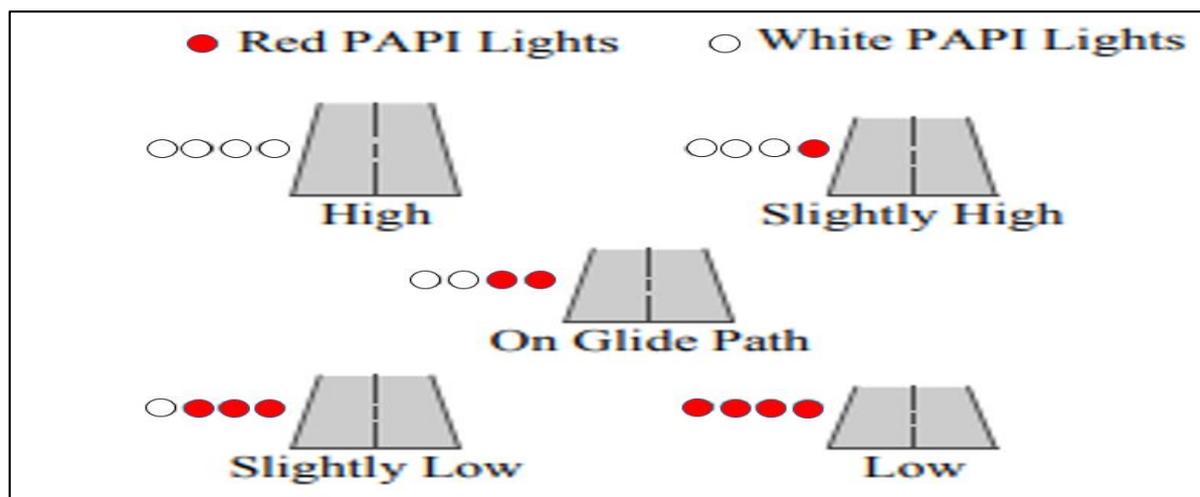
Figure 6: Precision Approach Path Indicator landing geometry

They provide a visual guidance to the pilot in non-precision approaches as indication of their aircraft's position relative to the correct glide path for the runway. The lights are colour-coded and are typically placed approximately 300 metres from the landing threshold of the runway on the left-hand side. When the airplane is on a normal 3° glide path, the pilot sees two white lights on the left and two red lights on the right. Light combinations as per Figure 6 above indicate when aircraft is slightly high, high, slightly low and low.

- 3.1.6 As per the AIP, the Precision Approach Path Indicator (PAPI) for Runway 13 is offset to NE and must not be used when more than 2.6 nm from the runway due to intervening high ground to the right of approach path. The aircraft was wings level at about 2.36 nm but crew did not follow the PAPI while approaching runway.
- 3.1.7 V_{APP} was selected less than recommended value and RoD was maintained higher than required for a portion of approach till 150 ft AGL.
- 3.1.8 The flight crew went ahead to complete the return sector without removal/downloading of CVR, which resulted in non-availability of the CVR recording.
- 3.1.9 Flight crew were not able to not notify the company from Seychelles regarding “Landing short on Runway 13” at Seychelles, but a Voluntary Report was filed on return to Chennai on the same night.
