Aircraft and Accident details of Cessna 152 Aircraft VT-ALI on 25 July 2022			
1	Aircraft	Type	Cessna 152
		Nationality	Indian
		Registration	VT – ALI
2	Owner		M/s Academy of Carver Aviation Pvt. Ltd
3	Operator		M/s Academy of Carver Aviation Pvt. Ltd
4	Pilot – in –Command		SPL holder
	Extent of injuries		Minor Injury
6	Passengers on Board		Nil
7	Place of Accident		Kabdanwadi(Indapur)Village, Pune
8	Date & Time of Accident		25 July 2022 &0543 UTC (approx)
9	Last point of Departure		Baramati Airfield
10	Point of intended landing		Baramati Airfield
11	Latitude/Longitude of accident site		Lat 18° 08'05.694"N, long 74°50'57.163"E
12	Type of operation		Solo Cross Country Training Flight
13	Phase of Operation		Cruise
14	Type of Accident		Fuel (Fuel Exhaustion)

On 25 July 2022, Cessna152 aircraft with registration VT-ALI of M/s Academy of Carver Aviation Private Limited (ACAPL), while carrying out a solo cross country training sortie, on the route Baramati-Akkalkot-Baramati, made a forced landing on an agriculture field near Kadbanwadi (Indapur) village at 0543 UTC.

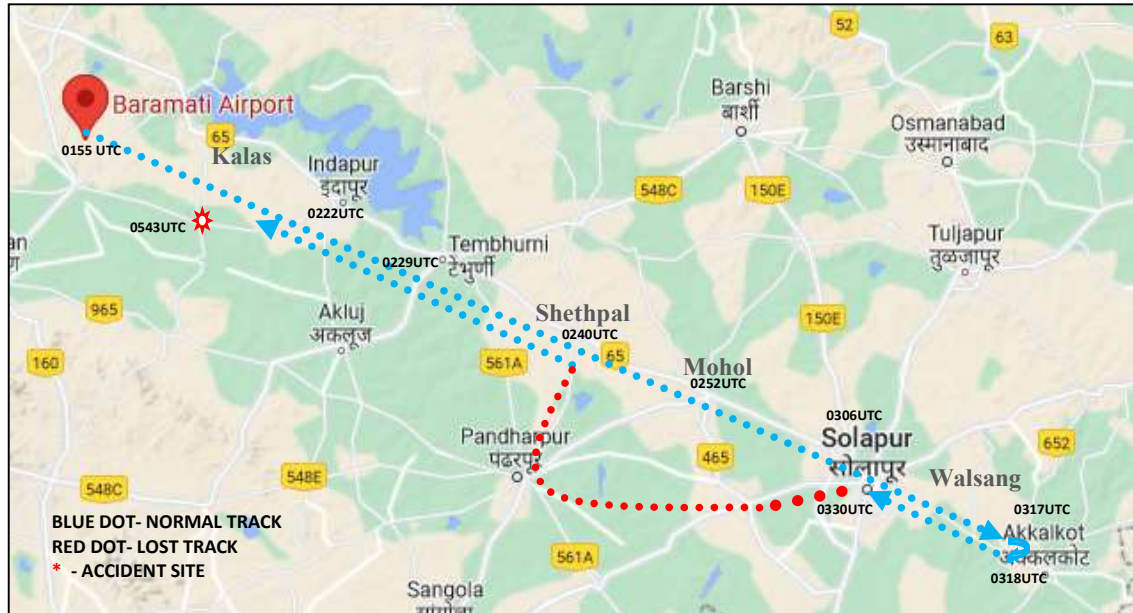
**Figure 1: Cross country route (courtesy to Google map)**

As per the statement of the trainee pilot, after Solapur, aircraft got deviated from its route as the trainee pilot followed a wrong visual reference i.e., a different highway and the aircraft heading was also not monitored.

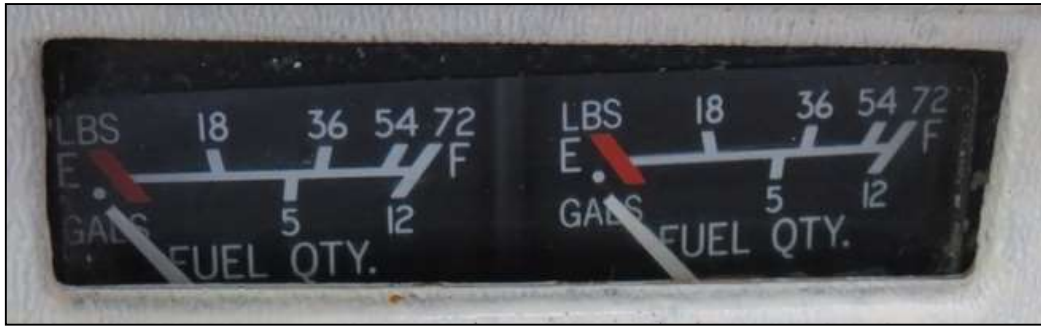
**Figure 4: Fuel Quantity Indicator**

During the onsite wreckage examination by the investigation team, both wing fuel tanks were found intact and almost empty i.e., RH tank was empty however, approximately 1.2 litres of fuel was drained out from the drain point of LH tank. Approximately 50ml of fuel was drained from the fuel strainer. Fuel system related components from tanks till engine intake, such as fuel tank, wing-fuselage attachment points and fuel supply lines etc. were inspected for leakage or abnormalities. However, no sign of fuel leakage or abnormalities were found. Further, Spark plug and magneto were also inspected to ascertain its condition and same was found satisfactory.

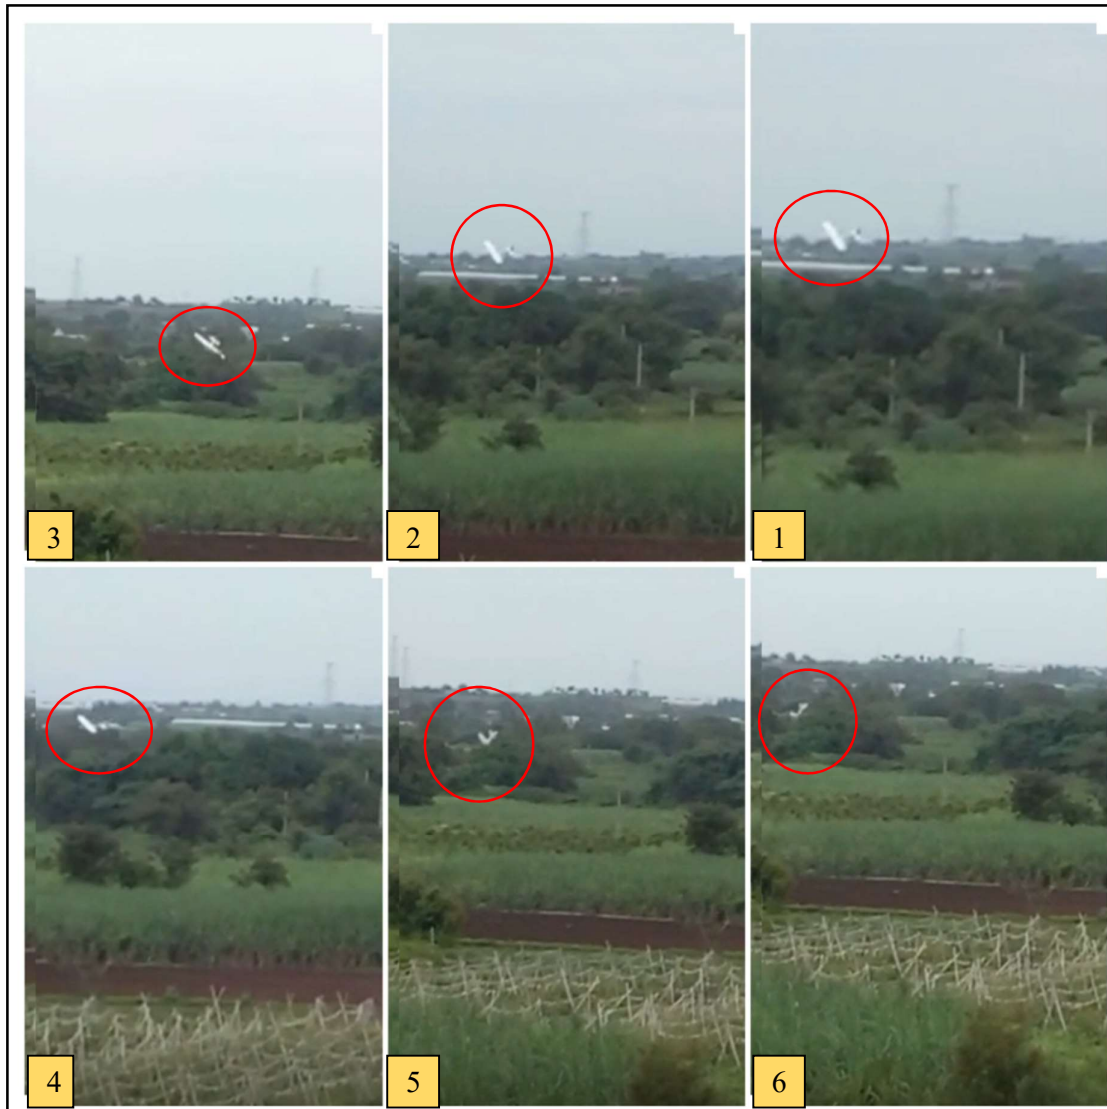
**Figure 7: Aircraft images just before crash**

Trainee Pilot searched for appropriate landing location. While executing the force landing, aircraft descended in LH circuit, aircraft LH wing and landing gear brushed the top branches of approx 30ft Neem tree in the landing path. Thereafter, aircraft's propeller hit the ground first with a steep angle. Due to impact propeller assembly got separated from the propeller hub and remained stuck in the ground. Then aircraft bounced on its RH wing and turned approx 90°. Before coming to rest aircraft's tail cone section dragged for approx 10 ft. Finally, aircraft came to rest on its two main landing gears with the support of empennage.
