**Final Report on Serious Incident Involving Airprox between
M/s Air India, B787 aircraft VT-ANM and
M/s Virgin Atlantic Airways, B787 aircraft G-VBZZ in Mumbai Oceanic region on
14 Sep 2022**

**Aircraft Accident Investigation Bureau
Government of India
Ministry of Civil Aviation**

Final Report on Serious Incident involving Airprox between Air India's B787 aircraft VT-ANM and Virgin Atlantic's B787 aircraft G-VBZZ in Mumbai Oceanic region on 14 September 2022

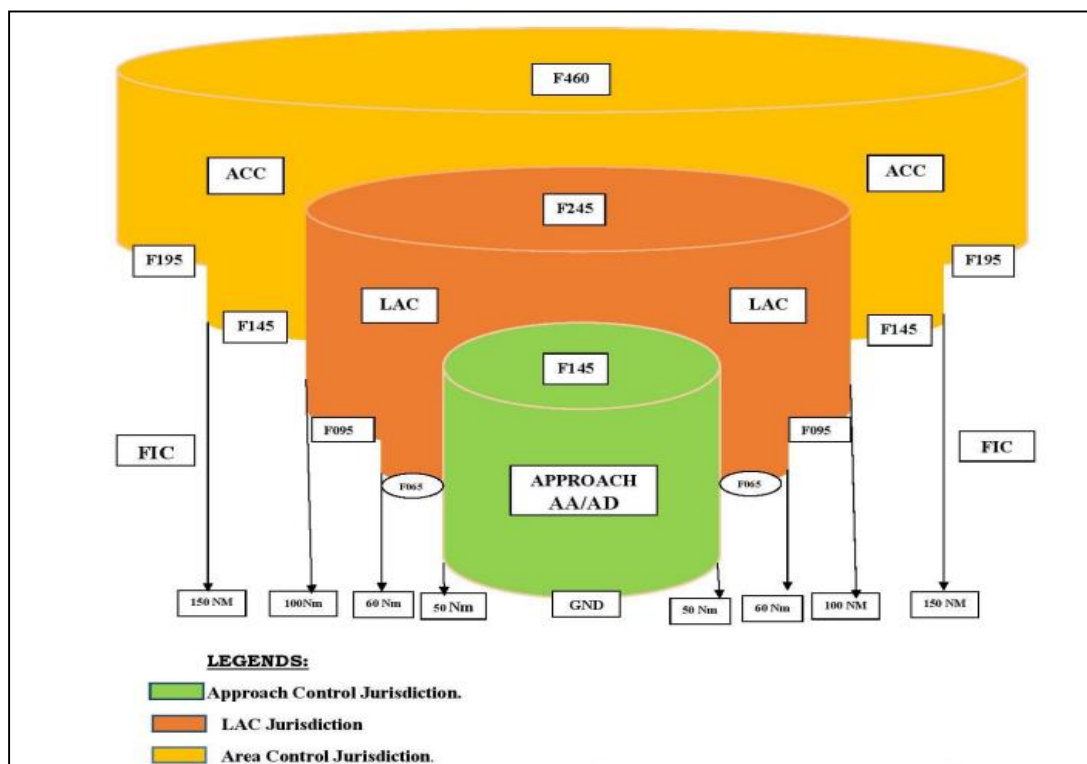
Fig 10: Jurisdiction of Mumbai Approach, LAC and Area Control

Jurisdiction of Mumbai Approach, LAC and Area Control as per MATS Part II Volume 2 is shown in the figure below:

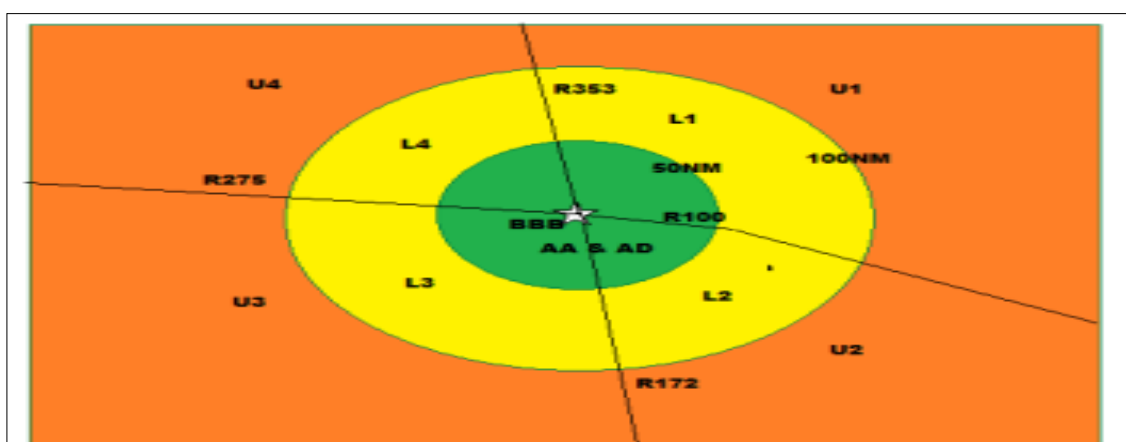
Fig 11: Top view of sector Map

The top view of sector Map is shown in the Figure below:

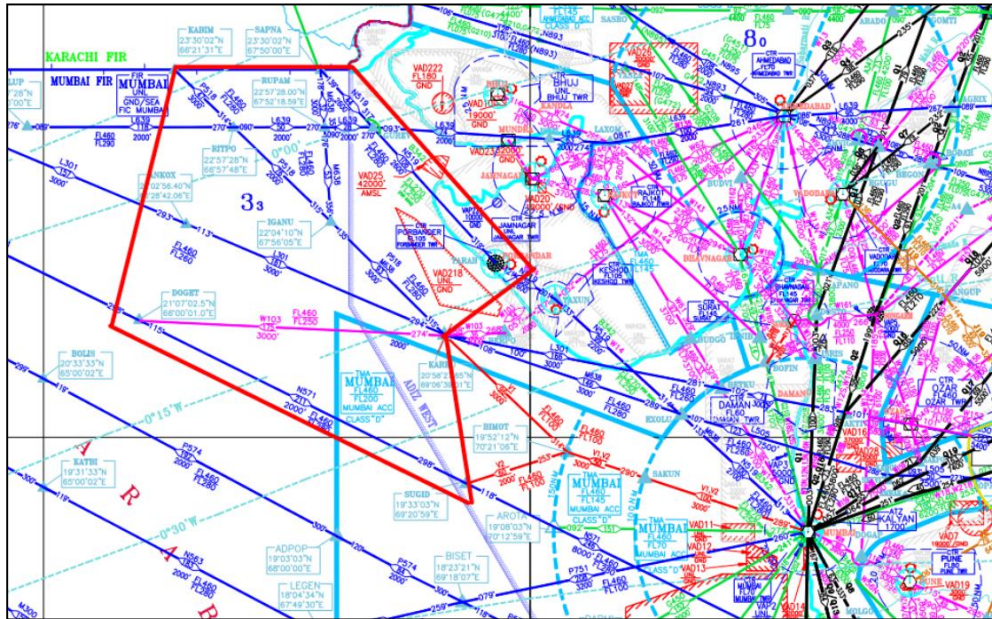
Figure 12: Sector U-5 in Mumbai Oceanic

The U-5 sector of Mumbai FIR is shown in the figure above. U-5 sector is considered extension of Area Control and U-5 controller is required to have Area Control Rating. U-5 controller sits in Mumbai Oceanic Control Centre adjacent to OCC-N controller.
