**Final Investigation Report**  
**on**  
**Accident to M/S Jharkhand Flying Institute,**  
**Sinus 912 Motor Glider aircraft, VT-GDI at Dhanbad airport on 23 March 2023**

**Government of India**  
**Ministry of Civil Aviation**  
**Aircraft Accident Investigation Bureau**

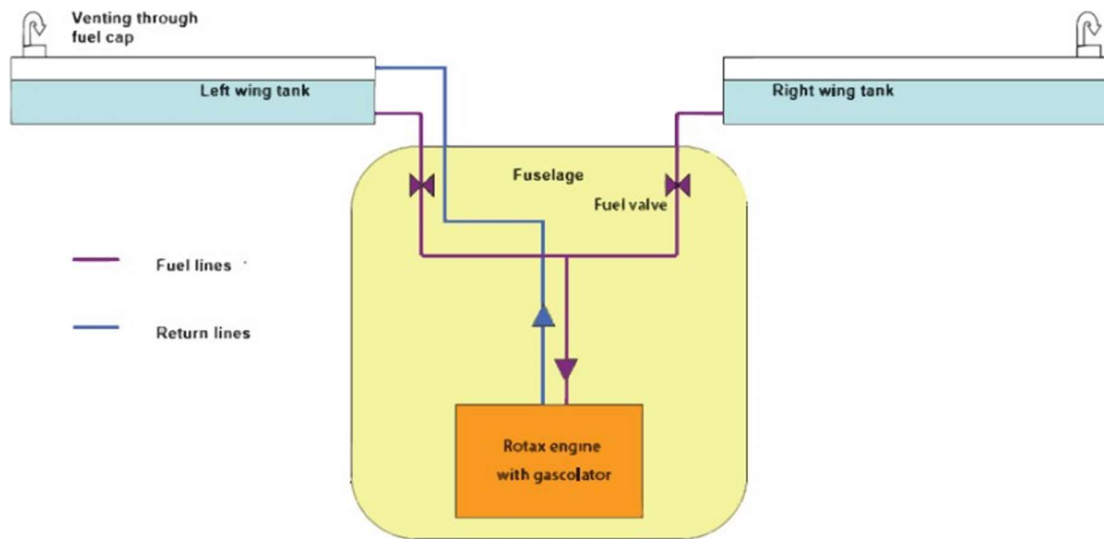
**Figure 5: Fuel System**

The aircraft is equipped with two integral fuel tanks and are located inside the wings i.e., one in each wing (Please refer figure 5). The maximum stored fuel quantity is 60 L (15.9 US gal) for the standard tanks. Two (left and right) transparent vertical tubes, which are visible from the pilot position and connected to the highest and lowers points of each respective tank, serve as a visual indicator of the fuel quantity available. Venting of the fuel tanks is through the fuel caps.

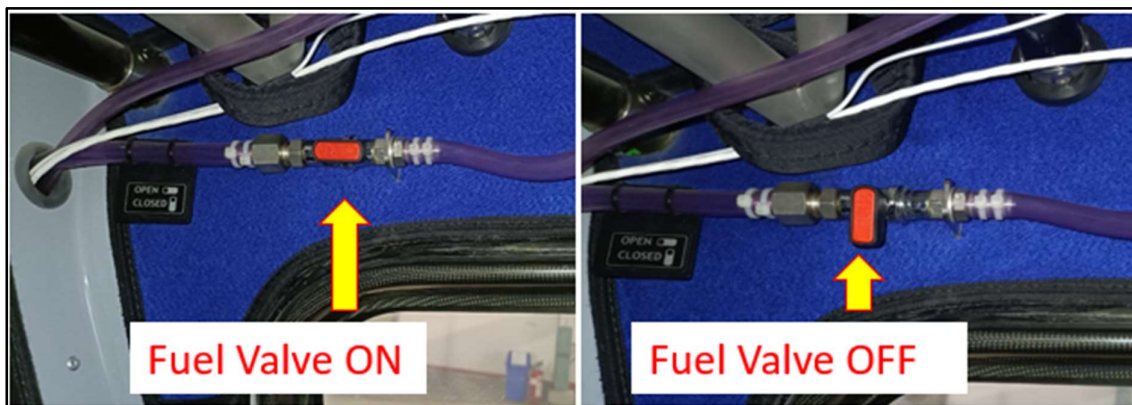
**Figure 6 Fuel Valves.**

During the onsite inspection, both fuel valves were found in closed position (Refer below pictures). It was also confirmed by the company personnel, who reached the accident site first that nobody has entered cockpit after the accident.

**The POH procedure underlines the importance of verifying fuel valves position after an engine failure in-flight. However, as per pilot statement, pilot did not check the fuel valves position after engine failure.**
