Subject: Accident to M/s PHLH Bell 407 Helicopter VT-PHH at Katra on 30.12.2012

Final Investigation Report on Accident to
Pawan Hans Helicopters Limited (PHHL)
Bell 407 Helicopter VT-PHH on 30-12-2012
at Katra Valley, Jammu & Kashmir

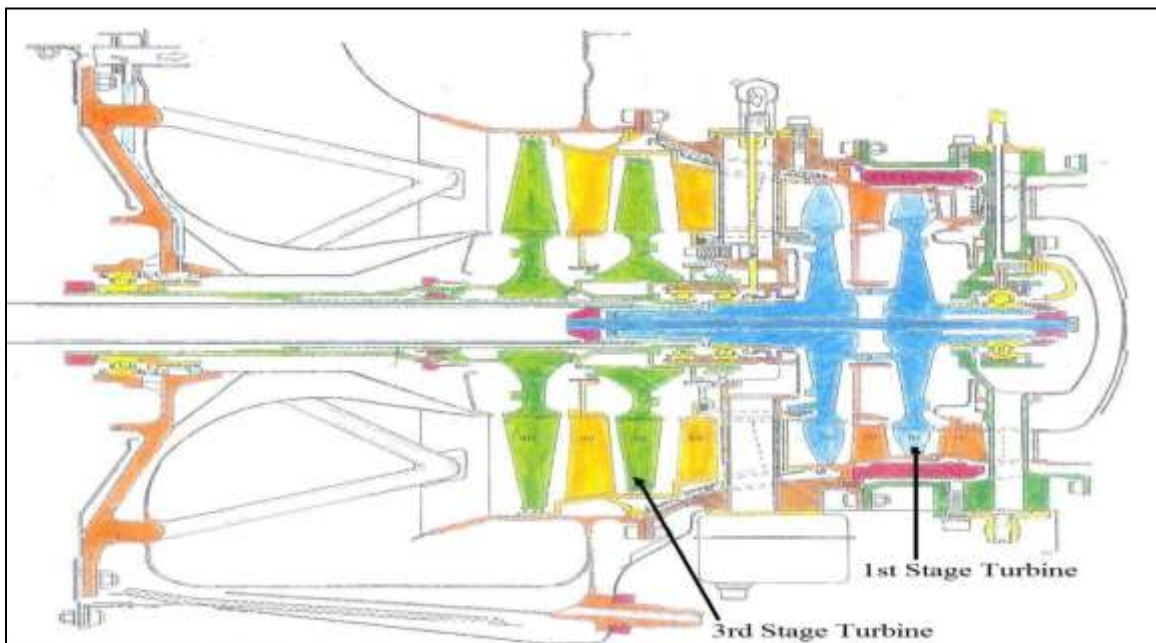
The 1st Stage Turbine wheel was fragmented into multiple pieces from an apparent overspeed burst, which is consistent with a decoupling of the gas generator turbine from the compressor. The 1st stage turbine Energy Absorption Ring was bulged from contact by the 1st stage turbine wheel. The gas-producer turbine support was bulged and fractured axially at the 12 o'clock position.
