FINAL REPORT ON ACCIDENT TO FAST HELICHARTERS INDIA PVT. LTD.
HELICOPTER BELL 206 B III VT-TBA AT GODHRA (GUJARAT) ON
29/08/2012

SUMMARY

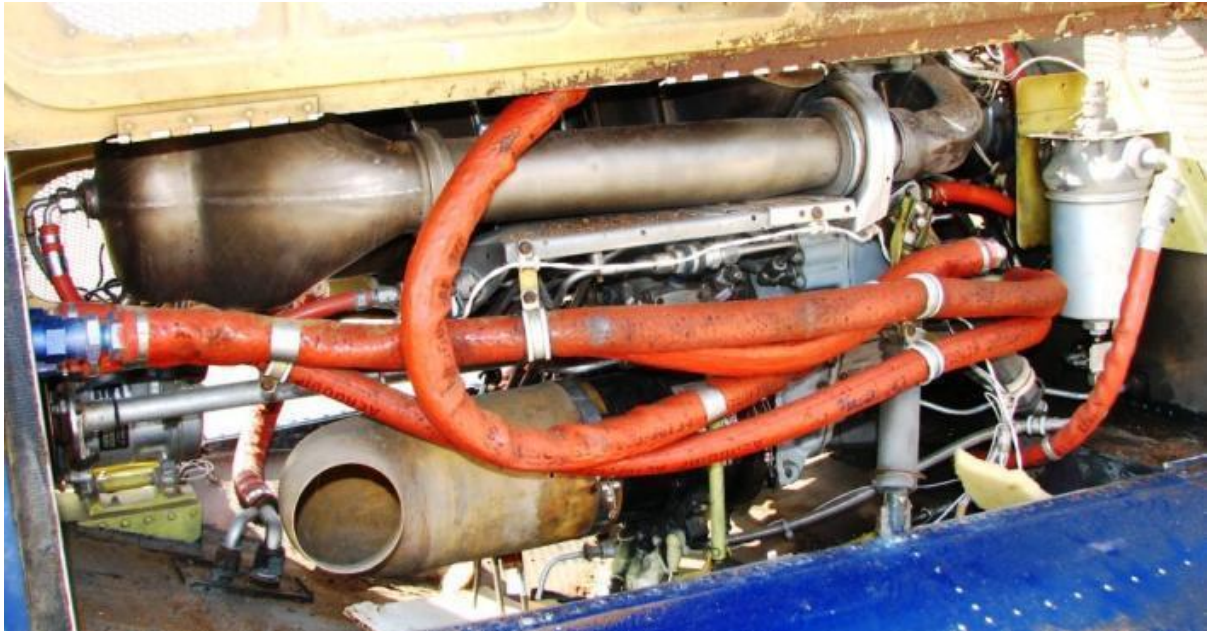
Engine Model	:	Allison 250-C20J
Rating	:	420 SHP
Serial Number	:	CAE-270591
Engine Total Hours	:	4571.08 Hours
Engine Last Overhaul	:	1239.55 Hours

1. Control continuity was established from the collective twist grip to the engine Controls (including PTG controls) were cycled fully from stop to stop, with no unusual resistance or excessive travel noted during the control movements.
2. All engine B-nuts and fittings were checked by hand for proper torque and were found to be satisfactory.

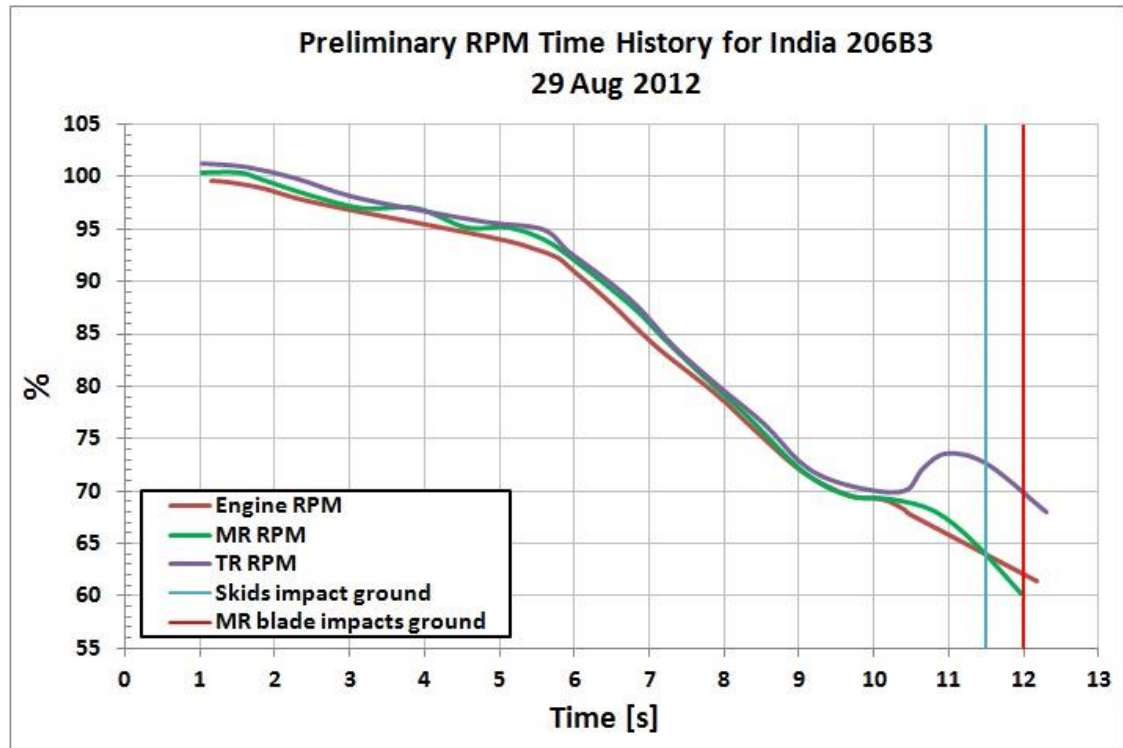
The video showing the forward starboard side of the aircraft, covers the final 30 seconds of flight before impact and 76 seconds after impact. The audio data extracted again provides information on main and tail rotor harmonics, but also provides information on a gear mesh frequency related to the compressor/gas turbine rpm (N1) before the crash. In addition, the N1- related gear mesh and the power-turbine torque meter gear rpm were identified for the full 76 seconds of audio available after impact.

It should be noted that the Bell 206B3 implements a low-rotor-rpm audio alert which activates when the main rotor rpm decreases to $90\% \pm 3\%$ (Reference 2). This audio alert consists of a steady tone. The tone would be heard inside the cockpit, but would not be audible in any of the available external camera recordings. According to Bell Flight Safety, the PIC had indicated that he heard the low-rotor-rpm alert during the descent.
