**FINAL REPORT ON ACCIDENT TO DIAMOND DA – 40
AIRCRAFT VT-FGE OF IGRUA NEAR VILLAGE
SITADONGRI, CHINDWARA DISTRICT,
MADHYA PRADESH ON 24.12.2013**

| 10. Type of Accident | : | Controlled Flight into Terrain |

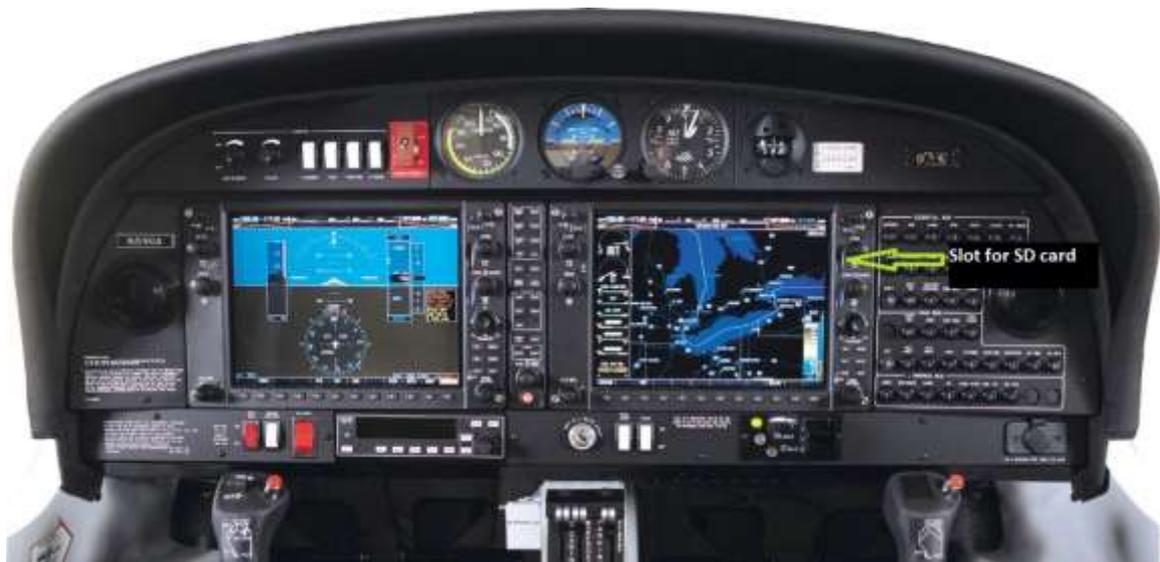
Location of Secure Digital (SD) card which records aircraft primary parameters

After the accident the aircraft was completely destroyed and the SD card could not be recovered from the aircraft.

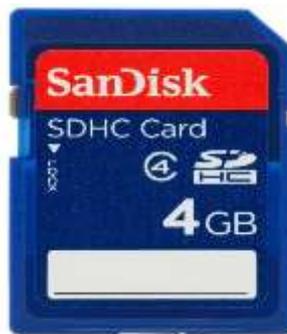
Plastic Secure Digital (SD) card which records aircraft parameters
