**FINAL INVESTIGATION REPORT ON ACCIDENT
TO M/s UNITED HELICHARTERS
BELL 212 HELICOPTER VT-HGB
AT (TUKAWADE) THANE
ON 29/09/2013**

**GOVERNMENT OF INDIA
MINISTRY OF CIVIL AVIATION
AIRCRAFT ACCIDENT INVESTIGATION BUREAU
NEW DELHI INDIA**

AAIB (India) Report No. : 2014-ACC-

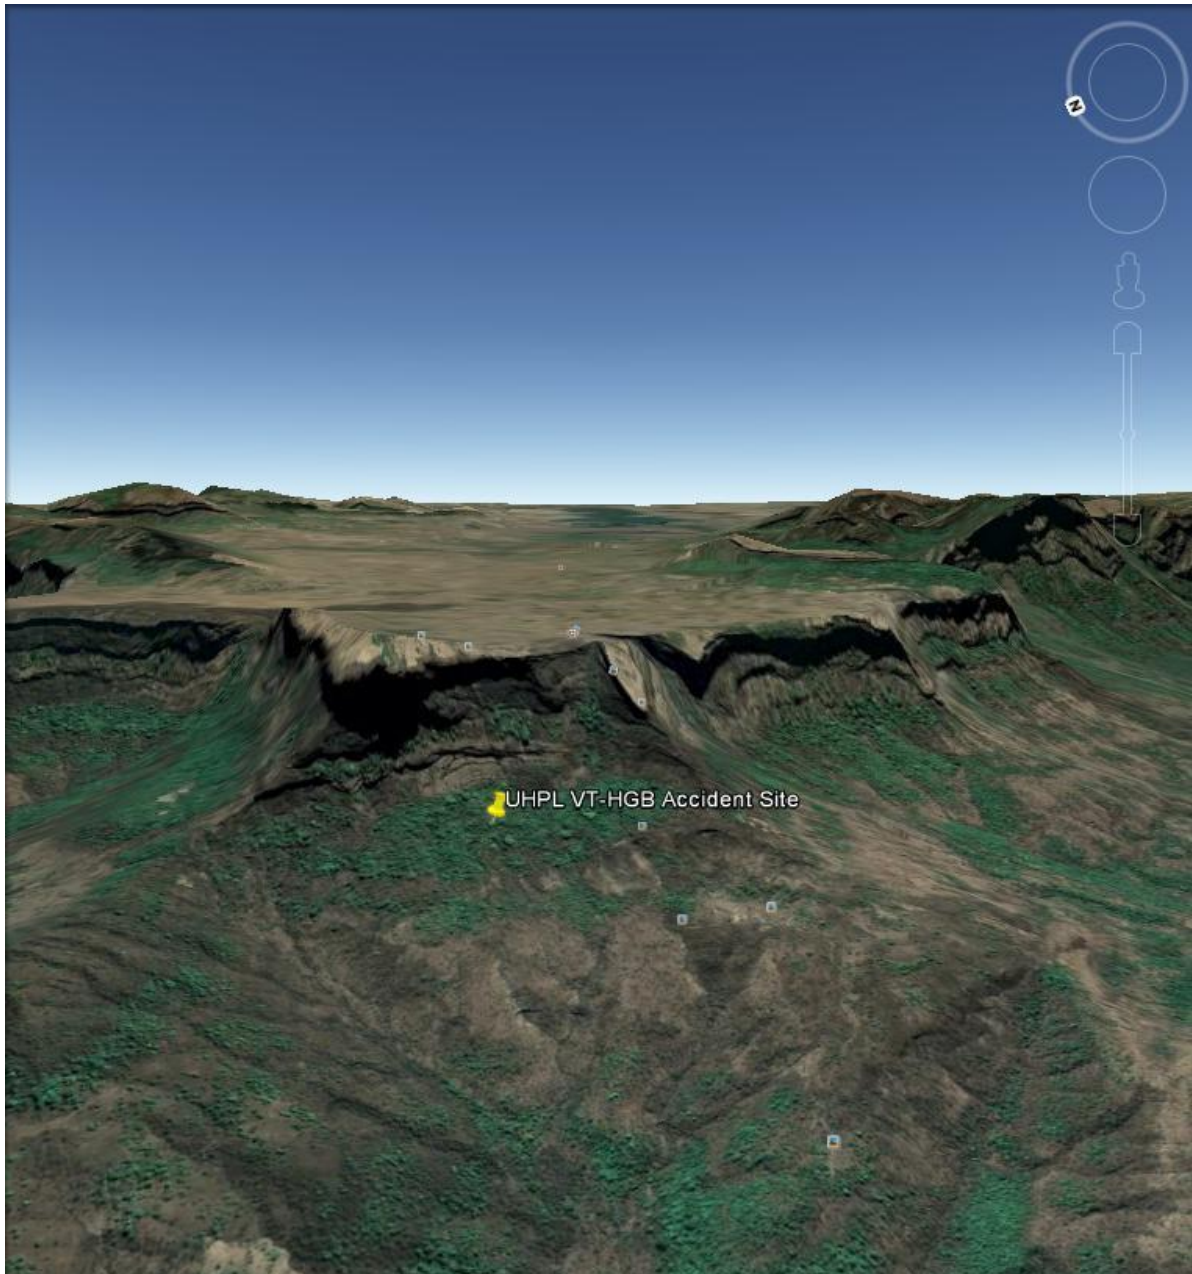
WRECKAGE PLOT

The wreckage was located approximately 85 kms North-East of Mumbai (track 076°) in Murbad district on the slopes of a forested hill. The slopes interspersed with number of rock covered nallahs. The wreckage was spread over approximately 150m. The initial contact was made with the trees probably by the main Rotor Blades after which the Tail-Boom broke away on impact with a tree. The residual forward velocity took the remaining parts consisting of the cockpit & passenger cabin, fuel tank, main gear box assembly and the twin engines further ahead. On contact with the rocky ground surface, it caught fire aided by the ATF spill. The following were the indications on the instruments:

1. Altimeter found at the crash site indicated 5300 barometric altitude with kollsmon window set to 1010 Hpa. The departure airport QNH provided by MET department was 1008 Hpa.
2. ATC transponder found to be set in OFF mode with squawk code set to 7310.
3. Helicopter active communication frequency was found to be set on 123.92 and other radio communication frequency was found to be set 120.90 in OFF mode.
4. Helicopter NAV/DME frequency found to be set on 116.50.
5. Helicopter VSI reading was found to be showing 600 ft/min climb.

**PHOTOGRAPH OF THE WRECKAGE SITE TAKEN FROM GOOGLE
EARTH**
