**GOVERNMENT OF INDIA
MINISTRY OF CIVIL AVIATION
AIRCRAFT ACCIDENT INVESTIGATION BUREAU**

**FINAL INVESTIGATION REPORT OF
ACCIDENT TO M/S PINNACLE AIR R-44
HELICOPTER VT-HPC
AT AHMEDABAD ON 14/08/2013**

**FINAL INVESTIGATION REPORT ON ACCIDENT TO M/s PINNACLE AIR R44
ROBINSON HELICOPTER VT-HPC AT AHMEDABAD, ON 14/08/2013**

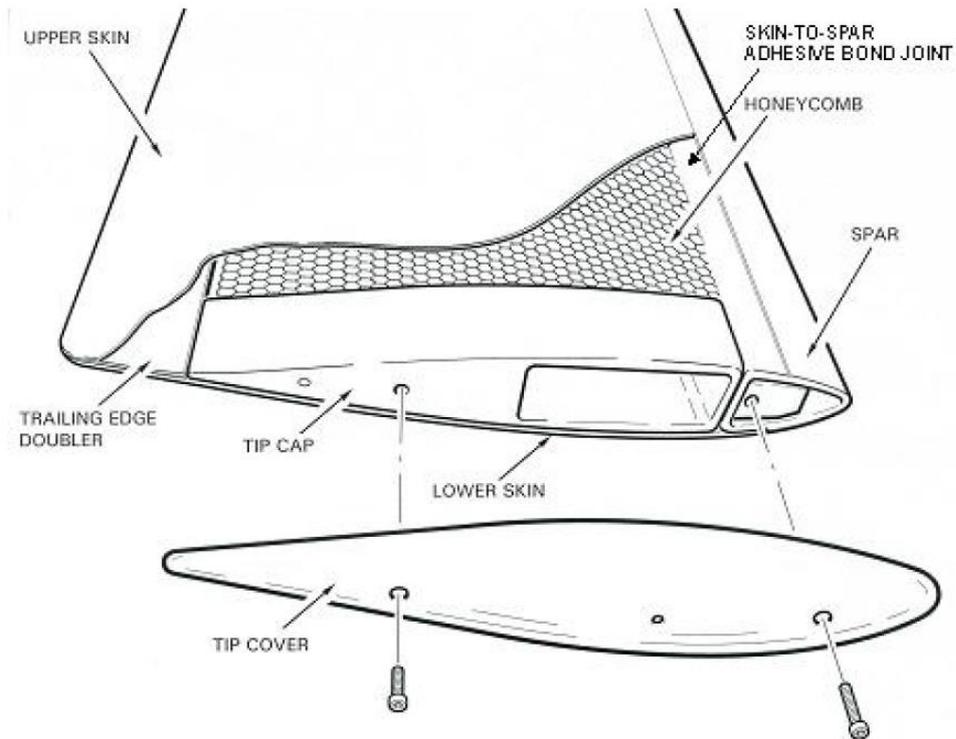
The main rotor blade construction is a normal honey comb construction. The tip portion of the blade contains a spar at the leading edge, skin (stainless steel) overlying a honeycomb core structure (Aluminium) trailing the spar (stainless steel), and a tip cap between the spar and the trailing edge doubler. A portion of the leading edge of the upper and lower skin (approximately 0.5 inch wide) is bonded to the upper and lower surfaces of the spar on the trailing side of the spar. The pieces on the blade are mostly bonded to each other with adhesive epoxy film, which is cured at elevated temperature since the blades were first introduced. A tip cover is secured to the tip of the blade by two attachment screws. The length of the blade is about 198 inches.

The cross-section of the outboard portion of a main rotor blade is shown below. The skin to spar joint is adhesive bond joint.

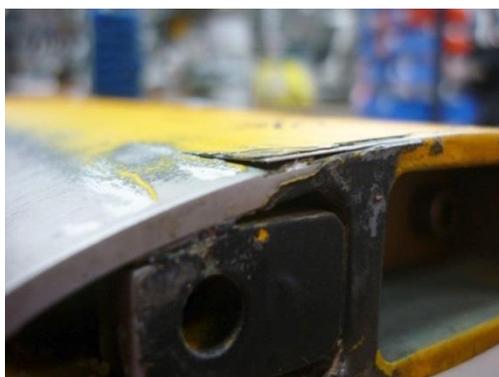
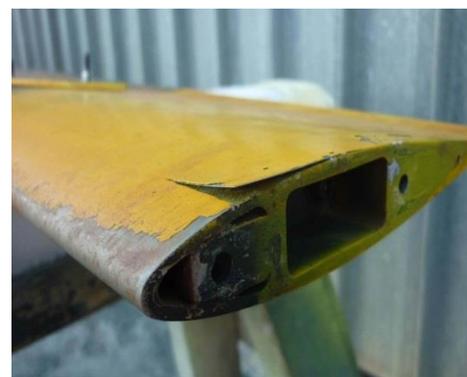
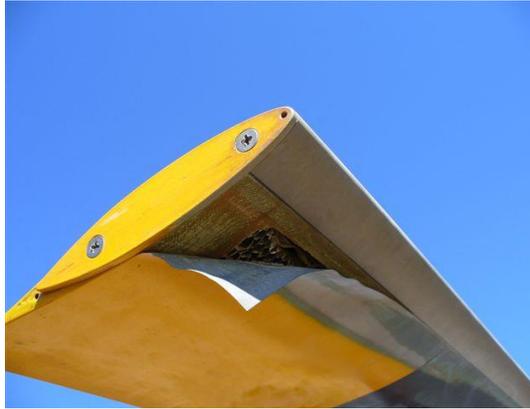
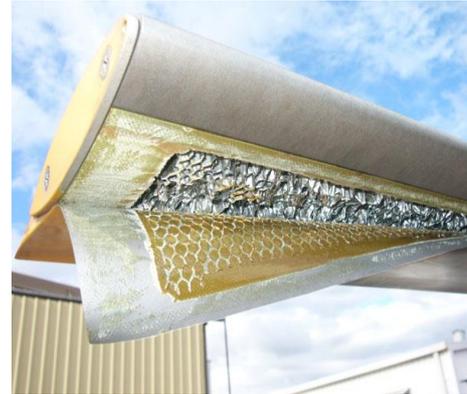
A weak bond in any area allows the leading edge of the skin to lift above the blade surface so that airflow during main rotor rotation peels the skin back further. If peel damage to the skin is minor, the main rotor blade will vibrate irregularly, indicating that the helicopter must be landed immediately. However, if the degraded bond on the main rotor blade is significant when the skin begins to peel, a large portion of the skin may peel back suddenly, resulting in catastrophic fracture of the blade and complete loss of control of the helicopter.

Examples of Peel damage to the skin

De-bonding of rotor blade skins can occur when the bond line is exposed due to erosion of the blade finish, or when corrosion occurs on the internal aluminum tip cap. Proper inspection and protection (refinishing) of bonded areas is required. De-bonding resulting from improper inspection and maintenance can cause a catastrophic accident. Recognizing this fact, Robinson Helicopter Company had issued a Service Bulletin SB-72A on 30th April 2010 regarding Main Rotor Blade Bond to be carried out at 100 hours/four months inspection.

Stringent checks of main rotor blades of R44 helicopters particularly at outstations before issuing CRS should be carried out prior to every flight.
