**FINAL INVESTIGATION REPORT OF
ACCIDENT TO GOVERNMENT OF
JHARKHAND IS-28M2/GR MOTOR GLIDER
VT-GJH AT DEOGHAR AIRSTRIP,
JHARKHAND ON 07/08/2013**

(A. X. Joseph)
Assistant Director-AAIB
Chairman, Committee of Inquiry VT-GJH

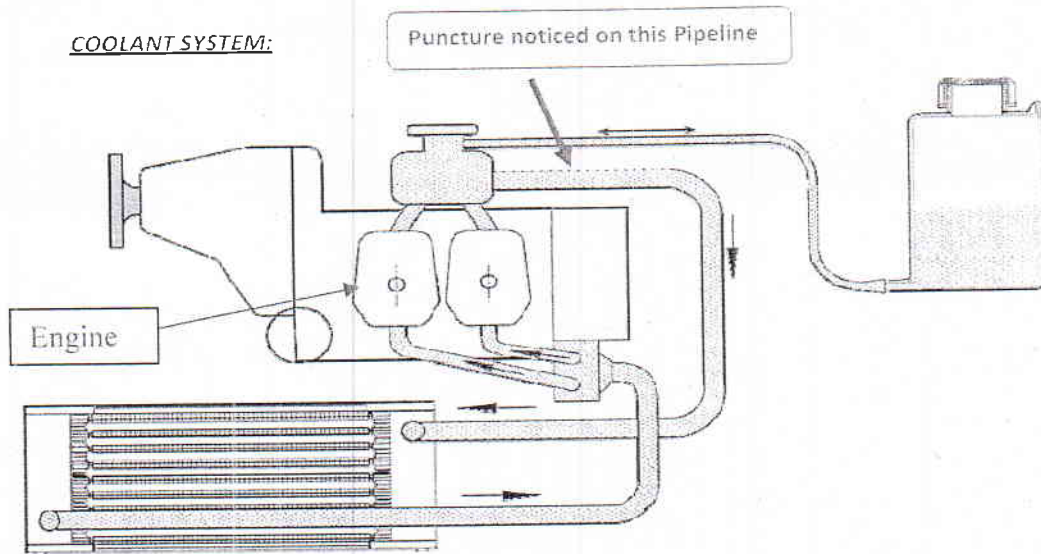
4. Coolant System

Block Diagram of Coolant system

1. Connection tube identified at No. 9 above from suspension tank to radiator was found punctured due to abrasion which had caused the coolant to be drained from the coolant system during flight. Hence engine was running dry of coolant resulting over heating of cylinder heads. This was also evident from the complaint impeller which was totally dry during disassembly of the engine.
2. Cylinders No. 2 & 4 piston ring was seized due to heavy deposits caused by burning of lubricating oil inside the combustion chamber due to overheating, which might have caused engine seizure / stoppage.
3. The engine failure was due to non-supply of coolant to the cylinder head because of the punctured coolant pipe resulting into overheating and subsequently seizure/stoppage of pistons of No. 2 & No. 4 cylinders and failure of engine.
