AIRCRAFT ACCIDENT INVESTIGATION BUREAU

**FINAL INVESTIGATION REPORT ON SERIOUS INCIDENT
TO
AIRBUS A-320 AIRCRAFT VT-IEW
AT
MUMBAI AIRPORT
ON
9th MARCH 2013**

**REPORT OF SERIOUS INCIDENT TO AIRBUS A-320 AIRCRAFT
VT-IEW ON 09TH MARCH 2013 AT MUMBAI.**

AAIB (India) Report No. : 2013-INC-

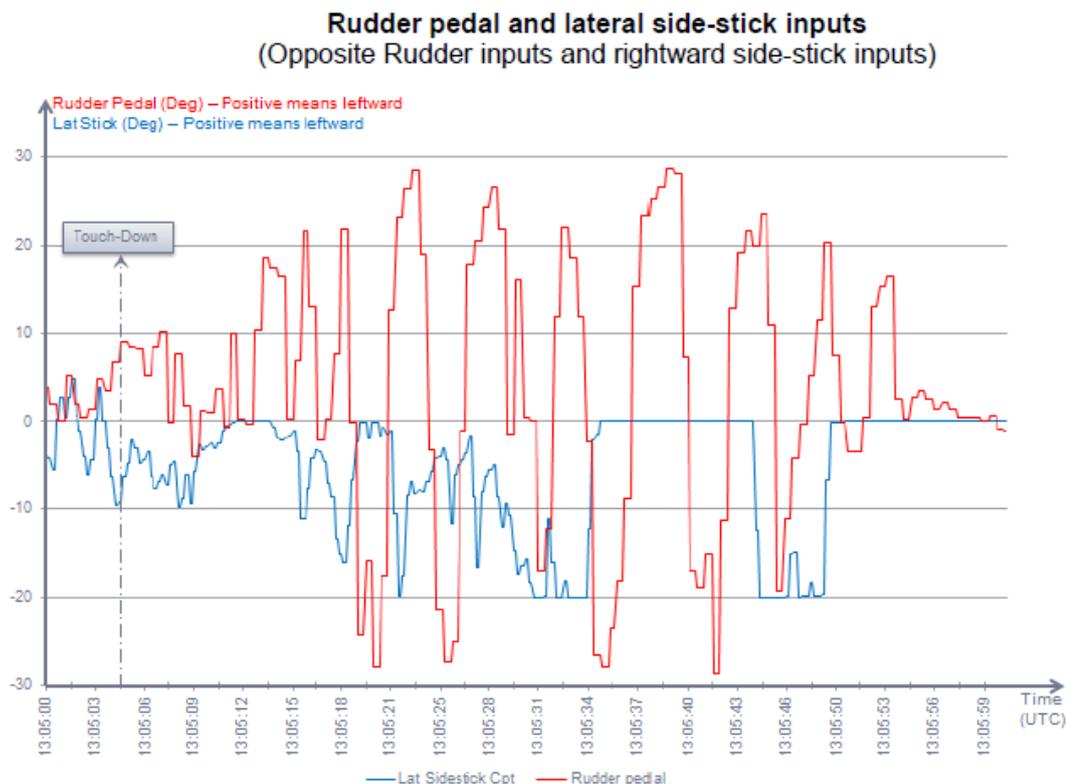
In addition Captain had given rightward side-stick inputs up to the max deflection (20⁰). There were several brake pedal inputs on both pedals with CAS decreasing.

Rudder deflection versus Lateral g
 (Rudder deflections up to max left and right – Lateral g variation between -0.35g and +0.23g)
