Final Investigation Report on Accident to
M/s Transbharat Aviation Pvt. Ltd.
Cessna 152 aircraft VT-CAX on 20-03-2014
at Salon near Fursatganj Airfield, Raibareli

FINAL INVESTIGATION REPORT ON ACCIDENT TO M/s TRANSBHARAT AVIATION PVT. LTD. CESSNA-152 AIRCRAFT, VT- CAX AT SALON NEAR FURSATGANJ AIRFIELD, RAIBARELY, U.P. ON 20-3-2014

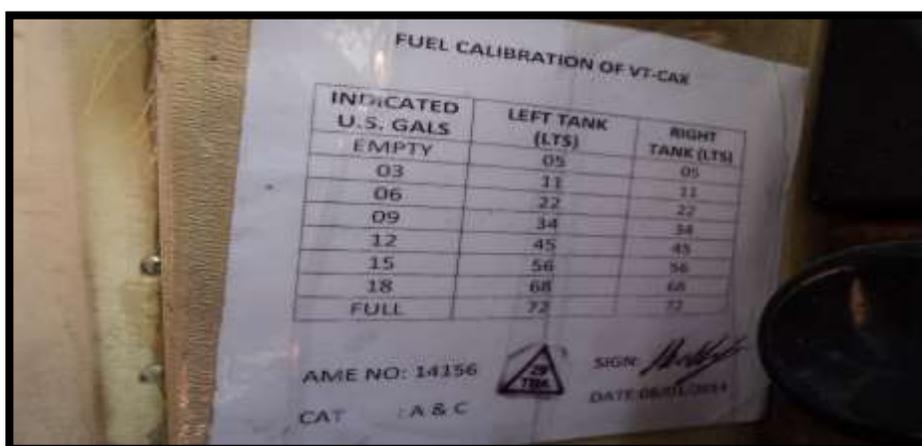
Fuel calibration card of VT- CAX

During flight left fuel quantity gauge was showing correct reading and but right fuel quantity gauge was not showing correct reading.
