**FINAL REPORT ON ACCIDENT TO M/s DECCAN AVIAION PVT, LTD., PC-12/45 AIRCRAFT VT-DAR AT GUWAHATI ON 28-11-2014**

| 7. Date & Time of Accident | : 28 <sup>th</sup> Nov 2014, 13:21 UTC |
| 13. Type of Accident | : Bounced Landing |

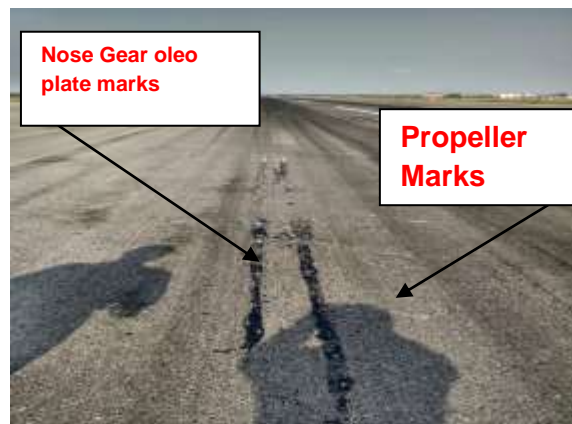
**BENT PROPELLER BLADES**

The intensity of the impact on the nose gear on the runway was so strong that both the fork link of the nose wheel broke due to impact on the runway. The nose wheel went away and the propeller hit the runway surface at about 1020 metres from threshold.
