**FINAL INVESTIGATION REPORT ON**  
**SERIOUS INCIDENT TO AIR INDIA**  
**LTD. AIRBUS A-320 AIRCRAFT VT-ESI**  
**AT COCHIN ON 21.08.2014**

**FINAL INVESTIGATION REPORT ON SERIOUS INCIDENT**

**TO AIR INDIA LTD. AIRBUS A-320 AIRCRAFT**

**VT-ESI AT COCHIN ON 21.08.2014**

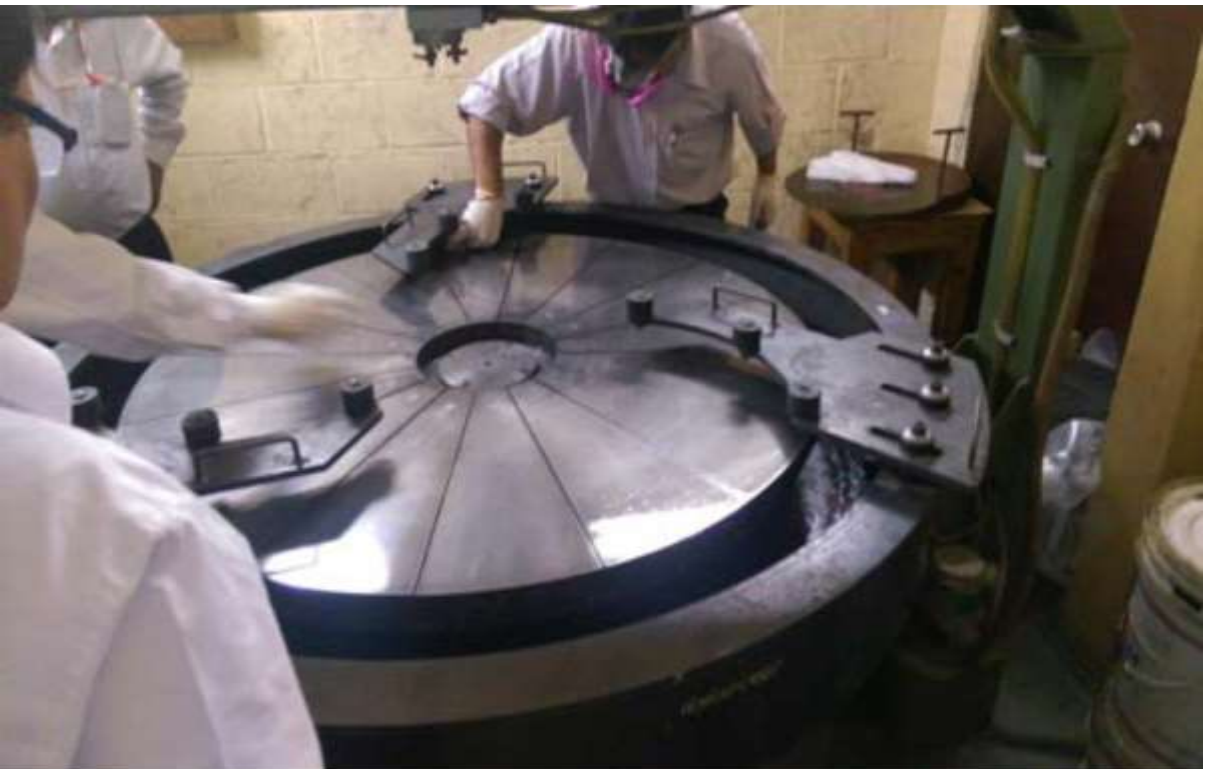
and then wiping the lapping table surface with a cloth while rotating the table. The intent of cleaning procedure is to ensure that all lapping residue from previous operations is removed. See image #2.

*Image #2 - Cleaning the Table with Hicrolap solvent prior to lapping.*

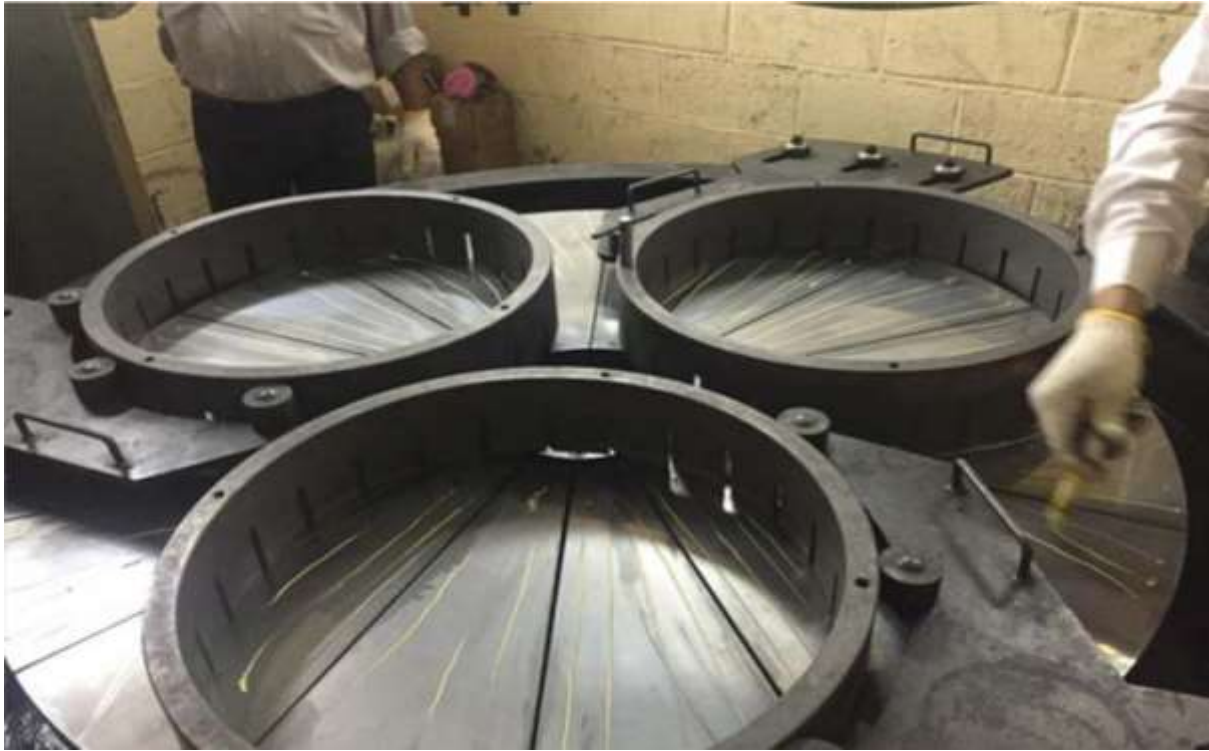
When the table cleaning process was completed, the lapping tooling was installed and diamond lapping paste applied to the table. See image #3. The machine was run for 5 minutes to distribute the diamond paste as per normal JEOC practice.

*Image #3 - Tooling Installed and Diamond Lapping Paste Applied (yellow streaks).*

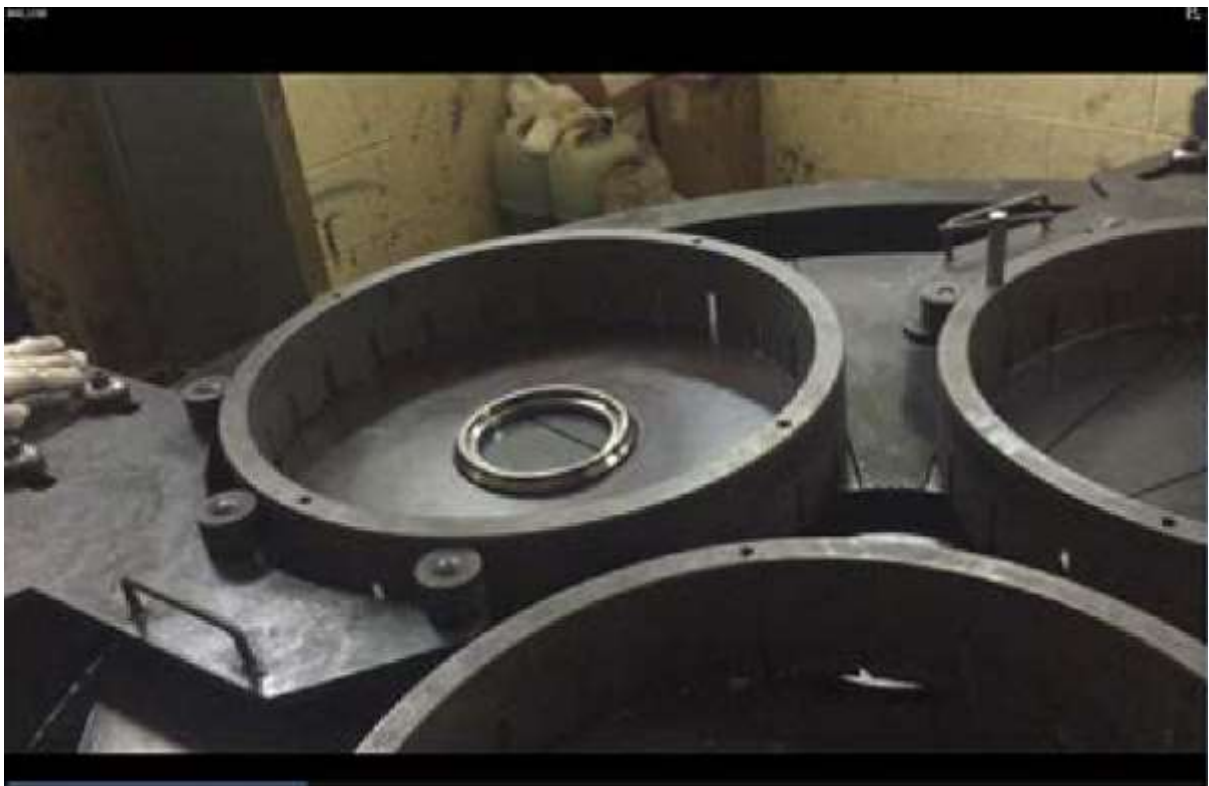
*Image #4 - Placement of seal plate for lapping.*

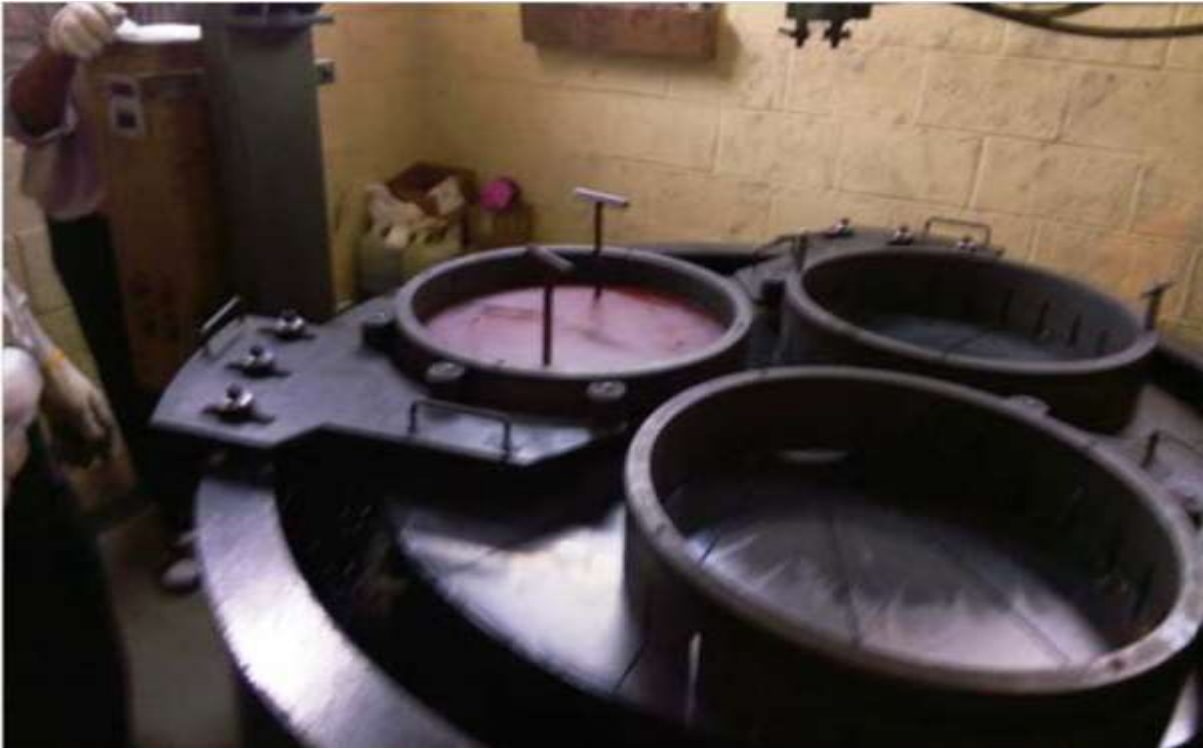
After the diamond paste was distributed, the subject seal seat was placed on table. See image #4. The positioning tooling was then installed and a weight consisting of a 28kg steel disc was placed on top of the seat. See image #5. The seat was lapped for 10 minutes. Additional solvent was added in small quantities during the process when the table appeared too dry to the operator performing the process.

*Image #5 – Seal plate installed in lapping machine with 28kg weight installed.*
