**Final Investigation Report on Serious Incident to M/s Mesco Aerospace Ltd. AS 350 BA Helicopter VT- MAB on 08-04-2014 at Chakwali Village, Near Saharanpur, U.P.**

1.	Helicopter	Type	Ecureuil AS 350 BA
		Nationality	Indian
		Registration	VT-MAB
2.	Owner		M/s Mesco Aerospace Ltd. New Delhi.
3.	Operator		M/s Mesco Aerospace Ltd. New Delhi.
4.	Pilot – in –Command		CPL (H) Holder
	Extent of injuries		NIL
5.	Co-Pilot		CPL (H) Holder
	Extent of injuries		NIL
6.	Date & Time of Incident		08-04-2014; 0610 UTC.
7.	Place of Incident		Chakwali Village, Near Saharanpur, U.P.
8.	Last point of Departure		Muradnagar, Dist. Ghaziabad, U.P.
9.	Intended landing place		Manakmau, Dist. Saharanpur, U.P.
10.	No. of Passengers on board		03
	Extent of injuries		NIL
11.	Type of Operation		Charter flight (NSOP Operations)
12.	Phase of Operation		Cruise
13.	Type of Incident		Forced landing due to Tail Rotor Pitch link failure
14.	Co-ordinates of Incident Site		Lat 29° 46' 21" N, Long 77° 30 ' 33" E AMSL 850 feet

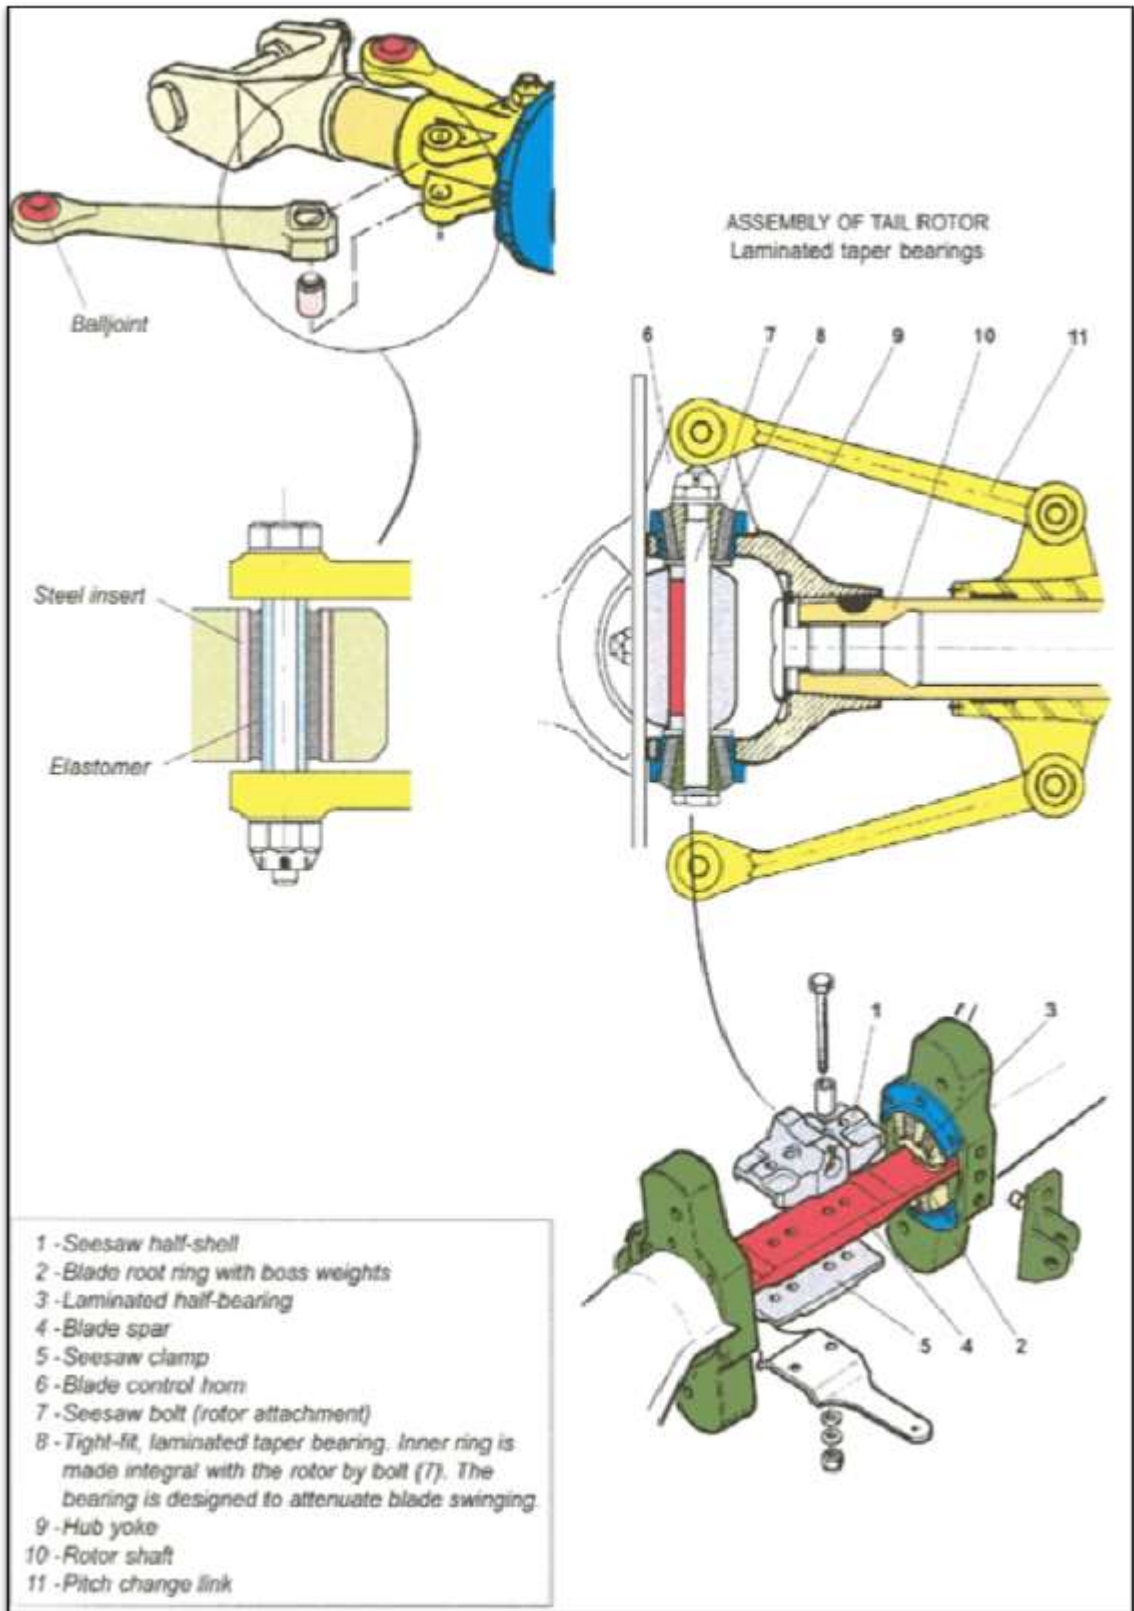
**Tail Rotor Drive Assembly**

The tail rotor pitch change links (02) were made of aluminum and consisted of a swivel swaged-in, self-lubricating spherical bearing at one end and an elastomer-damped sleeve-type bearing at the opposite end. The bearing is made of steel or tungsten carbide in steel race. The inner surface of bearing is lined with fiberglass impregnated with Teflon to reduce friction. The normal functional stresses including control input and centrifugal forces applied to pitch link bearing lead to wear of inner race Teflon. If preventive maintenance inspection not followed, the bearing exceed the current wear limit and allow metal-to-metal contact leading to load on tail rotor pitch change link and onset of fatigue crack in material which propagate until link fails.

The pitch change link swivel bearing was found excessively damaged. Tail rotor pitch change link of the same blade was broken from the swivel bearing side and found attached. The broken portion Tail rotor pitch change link could not be located. Metal particles were found on the TGB chip detector.

DGCA has issued a mandatory Modification DGCA /AS-350 Series /119 applicable to AS 350 and AS 355 Series Helicopters regarding “Time Limits/Maintenance Checks- Tail Rotor (T/R) Pitch Change links Inspection as per EASA AD No. 2010-0006.
