**GOVERNMENT OF INDIA
MINISTRY OF CIVIL AVIATION
AIRCRAFT ACCIDENT INVESTIGATION BUREAU
NEW DELHI INDIA**

**REPORT ON
ACCIDENT TO M/s PAWAN HANS
DAUPHIN N3 HELICOPTER VT-PHK
AT KHONSA
ON 04/08/2015**

**REPORT ON
ACCIDENT TO DAUPHIN N3 HELICOPTER VT-PHK
NEAR KHONSA (ARUNACHAL PRADESH) ON 04/08/2015**

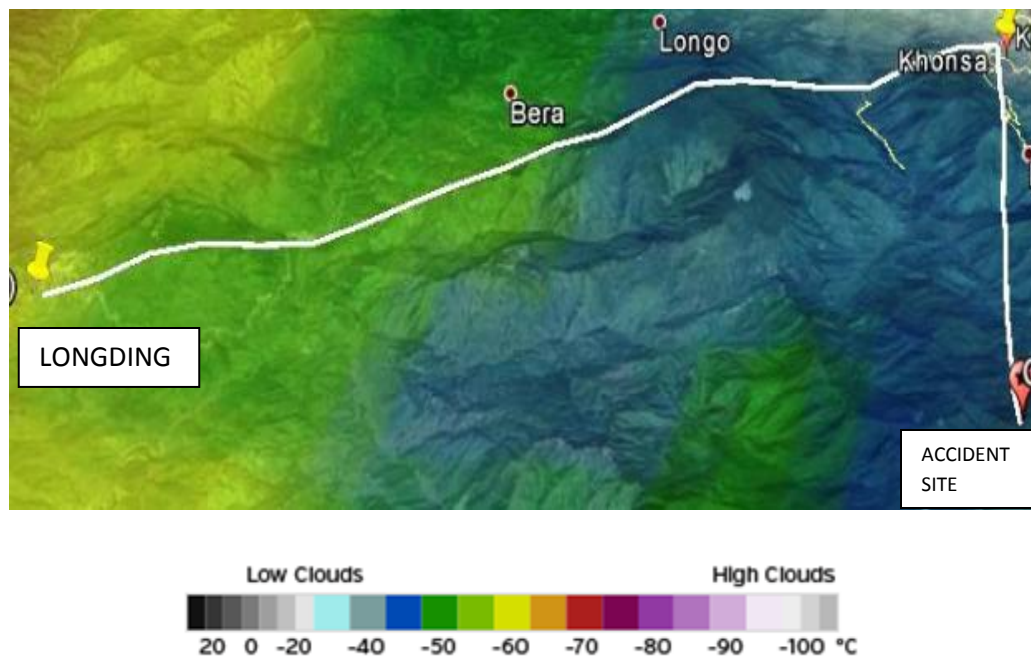
There is no meteorological observatory in Khonsa. The weather report issued at 1030 hours IST by the IAF (MET) department of Chabua which is in plain areas of Brahmaputra valley indicated a total cloud count of 7 octa with temperature and dew point of 29.4° C and 25.6° C respectively. There were few, scattered and broken clouds at 450m (1500 feet), 750m (2500 feet) and 2.7 kms (9000 feet) of height respectively.

The cloud amount in the valleys and around ridges generally is greater than what is observed over plains and the weather changes very fast in the valley

particularly settling of clouds. There could also be scattered rain patches in the area.

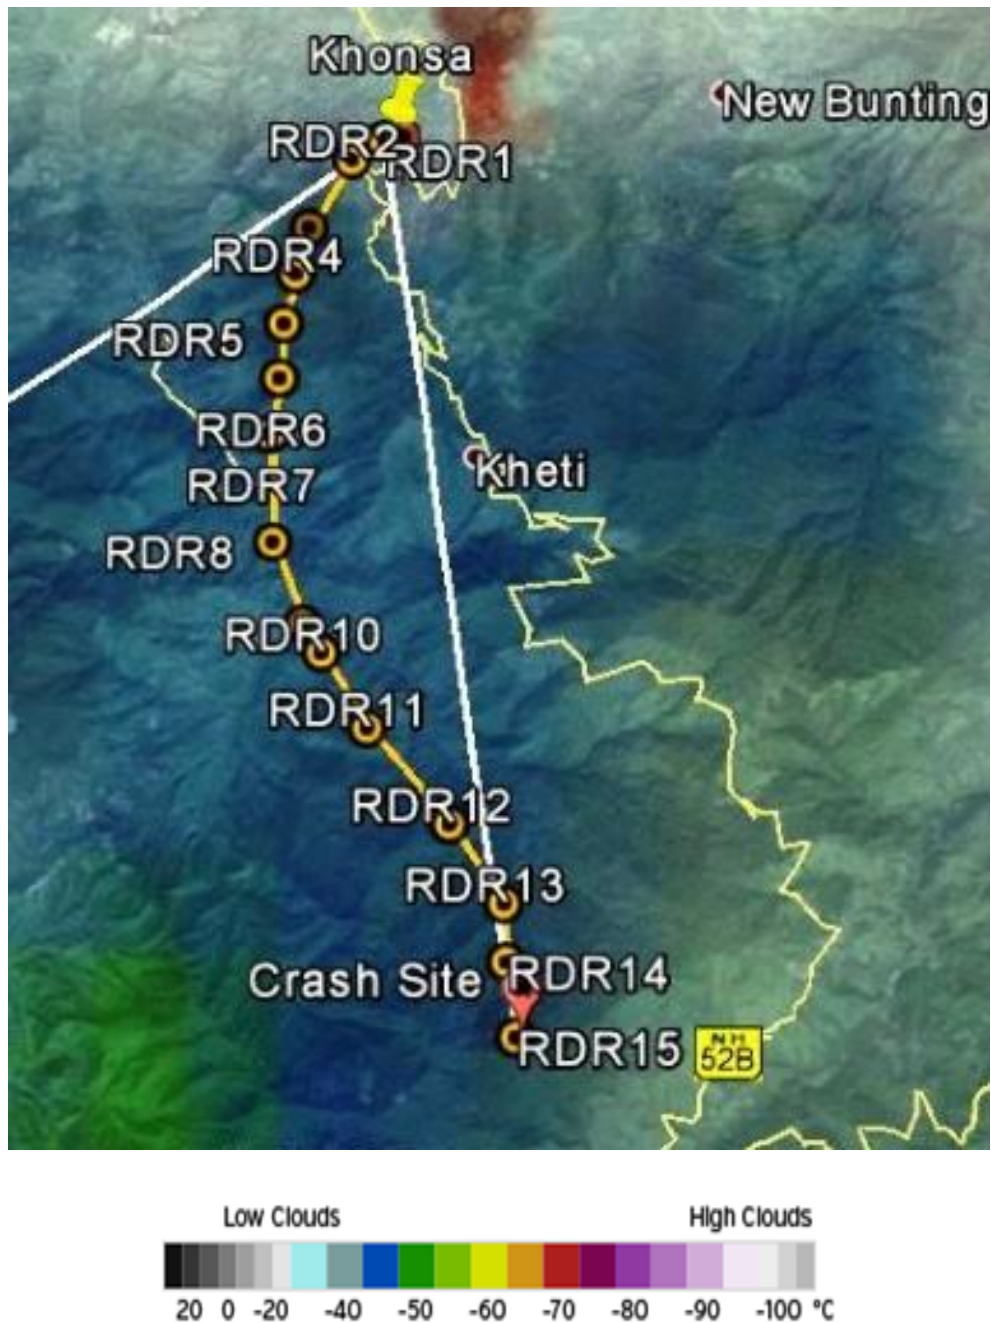
The RADAR was not having the capability of giving weather picture. Against the plot in the picture below, is also shown the weather as available at the time of accident with color coding (variation) of the clouds.
