**REPORT ON ACCIDENT TO
M/s PAWAN HANS DAUPHIN N3 HELICOPTER
VT-PWF
AT BOMBAY HIGH
ON 04/11/2015**

**AIRCRAFT ACCIDENT INVESTIGATION BUREAU
MINISTRY OF CIVIL AVIATION
NEW DELHI**

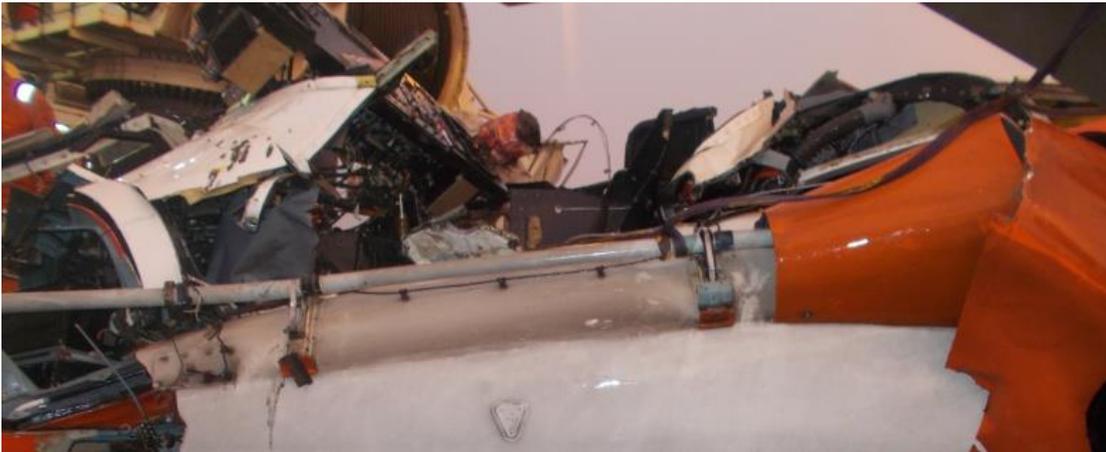
When the wreckage was recovered from the sea, the main rotor was connected to the main gear box. All the four blade root ends were connected though only portion of blades were available. Three blades (red, blue and yellow blades) had almost similar length available and the fourth blade (black blade) portion available was of shorter length. The main gear box was attached to the transmission deck with all the linkages in place.

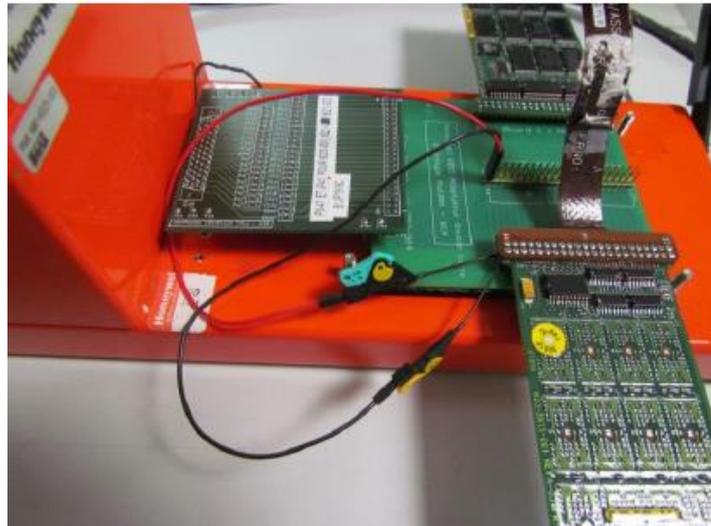
On external examination, no damage was observed on the unit. It was decided to remove the CSMU from the chassis and to extract the memory support. On opening CSMU, the white thermal protective powder inside the unit was found wet. The electronic boards were separated to check the status

of the memory components between the boards. The memory support was found exposed to water. The memory components were in a good physical condition but were also exposed to water. As the connector was broken (two pins), it was decided to explore the further options in BEA laboratory to perform the download of the data.

The further actions were taken at BEA avionics laboratory and BEA has submitted a report to the Committee. As per the report, the memory boards were first cleaned with demineralized water and then with alcohol. The boards were dried in an oven. After drying, electrical tests were performed to check the electrical continuity of the boards. The tests values were consistent with reference values provided by the manufacturer.

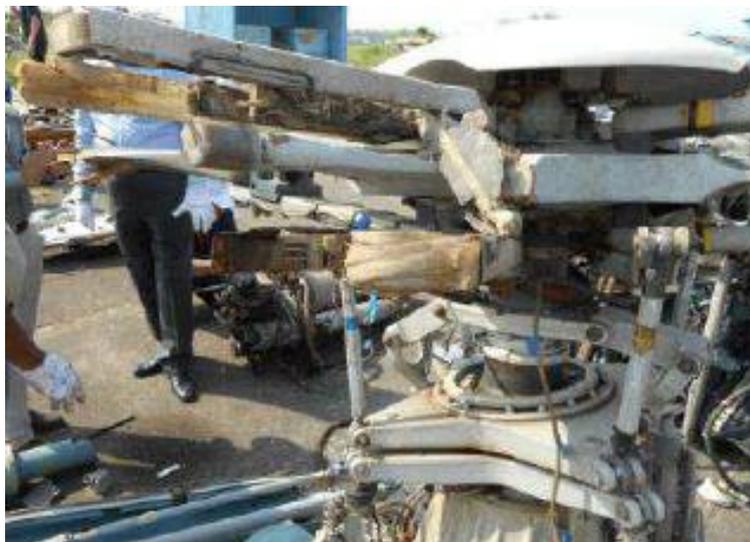
Outer ends of the blue blade attach beam

During the examination performed by the BEA, only one fragment of the black blade was in position on the main rotor head. The other fragments had been removed previously.

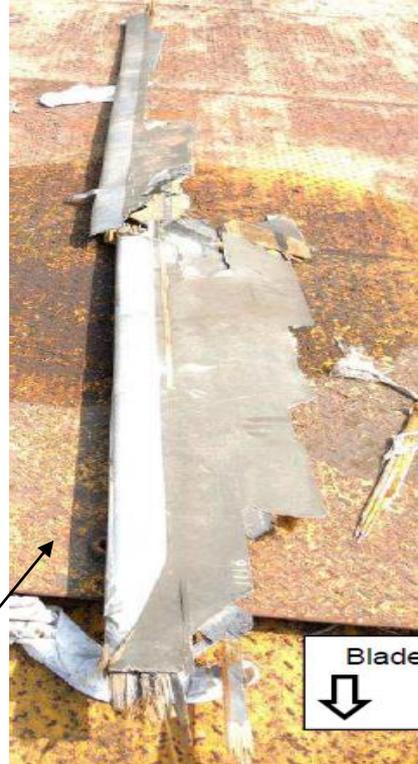
- The root of the black blade was in position on the main rotor head. The fragment still attached to the main rotor head was about 1 metre long.

The fragment of the black blade attached to the rotor head

Others fragments of the black blade

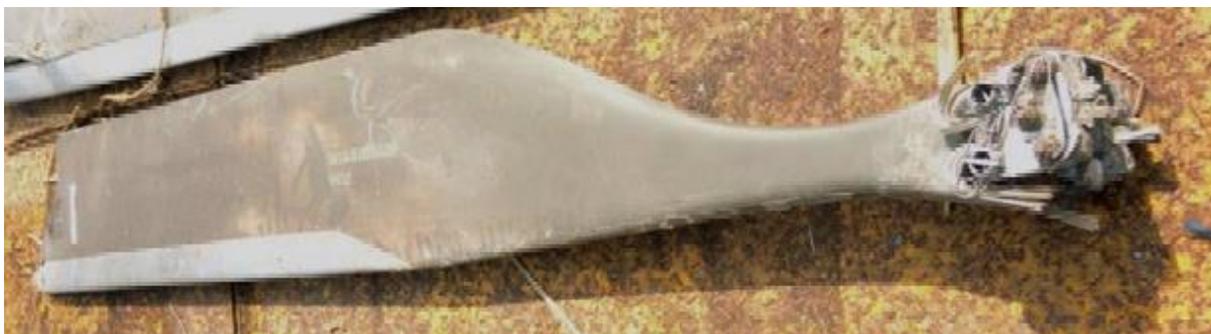
Blue blade – lower surface

Only one fragment of the blue blade was identified. This fragment was composed of the root of the blade and was about 2.4-2.5 metres long. On this fragment, the profile was complete and no impact marks were identified on the leading edge.

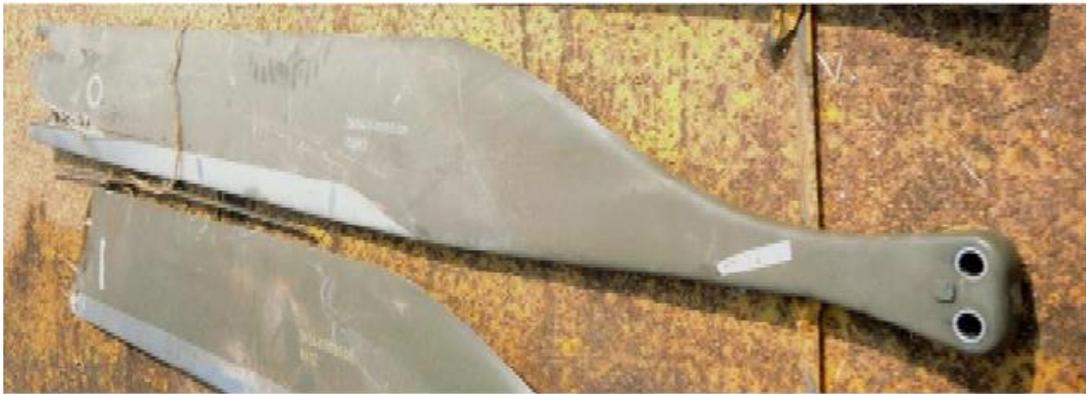
Yellow blade - Lower surface

- Only one fragment of the yellow blade was identified. This fragment was composed of the root of the blade and was about 2.6-2.7 metres long. On this

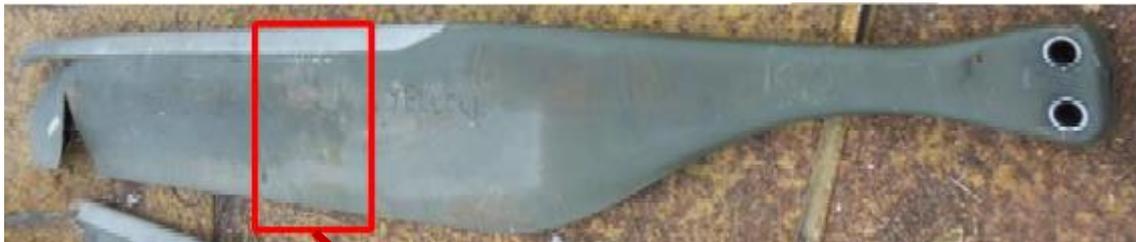
Yellow blade - Upper surface

On the upper side, several cracks and several yellow marks were identified. The cracks were parallel to the leading edge and located at the centre of the profile and close to the leading edge.

The yellow marks were at about 1.2 metres from root of the blade.

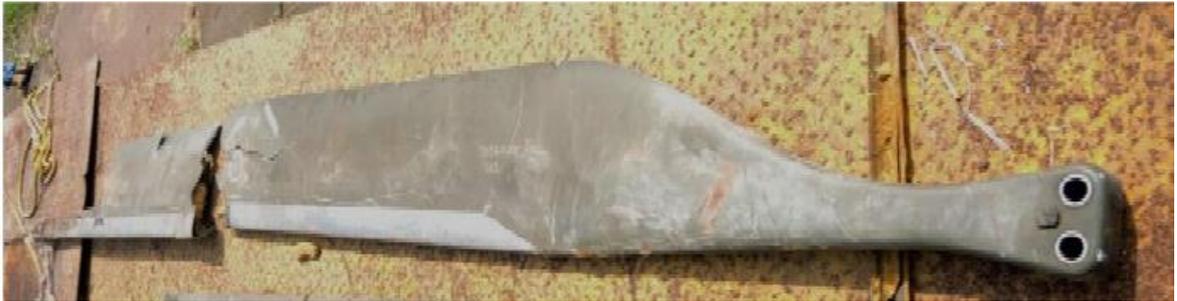
Red blade - Lower surface

On the main fragment, the profile was complete and no impact was identified on the leading edge.

On the other fragment, the profile was destroyed but no impact was identified on the rest of the leading edge.

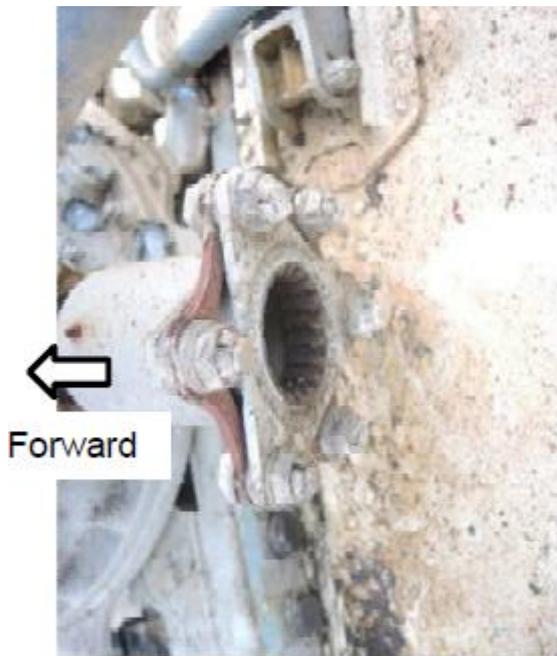
Exit of the main gearbox toward the tail rotor drive

The flexible coupling located at the tail rotor drive shaft output flange on the main gearbox was complete. The internal splines were not damaged.

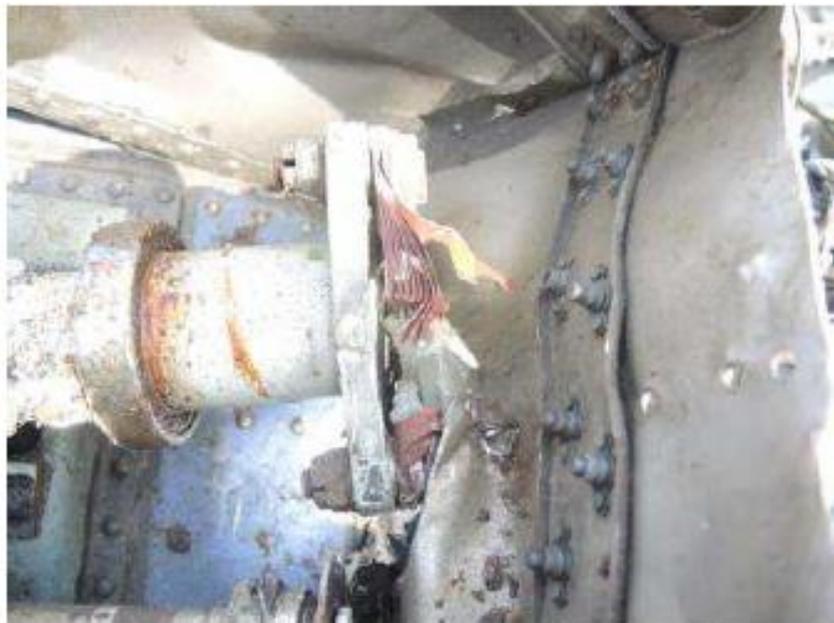
Flexible coupling between the front drive shaft and the centre drive shaft

The flexible coupling between the front drive shaft and the centre drive shaft was destroyed by overload.

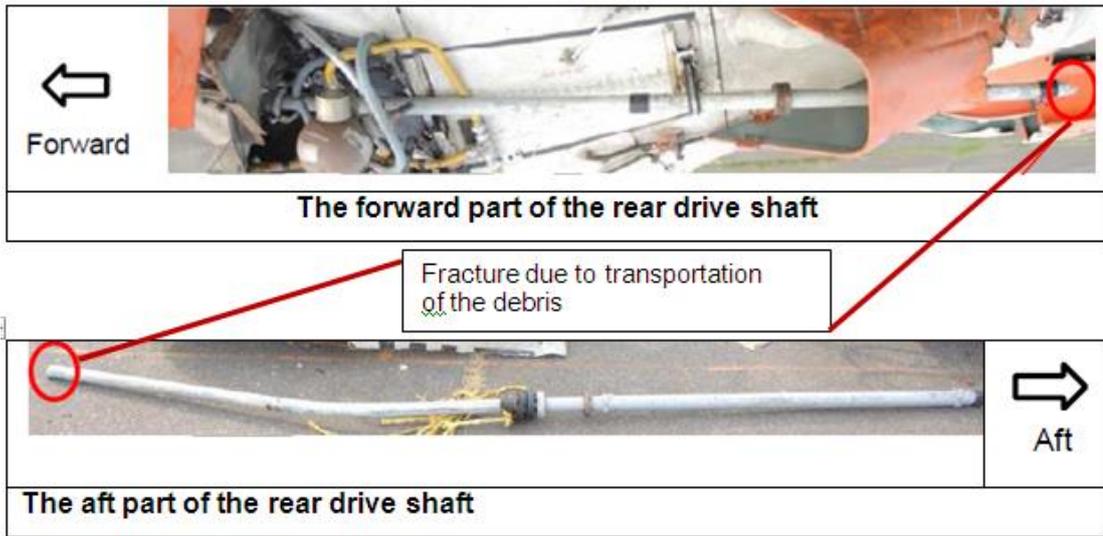
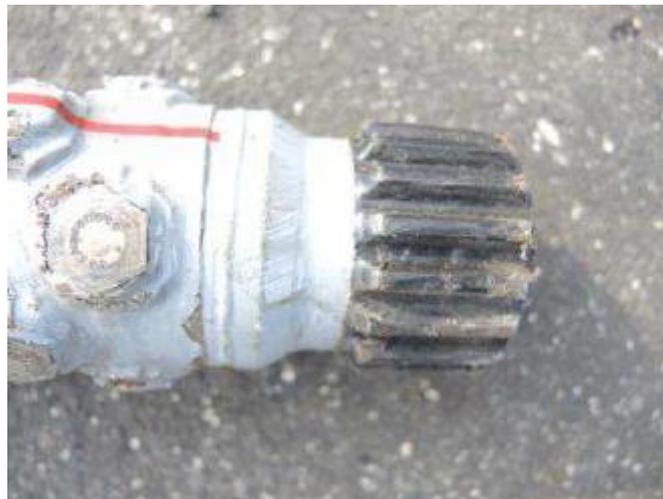
Splined end fitting

The rear drive shaft was broken in its centre area and bent. The fact that the shaft was complete on recovery from the sea indicated that the shaft fracture identified by the BEA was a consequence of transportation of the debris.

The splined end fitting was either not damaged or only superficially.

All bearings were extracted from their clamps. The bearings were corroded due to contact with salt water.

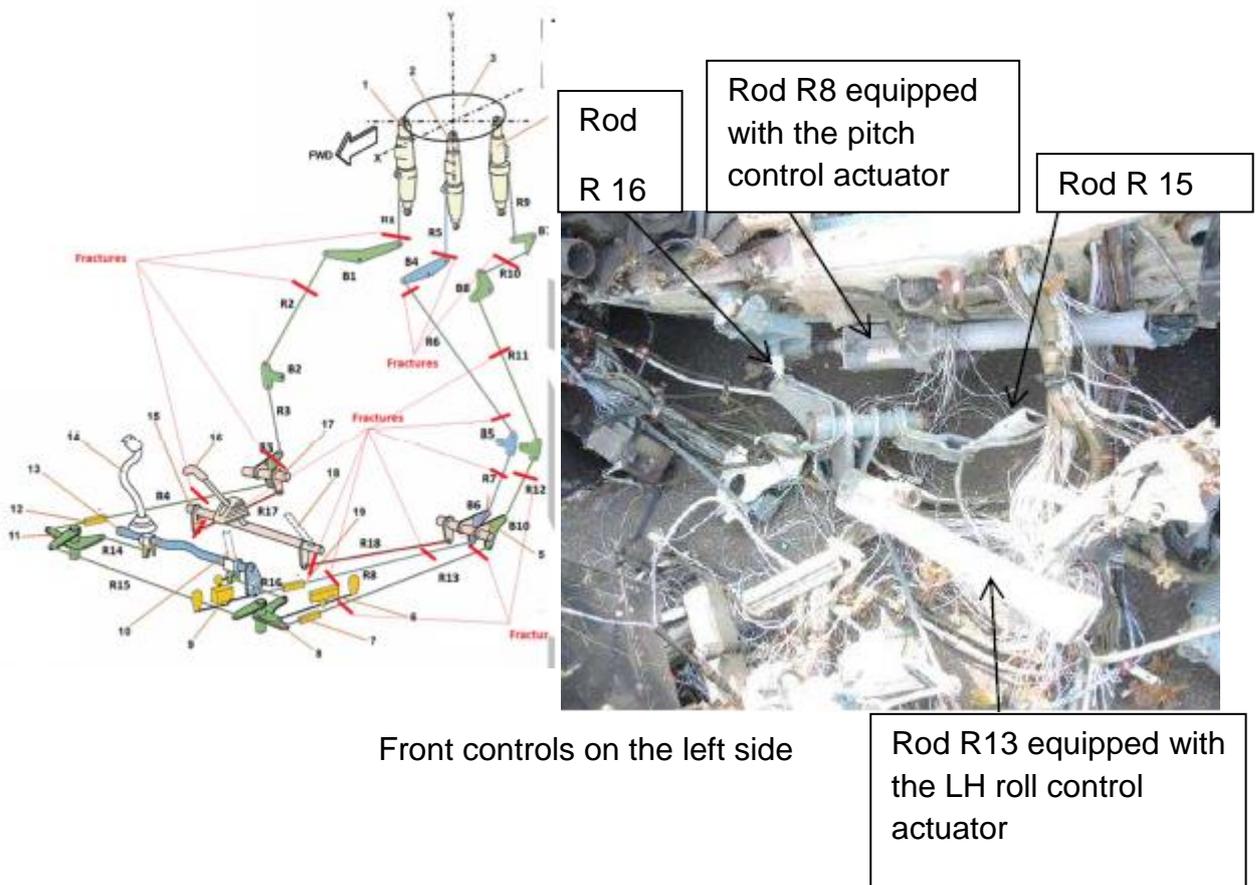
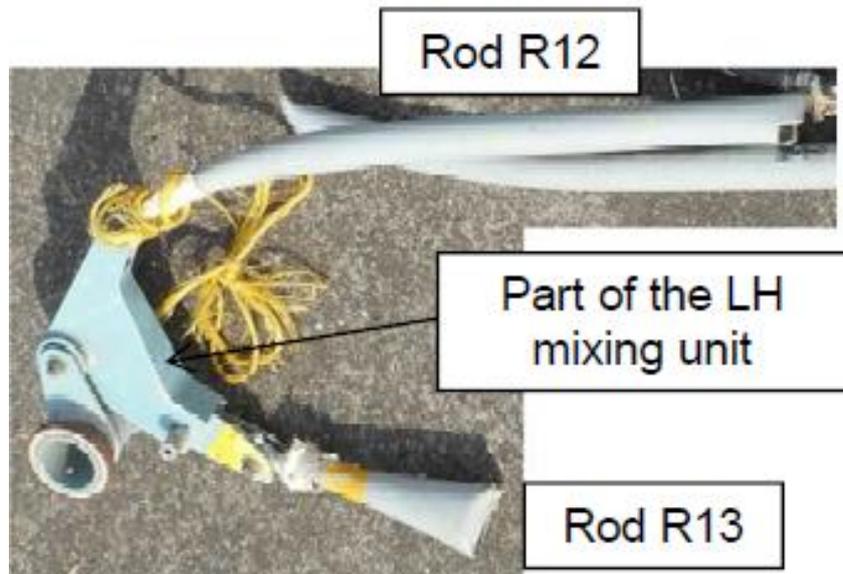
Parts of controls probably on the left side

- LH mixing unit totally destroyed and disconnected from the structure;
- Bellcranks B5 and B9 connected to a fragment of the structure.
(On each bellcrank, two fragments of rod were connected; R7, R8, R12 and R13.)
- rod R6 broken twice;
- rod R5 broken close to the lower rod end;
- rods R10 and R11 broken.

Fragments of rods R6, R8 and R13 were missing.

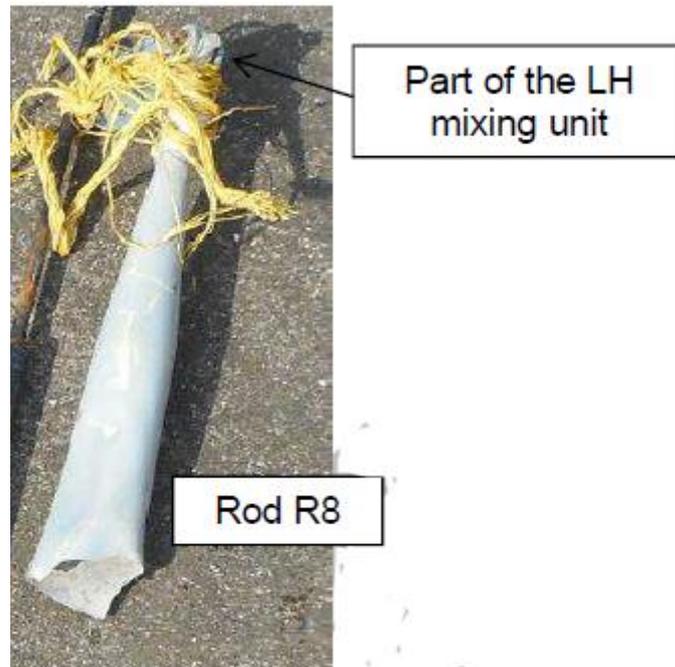
Part of controls on the left side

To conclude, the main rotor controls were clearly continuous before the impact. This observation was consistent with parameters recorded on the FDR.

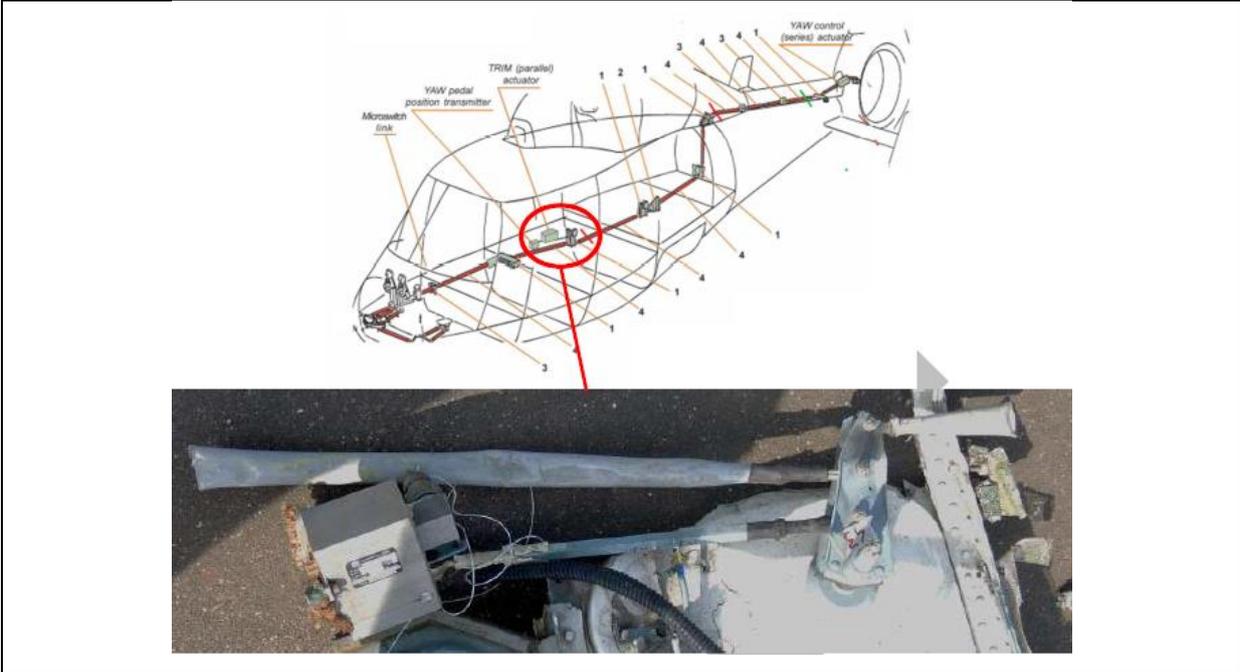
Part of the tail rotor control

Several fractures were identified on the controls. All fractures observed were the consequence of overload (static fractures) without damage prior to the accident.

The end of the tail rotor control was cut previously by the Indian Authority.

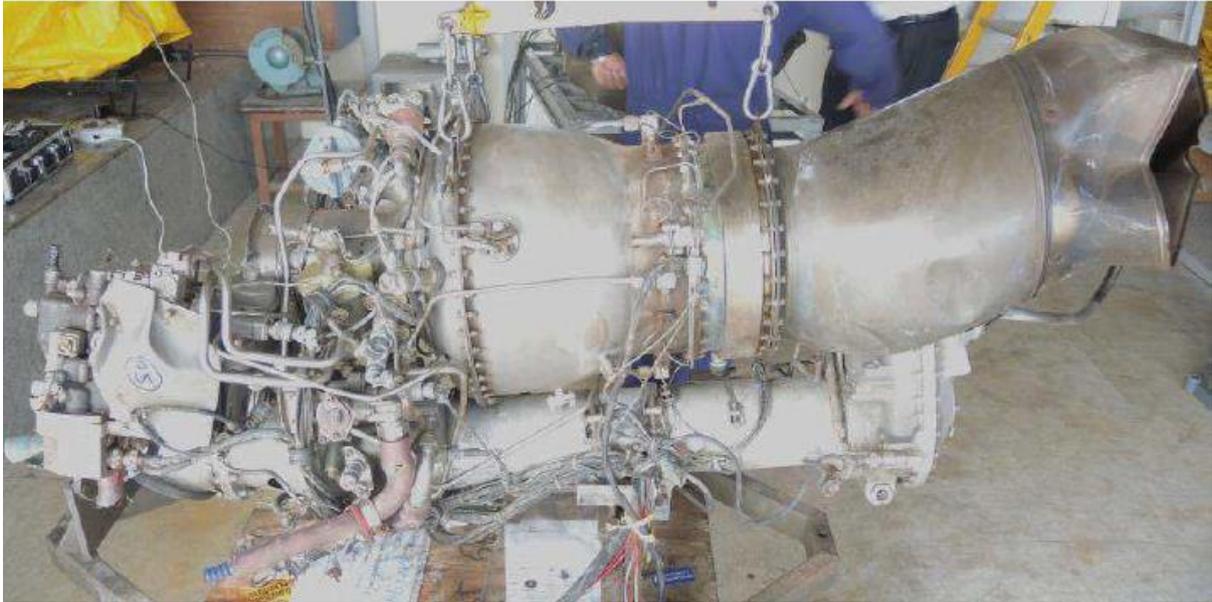
The left side of the left engine

<p>mounts broken.</p> <p>The air intake was attached to the engine.</p> <p>The air intake was deformed during the impact.</p> <p>The engine casings and the transmission shaft casing were neither deformed nor perforated.</p> <p>The exhaust pipe was deformed but it kept its initial form.</p> <p>On the front of the engine, the starter generator was in position and connected to the engine.</p> <p>The shaft of the pump and metering unit assembly was outside of the engine. The clamp of this shaft was found deformed and was found under the joint area.</p> <p>On the top of the engine, the fuel valves assembly and the bleed valve unit were in position.</p> <p>The bleed valve was open, this position is normal with the engine stopped.</p> <p>On the pump and metering unit assembly, the fuel supply pipe was connected but broken about 0.1 metres from the engine.</p> <p>The external pipes were connected and complete. Some deformations were identified; these deformations were a consequence of the impact.</p>	<p>broken.</p> <p>The air intake was attached to the engine.</p> <p>The air intake was deformed during the impact.</p> <p>The engine casings and the transmission shaft casing were neither deformed nor perforated.</p> <p>The exhaust pipe was deformed but it kept its initial form.</p> <p>On the front of the engine, the pump and metering unit assembly and the starter generator were in position and connected to the engine.</p> <p>On the top of the engine, the fuel valves assembly and the bleed valve unit were in position.</p> <p>The link was broken at the entry to the start electro-valve. The fracture was a consequence of the impact during the accident.</p> <p>The bleed valve was open, this position is normal with the engine stopped.</p> <p>On the pump and metering unit assembly, the fuel supply pipe was connected but broken about 0.4 metres from the engine.</p> <p>The external pipes were connected and complete. Some deformations were identified, these deformations were a consequence of the impact.</p>

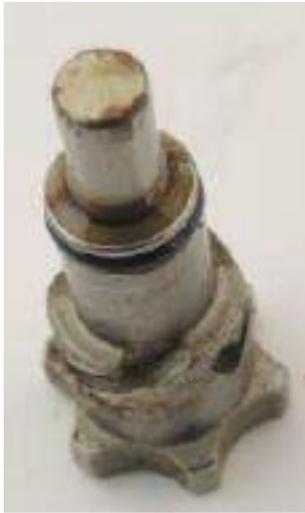
Front mechanical magnetic plug

damage. No metallic chip was identified on the other plugs. There were just oil residues mixed with water.

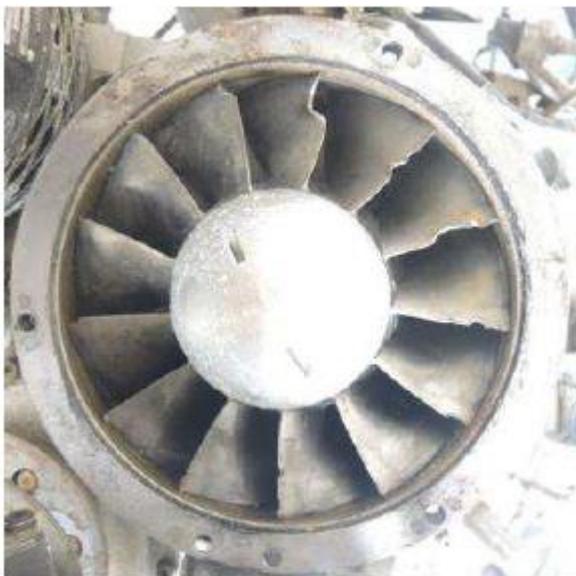
Left engine

The axial compressor blades were damaged on the leading edge. This observation shows that some debris passed through the compressor whilst the engines were rotating, most probably due to the consequences of the impact with the water.

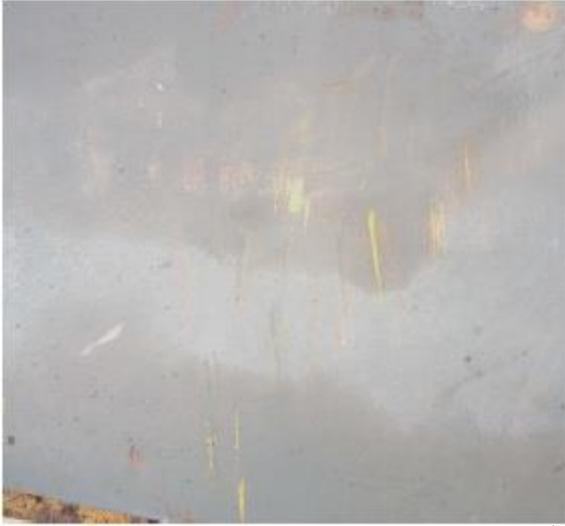
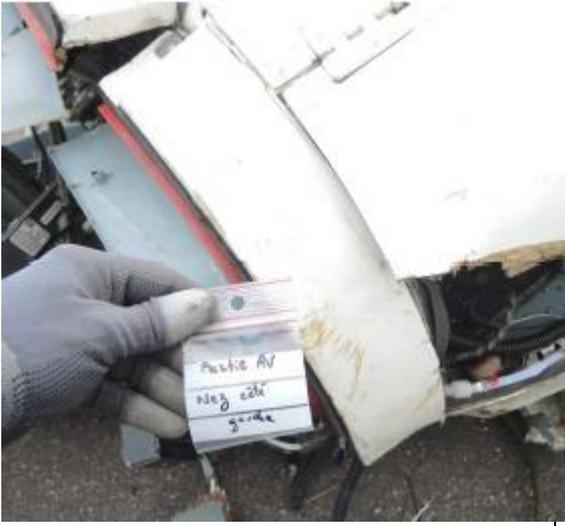
Upper side of the yellow blade	Forward structure

Various traces of paint have been identified on the items listed below:

- upper side of yellow blade;
- forward structure;
- upper side of the aft structure;
- rope used to recover the wreckage;
- rope used to recover the wreckage and attached to the aft structure.

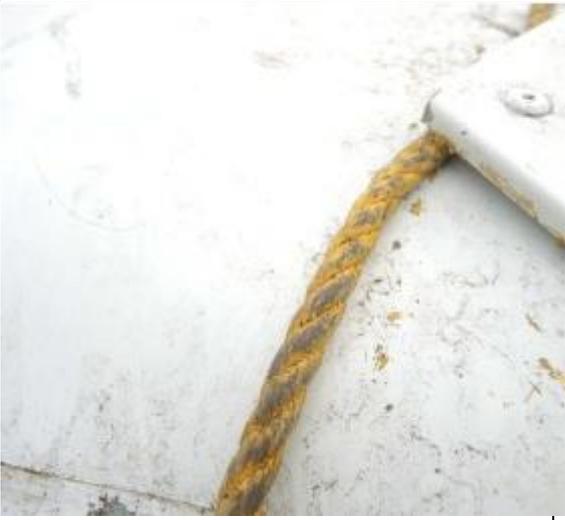
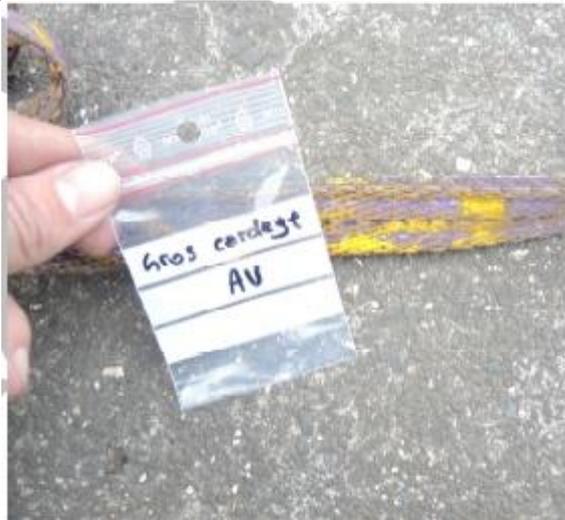
Upper side of the aft structure	Rope used to recover the wreckage

During the examination of the wreckage by the BEA, samples were taken on these elements.

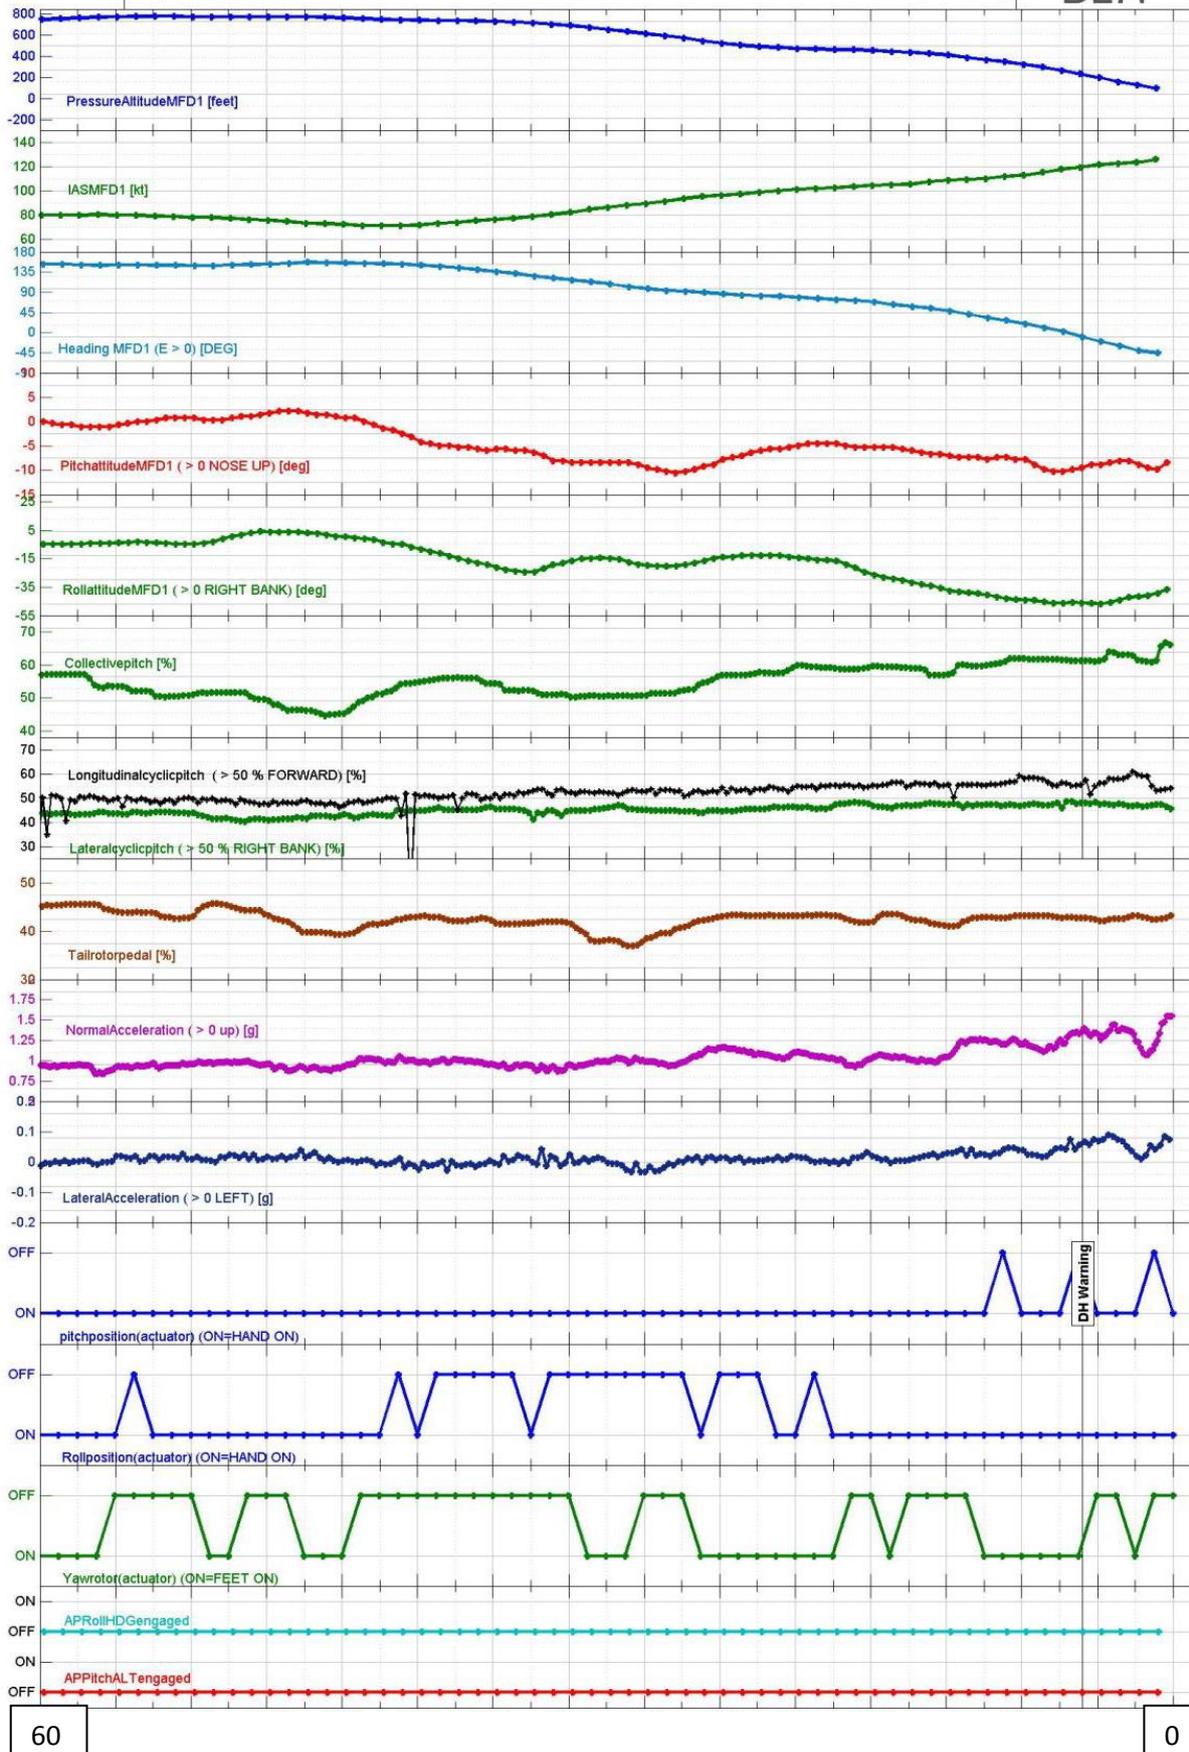
FLIGHT PARAMETERS FOR LAST 60 SECONDS

At that point the pilot slightly moved the cyclic stick backward and the collective stick downward. Consequently, the pitch increased and the power decreased. This maneuver looks like a standard approach procedure to decrease the speed. Thereafter, the pilot moved the cyclic stick slightly to the left and began a left turn. For about 38 seconds from T_0 , the roll attitude was always more than 12° left and the altitude continued to decrease. The collective pitch was slightly moving upward. At 34 seconds from T_0 , the roll attitude was 24.26° left. At 4 seconds from T_0 , the FDR recorded a maximum left roll of 46.76° . The pitch attitude was 8.79° down.

During the last ½ to 1 second the collective pitch significantly increased from 61.25% to 66.84%. At that moment, when the recording stopped, the recorded attitude of the helicopter was 8.44° pitch down and 36.58° left for the roll. The lateral cyclic stick was 4.41% left.
