**FINAL REPORT ON ACCIDENT TO M/S ALCHEMIST AIRWAYS PVT.  
LTD. KING AIR C-90A AIRCRAFT VT-EQO NEAR KAIR VILLAGE,  
NAJAFGARH, NEW DELHI ON 24.05.2016**

**FINAL INVESTIGATION REPORT ON ACCIDENT OF M/S ALCHEMIST  
AIRWAYS PVT. LTD. KING AIR C-90A AIRCRAFT VT-EQO NEAR  
KAIR VILLAGE, NAJAFGARH, NEW DELHI ON 24.05.2016**

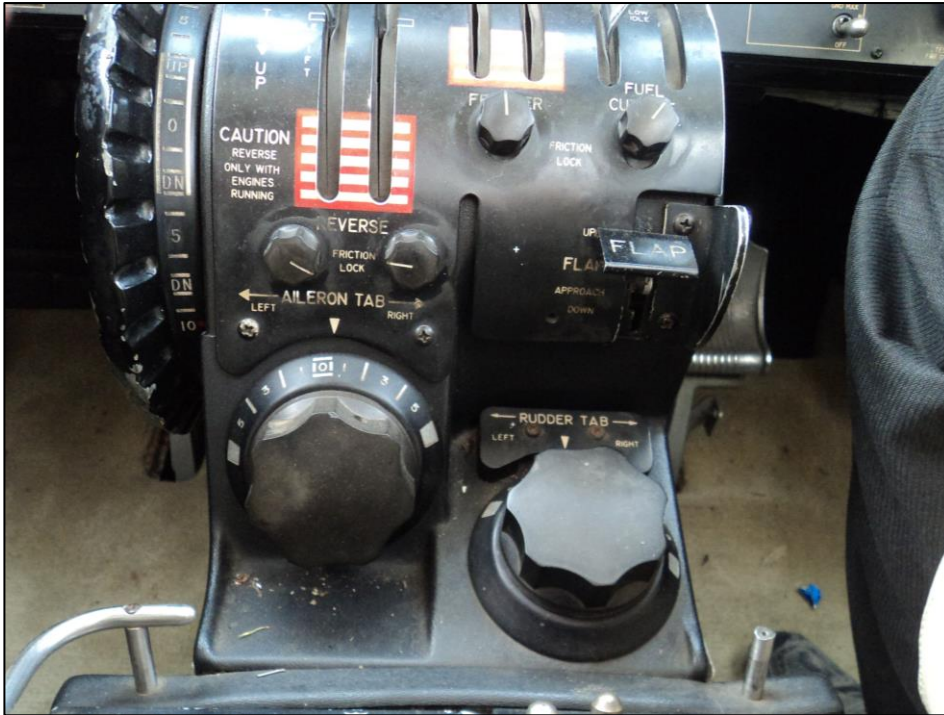
In the cockpit, the throttle levers were found in idle position. Fuel shutoff valve was found in "ON position". Flaps were in "UP position".
