**FINAL INVESTIGATION REPORT ON ACCIDENT
TO AMAN AVIATION & AEROSPACE
SOLUTIONS (P) LTD.**

**ROBINSON R-44 HELICOPTER VT-PHB
ON 11-12-2016 NEAR JUHU, MUMBAI**

**AIRCRAFT ACCIDENT INVESTIGATION BUREAU
MINISTRY OF CIVIL AVIATION
GOVERNMENT OF INDIA**

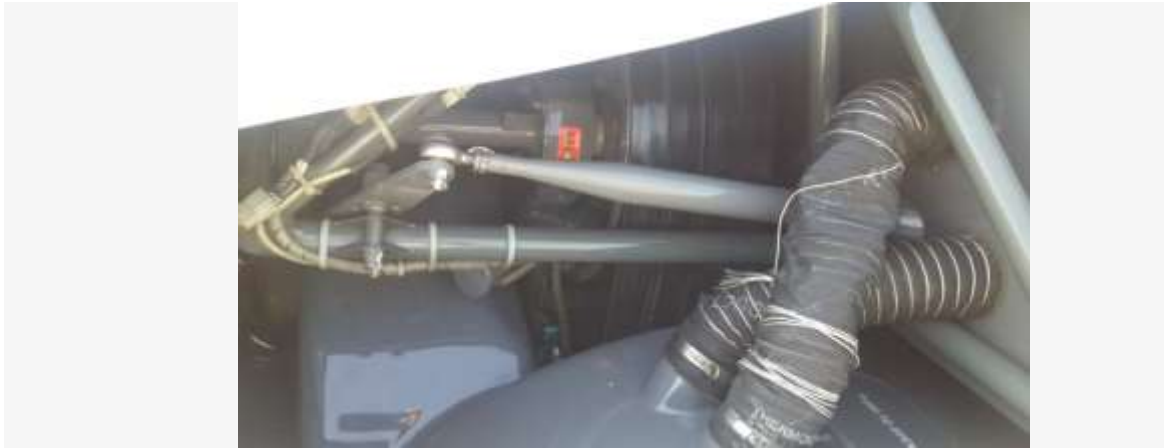
BEARINGS

In a typical arrangement on R44 helicopter (above photo from other R44 helicopter available with the operator), just to the left of the four belts, there is an upper bearing. The purpose of the upper bearing is to hold the drive shaft up (or down) while allowing it to turn. There is an orange teletemp mounted on the bearings which gives an idea of the temperature the bearing has been running at because bearings can run hot before failure. If the bearing suddenly starts to run hot, that would indicate a developing problem. Just to the right of the upper bearing, built into the hub of the upper sheave is the freewheeling unit. The purpose of the freewheeling unit is to allow the rotor to keep turning if the engine stops (to autorotate).

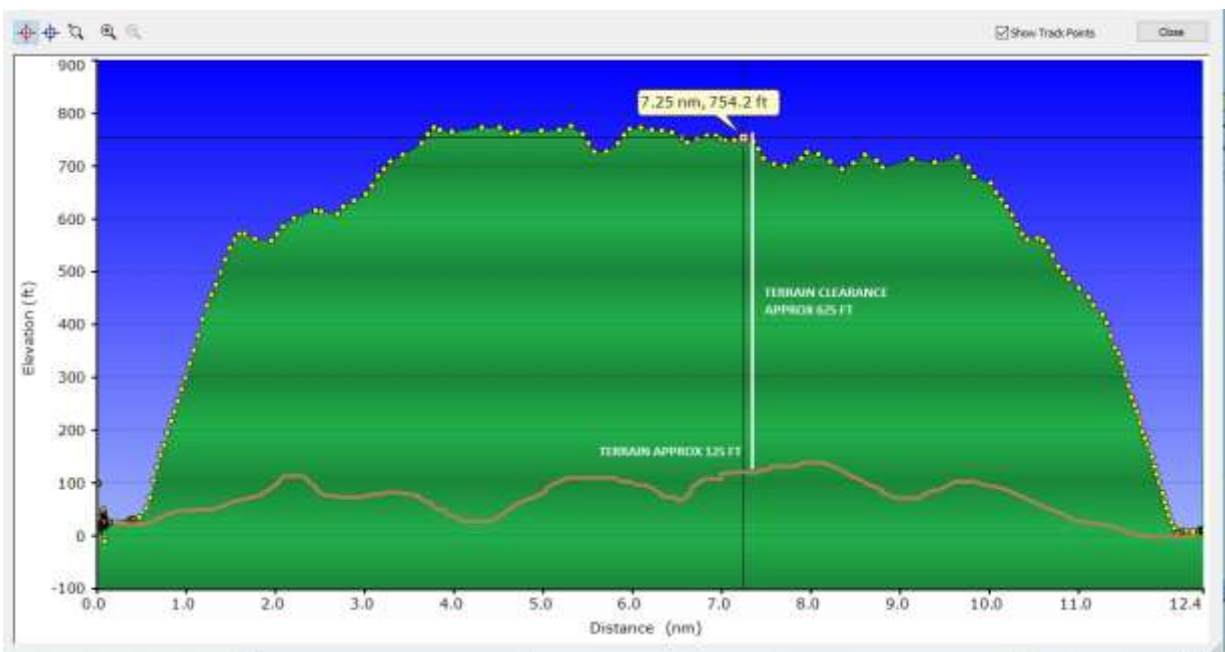
This flight was being operated by single pilot, maintaining 500ft AGL and fully loaded with 4 persons on board. The time to get back to ground from this height was going to be less than a minute as he had to maintain minimum 700-800 fpm ROD to keep the rotor rpm in autorotation, which would actually be 30-40 seconds of autorotative flight, keeping in view the time available with the pilot for decision making and human reaction.

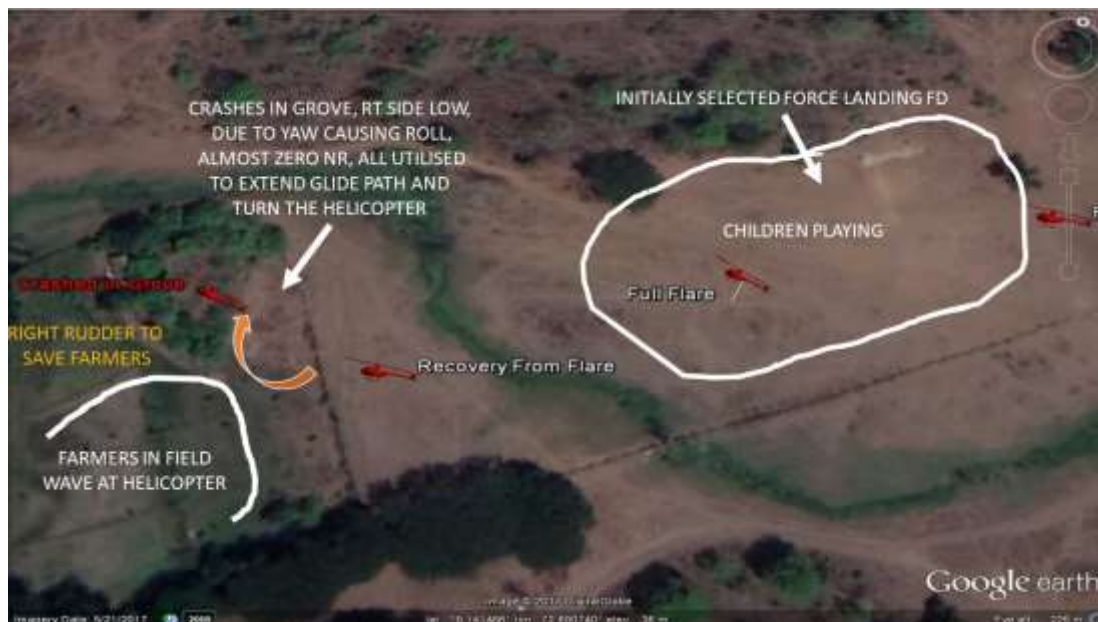
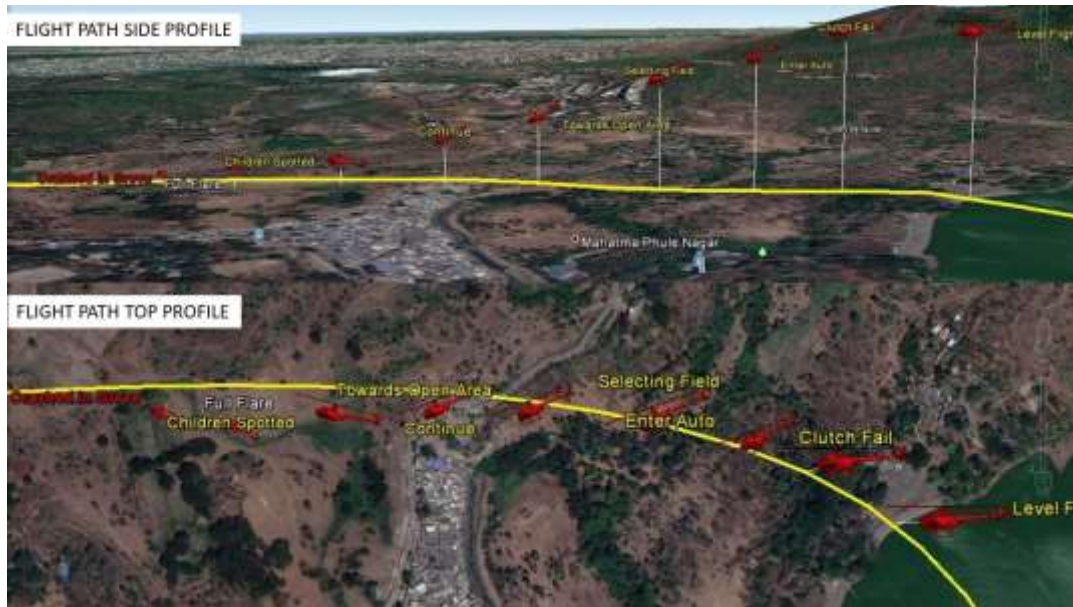
The pilot had put the helicopter in proper autorotation and selected a force landing field which was clear of obstructions. During autorotation when the helicopter came close to the ground, PIC realised that there were children playing there. He stretched his glide path by using some collective input and proceeded further, in this process he must have lost some of his rotor RPM. While he was flaring he saw a few workers in the field where he would have landed, hence he carried out a right yaw to avoid landing his helicopter on those workers. This resulted in the helicopter side slipping and slight roll to the right into a grove of trees and bushes. To cushion the landing he had used his full collective which led to zero rotor RPM while impacting the trees/bushes/ground. This is evident from the fact that neither the main rotor or the tail rotor blade had any frontal impact marks, suggesting that during the autorotative process, all kinetic energy of the main rotor system generated due to auto-rotation was utilized during the flare and recovery of the helicopter.

Just prior to the impact, as the helicopter was yawing to the right, it got into further effect of right yaw and rolled towards the right. It made contact with the ground and tilted to the right, which led to impact loads on PIC and right rear passenger side. The technician who was sitting on the co-pilot seat (left side) was unhurt. As the engine was still running without giving power to the transmission system and helicopter, it caught fire on impact.
