**AIRCRAFT ACCIDENT INVESTIGATION BUREAU**

**FINAL INVESTIGATION REPORT  
ON SERIOUS INCIDENT INVOLVING  
M/S AIR INDIA'S BOEING 777-300 ER AIRCRAFT VT-ALJ  
AT MUMBAI ON 22.02.2016**

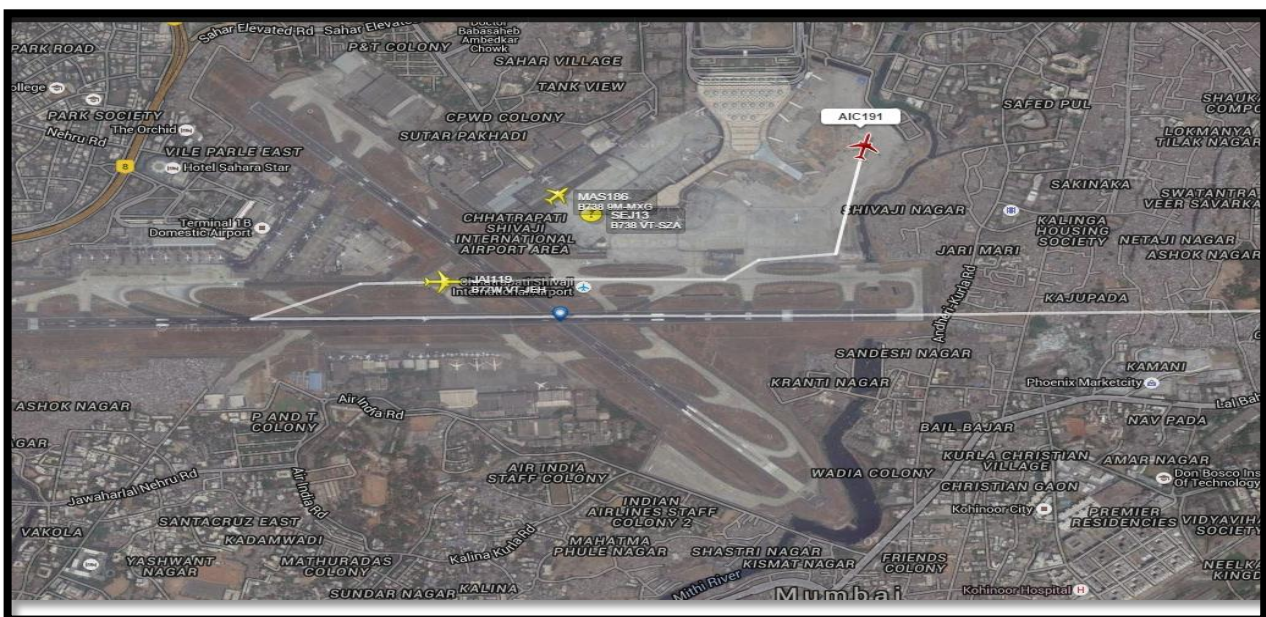
Figure : 1

The actual time of departure of AI144 from Mumbai was 1502 UTC and flight landed at Ahmedabad at 1620 UTC. There was ground halt of 01 hour at Ahmedabad. Ahmedabad to Mumbai leg was to be operated as Flight AI191. At Ahmedabad the aircraft pushed back at 1720 UTC. But the aircraft had to be towed back to the bay as it's Left Engine could not start. After maintenance action, left engine was started at bay and aircraft was pushed back again at 1845 UTC. The flight AI191 took off at 1856 UTC from Ahmedabad to Mumbai and was uneventful. Aircraft landed at RWY 27 at 1940 UTC. Both flights (AI191 and AI 144) were operated by the same crew. The layout of aerodrome showing track followed by aircraft is shown in Figure 1 below:-
