**Final Investigation Report on Serious Incident to M/s Jet Airways
aircraft VT-JEK at London Heathrow Airport on 30.08.2016**

Final Report on Serious Incident to M/s Jet Airways Ltd. B777-300, VT-JEK at London Heathrow Airport on 30.08.2016

| 13. Type of Occurrence | : Serious Incident (Late take-off) |

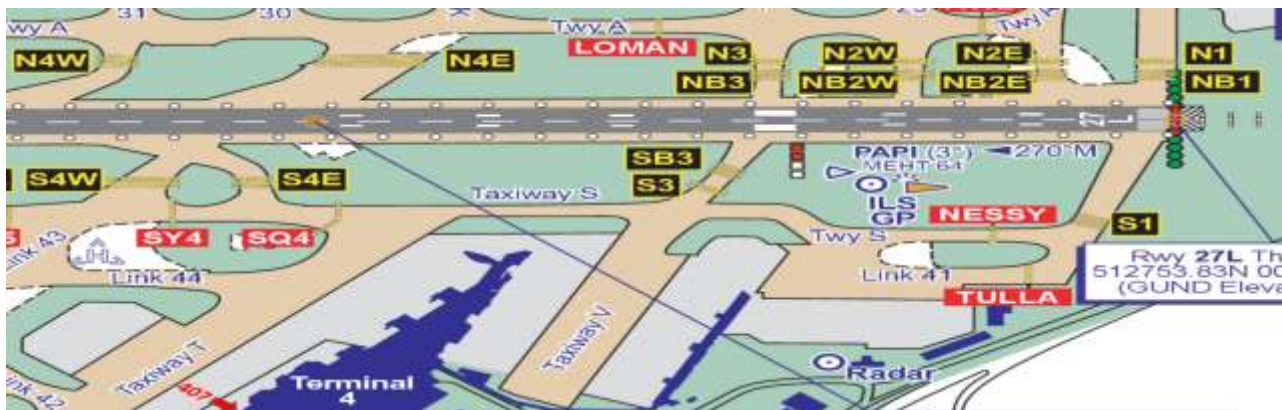
Figure 1: London Heathrow Airport south of Runway 27L

Jet Airways aircraft B777-300 was operating a Commercial Air Transport flight from London Heathrow Airport to Chhatrapati Shivaji Airport in Mumbai, India with 231 passengers and 15 crew on board. The aircraft departed from stand 407 and the runway in use was Runway 27L (Figure 1).

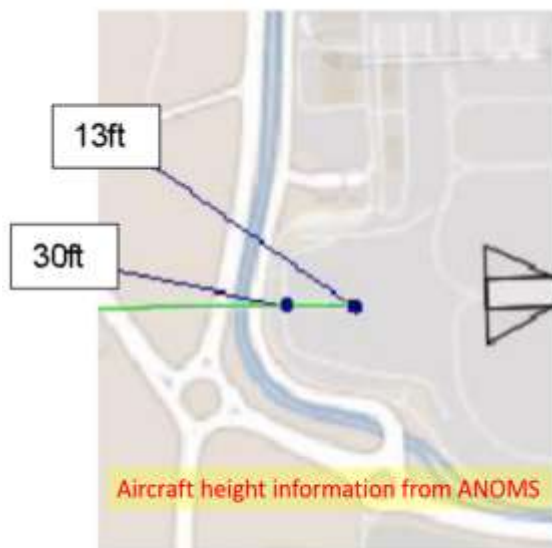
Figure 3(a) Noise Monitor

- V. When considering the reported heights of the aircraft, the following information has been obtained from both Heathrow and NATS engineers, together with a report from the Netherlands Aerospace Centre (NLR), which was commissioned earlier this year to complete a verification of the Heathrow Noise and Track Keeping System. NLR compared the raw

data received and displayed from the NATS source with separate ADS-B data in the same period.

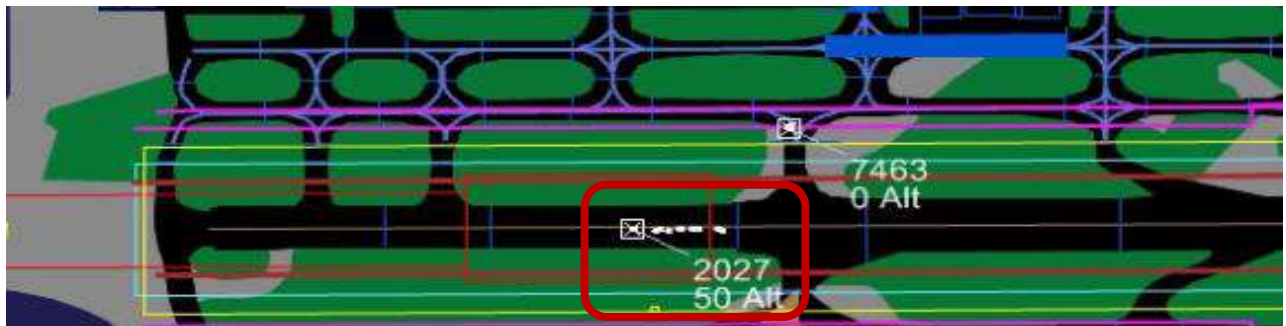
Figure 4(a): Departing **BAW 77 (B772)**

- VII. ATSI reviewed the ASMGCS radar for the period 1945 – 2045 UTC, noting which of those aircraft which were based on the south side of Runway 27L, elected to take an S4 intersection departure, and those which crossed to the north side to take full length. Also, snapshots were taken of the first point an altitude was recorded by the ASMGCS for a departing aircraft, (all of whom took full-length departures.) This gave a broad picture of the point of rotation of each aircraft. Only those results which show a similar type (Boeing 777) are included in this report.

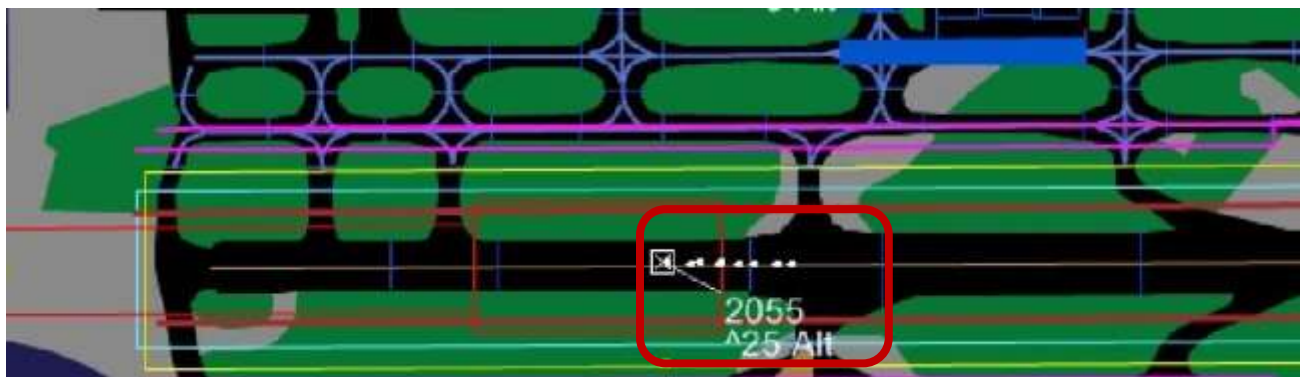
Figure 4(f): **AAR 552 (B772) airborne**

- VIII. During the period of observation, only one other aircraft was observed to take the S4 intersection (an A320). Three other aircraft elected to cross to the north side for a full length departure, an A346, an A332 and another B77W belonging to the same operator as the subject aircraft.
- IX. Using an ADS-B Multistatic Dependence Surveillance System (MDS) as its source, ASMGCS data is believed to be accurate to within 7.5m laterally however, height is reported

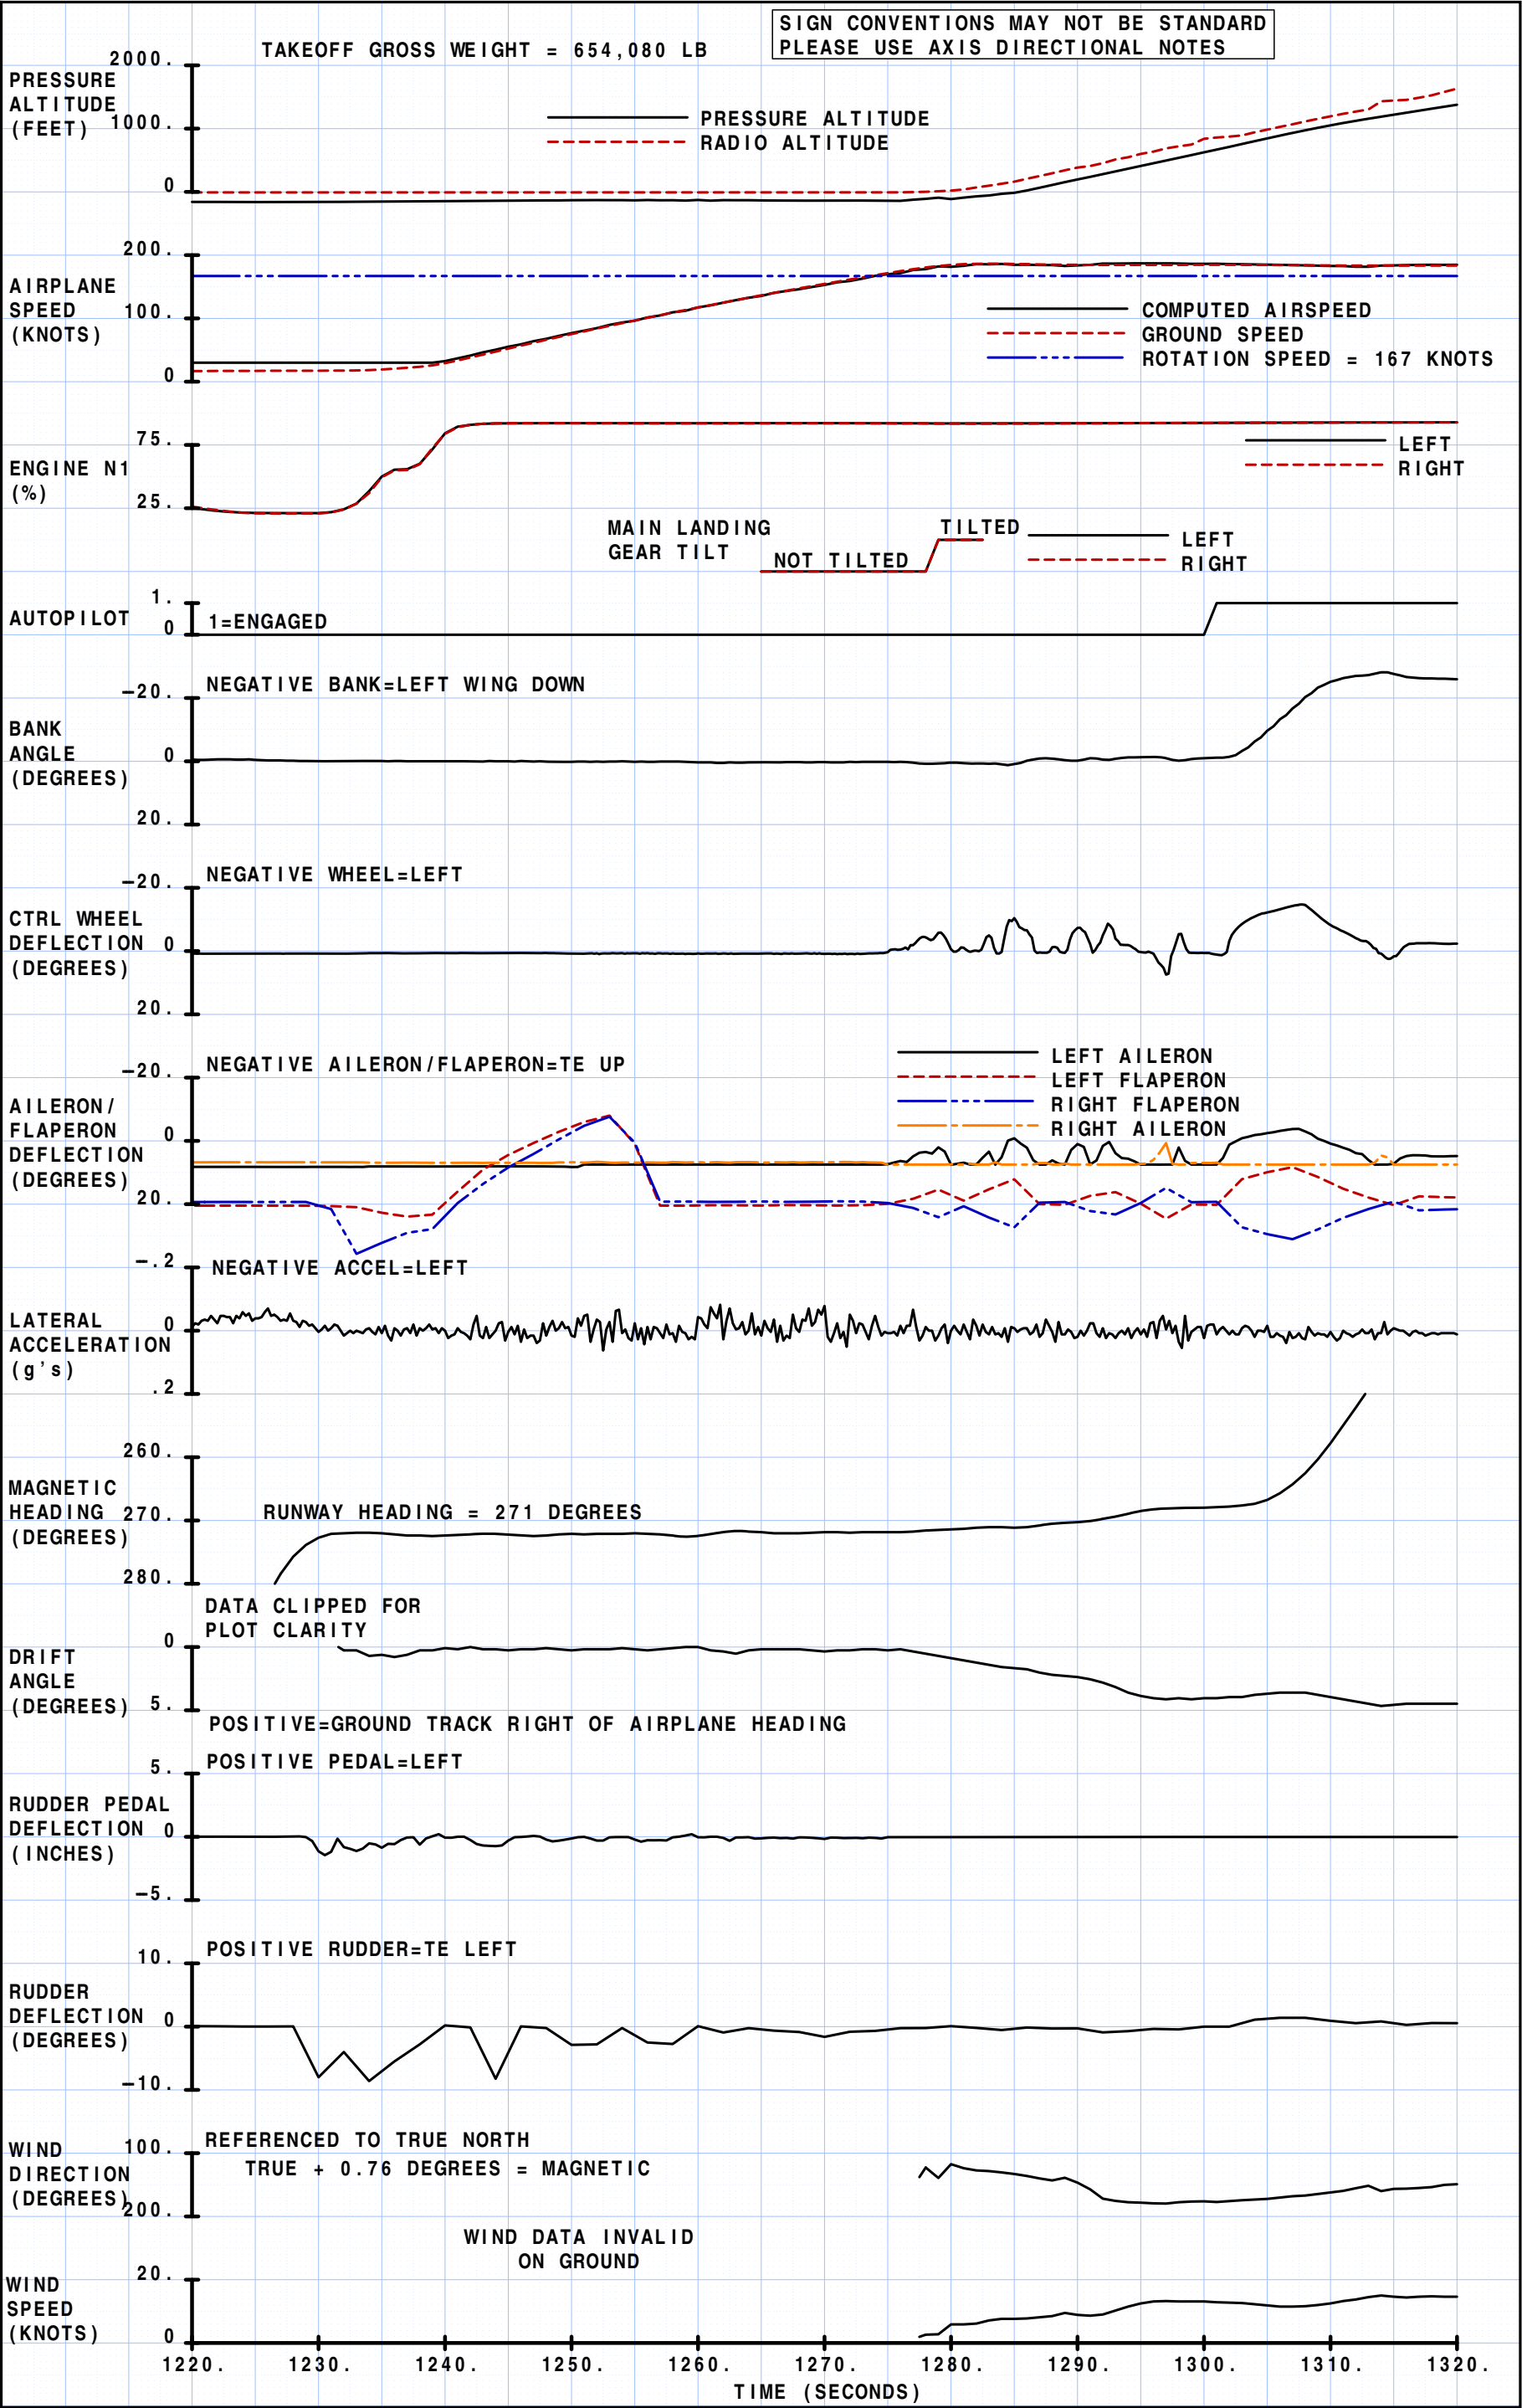
CALC	AERODYNAMICS	28AUG17	REVISED	DATE	JPL 777-300ER VERY LOW TAKEOFF 30 AUG 2016 -- NON-TIME-ALIGNED QAR DATA LONGITUDINAL PARAMETERS - ZOOM-IN	WD770/VT-JEK
CHECK						
APPD						FIGURE
APPD						3

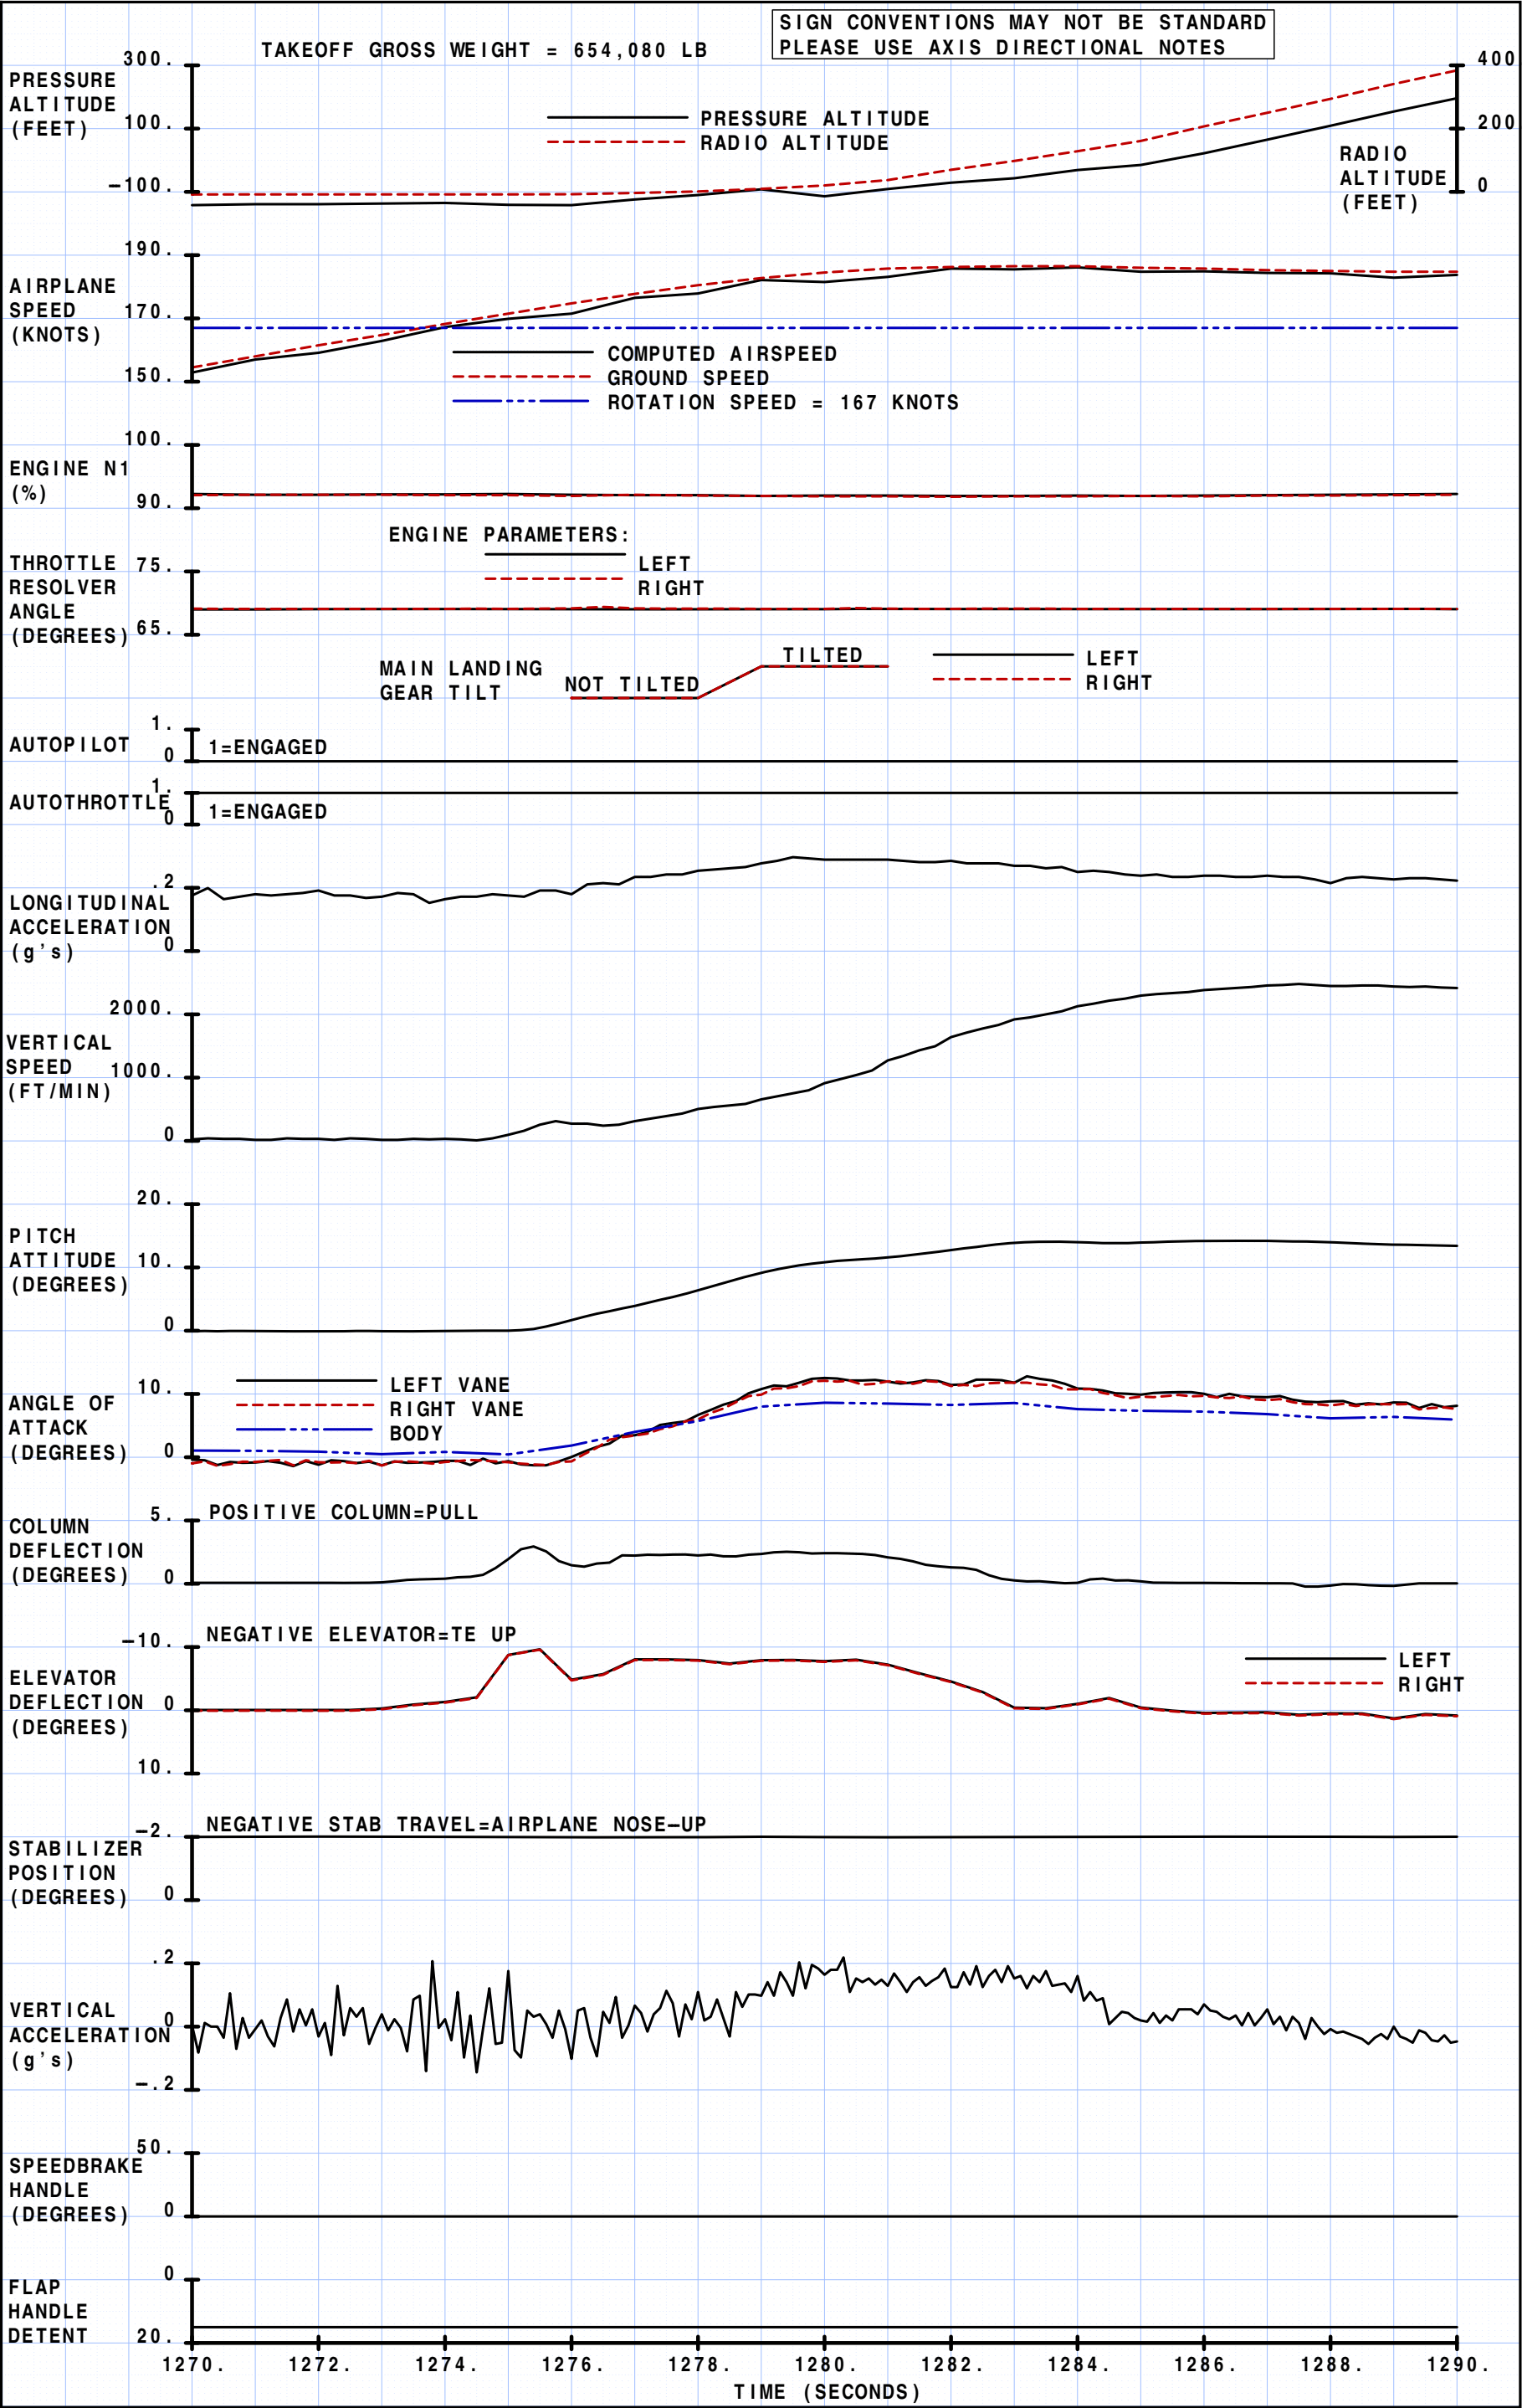
CALC	AERODYNAMICS	28AUG17	REVISED	DATE
CHECK				
APPD				
APPD				
JPL 777-300ER VERY LOW TAKEOFF 30AUG2016 -- NON-TIME-ALIGNED QAR DATA LATERAL-DIRECTIONAL PARAMETERS - ZOOM-IN				
WD770/VT-JEK				
FIGURE				
4
