**FINAL REPORT ON ACCIDENT TO
GOVT. OF MAHARASHTRA
SIKORSKY S-76C++ HELICOPTER
VT- CMM
AT NILANGA, LATUR
ON 25/05/2017**

**A X Joseph
Deputy Director, AAIB
Chairman, Committee of Inquiry**

1. Aircraft Type : Sikorsky S76 C++
Nationality : INDIAN
Registration : VT – CMM
2. Owner : Government of Maharashtra.
3. Operator : Government of Maharashtra.
4. Pilot – in –Command : CHPL holder on type
Extent of injuries : Nil
5. First Officer : CHPL Holder on type
Extent of injuries : Nil
6. Place of Incident : Nilanga, District Latur
7. Geographical Co-Ordinates : 18°07’34’’N, 76°44’57’’E
8. Date & Time of Incident : 25th May 2017, 0625 UTC
9. Last point of Departure : Nilanga, District Latur
10. Point of intended landing : Raj Bhawan, Mumbai
11. Type of operation : Non Schedule Operation
12. Crew on Board : 02
13. Passengers on Board : 04
14. Phase of operation : Take off
15. Type of accident : Crash landing after hitting Electrical
High Tension Cables

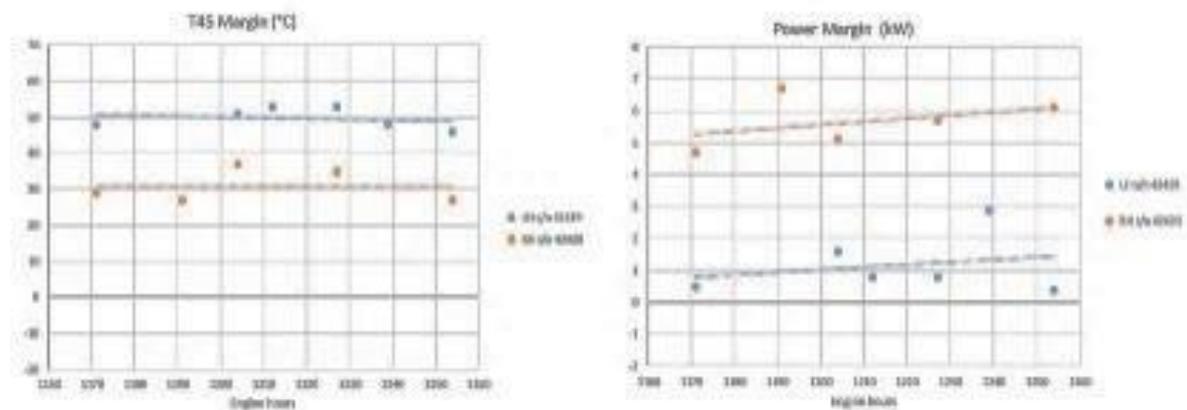
Fig:53 – Engine Power margin trend

One graph shows the T45 margin (shown in °C) and the other one shows the Power margin (shown in kW). Over the period, the trend for the T45 is observed to be stable and the trend for the Power margin is seen rising slightly. Both margins remain positive over the period.
