**FINAL INVESTIGATION REPORT ON SERIOUS  
INCIDENT TO M/s SPICEJET LTD. BOMBARDIER  
DHC – 8 – 402 (Q-400) AIRCRAFT VT-SUL AT IGI  
AIRPORT, DELHI ON 08.11.2017**

**AIRCRAFT ACCIDENT INVESTIGATION BUREAU**

On 08.11.2017, M/s Spice Jet Ltd. Bombardier DHC – 8 - 402 aircraft VT-SUL while operating a scheduled flight SG-2642, (Jabalpur-Delhi) was involved in a serious incident of hard landing and subsequent tail strike while landing at IGI airport, Delhi. The aircraft was under the command of pilot holding valid ATPL and duly qualified on type along with First Officer having a valid CPL holder and qualified on type. There were 02 cabin crew and 72 passengers on board the aircraft.

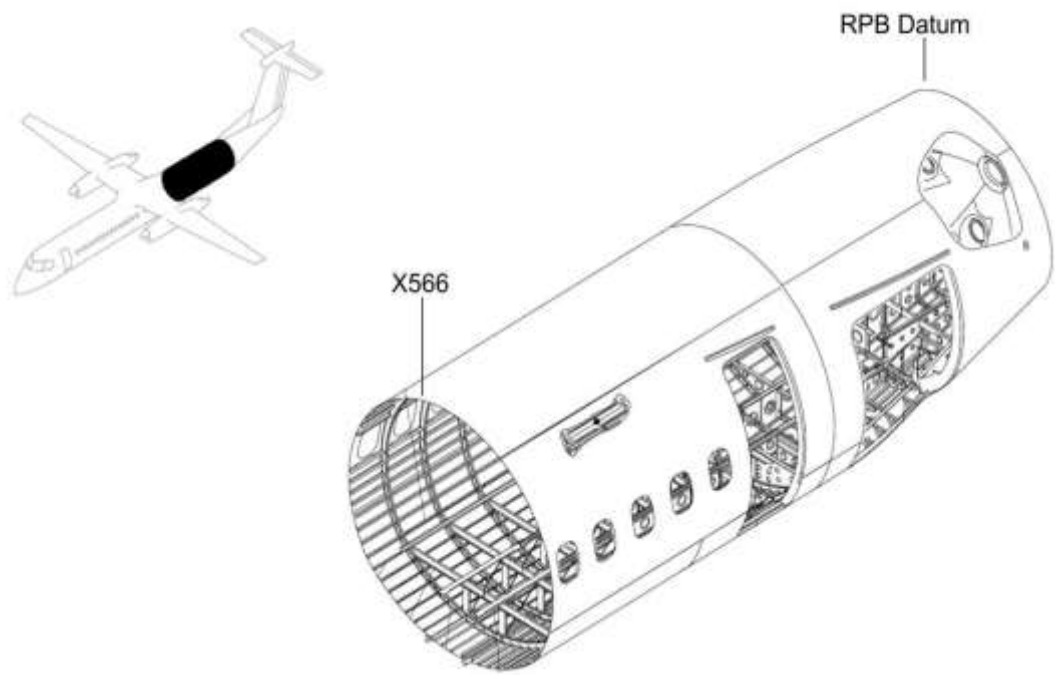
***Aft Centre Fuselage Section***

- Lower surface skin received heavy scrape marks, cracks, buckles, tears and crease damages between cross section 697.5 to 801 and between stringers 29P to 29S.

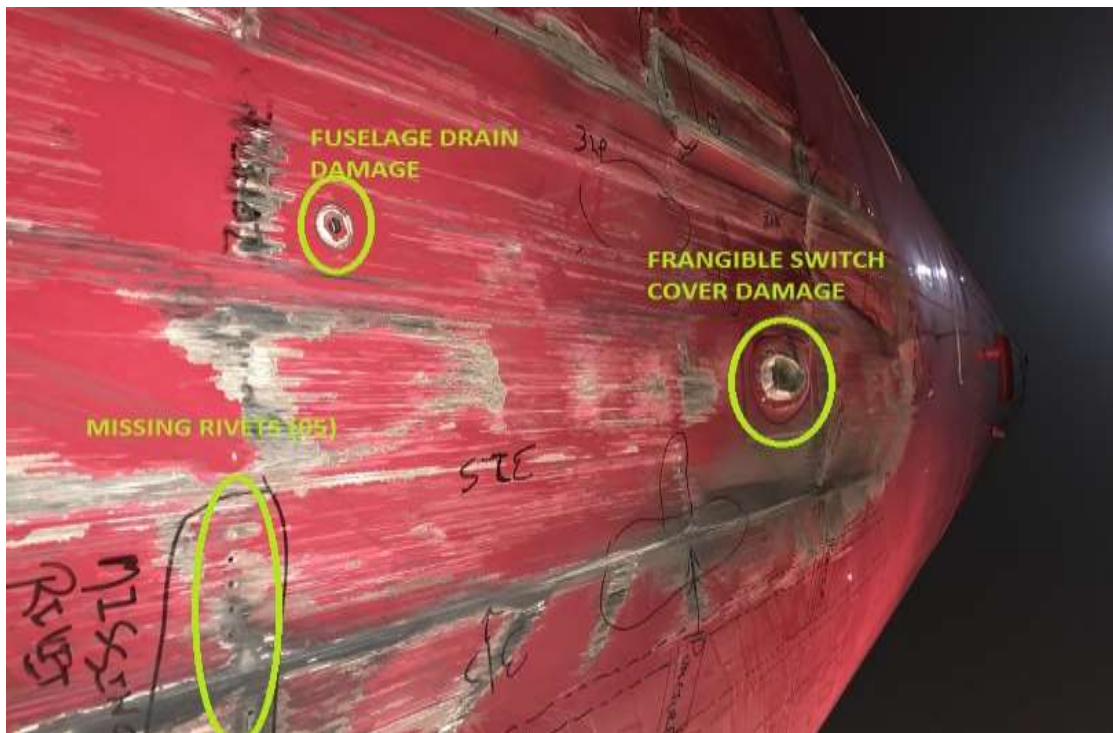
**Heavy Scrape marks on lower surface**

- The Frangible Switch Cover was found missing
- Fuselage Drain was found damaged.
- Few rivets were found missing between cross section 698 & 801

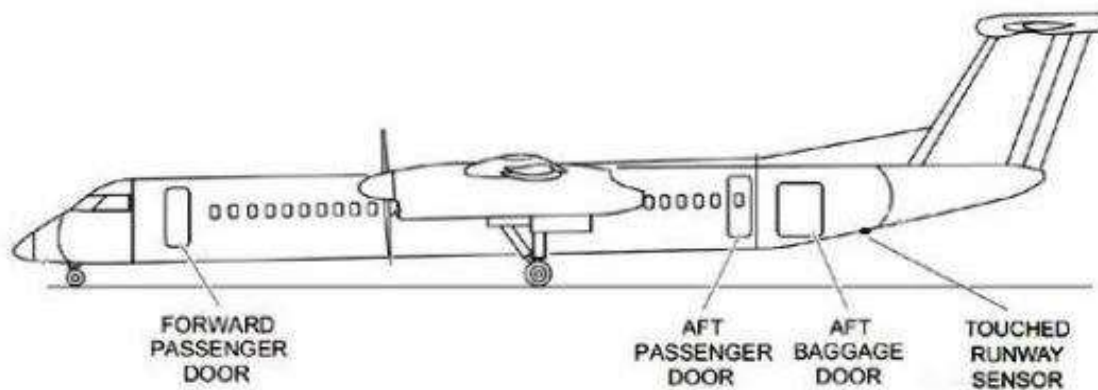
***Touched runway sensor located at aft fuselage lower surface***
