**FINAL INVESTIGATION REPORT ON
ACCIDENT TO M/s AHMEDABAD AVIATION &
AERONAUTICS LTD., CESSNA 172S AIRCRAFT,
VT-ABK ON 24-11-2018 AT MEHSANA
AIRFIELD, GUJRAT**

**GOVERNMENT OF INDIA
MINISTRY OF CIVIL AVIATION
AIRCRAFT ACCIDENT INVESTIGATION BUREAU**

FINAL INVESTIGATION REPORT ON ACCIDENT TO
M/s AHMEDABAD AVIATION & AERONAUTICS LTD., CESSNA 172S
AIRCRAFT, VT-ABK ON 24-11-2018 AT MEHSANA AIRFIELD, GUJRAT.

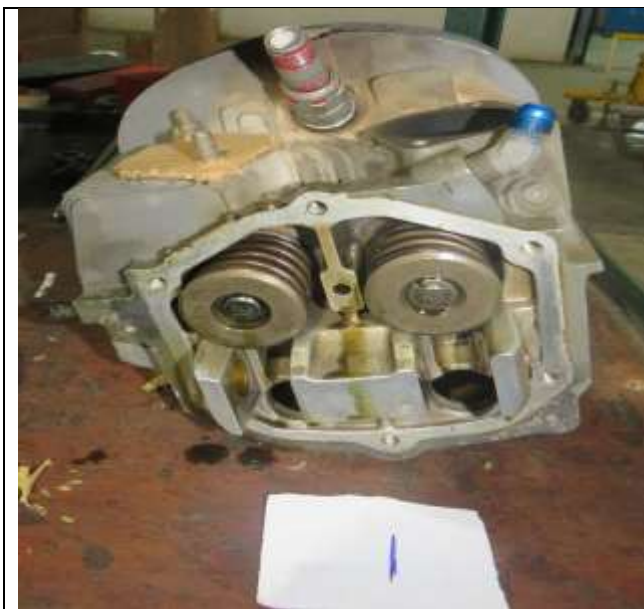
Head Side

- Traces of oil were observed in cylinder # 2 & # 4 which were fresh and may be due to the engine impacting with ground.
- The condition of the piston heads & the bore was found satisfactory in all the cylinders.
- The condition of the piston rings was found satisfactory on all the pistons.

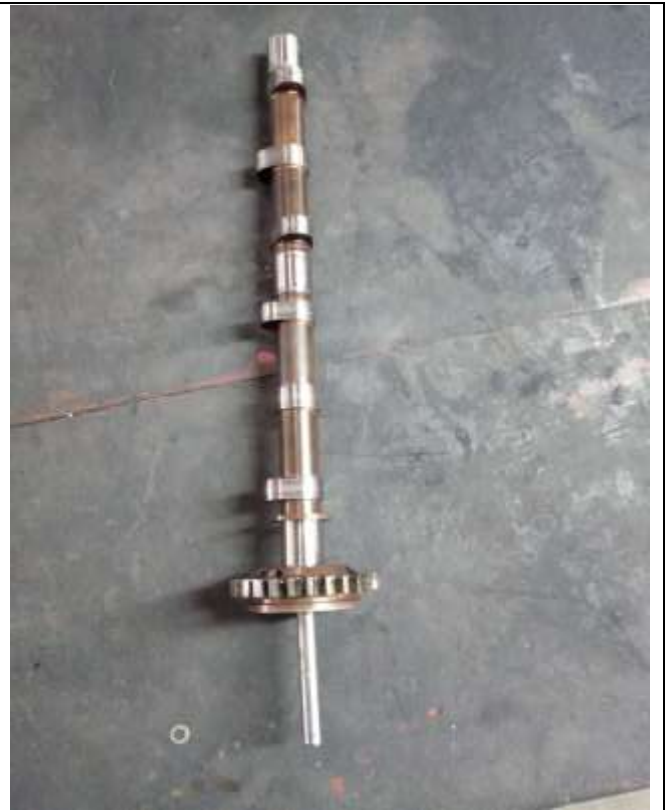
Cam Shaft

- The condition of internal parts were found satisfactory. No abnormalities noticed on the crank shaft. All the metal bearings were in position & in good condition. The journal diameters of crank shaft were in good condition.
- There was no sign of oil starvation noticed in the engine, i.e. all the moving parts were well lubricated.
- The cam shaft was found in good condition.
- Sufficient amount of oil was present in oil sump and the condition of oil sump was found satisfactory.
- The condition of gears were found satisfactory.
