**FINAL INVESTIGATION REPORT OF
ACCIDENT TO M/S PHL
DAUPHIN SA 365 N3 HELICOPTER VT-PWA
AT BOMBAY HIGH ON 13th JANUARY 2018**

**AIRCRAFT ACCIDENT INVESTIGATION BUREAU
MINISTRY OF CIVIL AVIATION
GOVERNMENT OF INDIA**

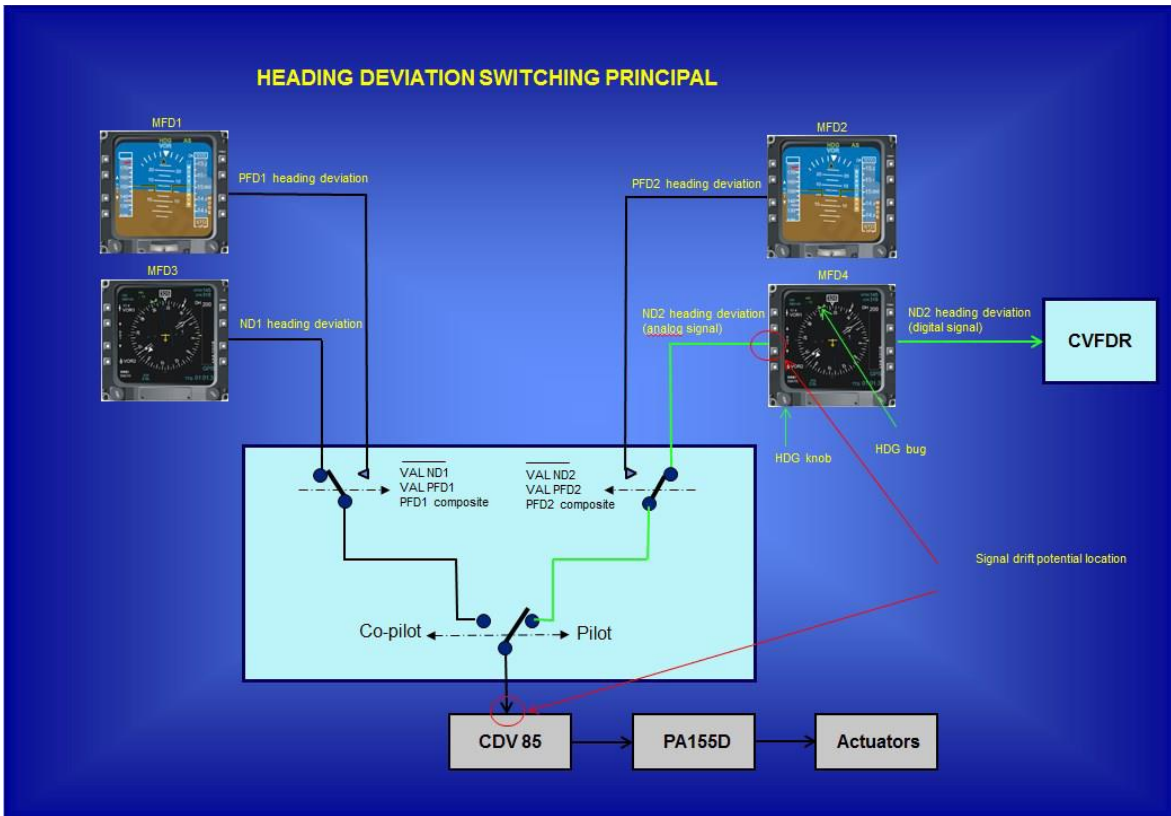
(C) Heading Deviation Signal Switching Principal

During accident flight, heading deviation signal came from MFD4 meaning that selector was set to pilot flying position. The heading deviation drift is supposed to come from either MFD4 output defect or CDV85 input defect. (The CVFDR does not record analog signal. It records digital signal coming from MFD which is not affected by the drift).

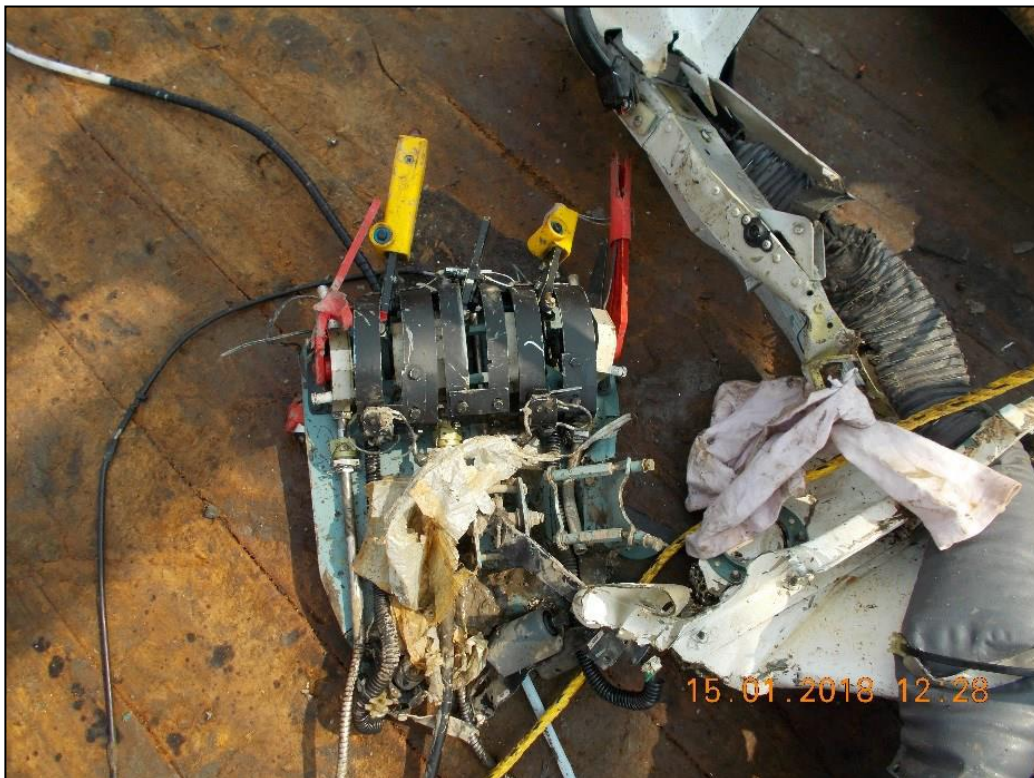
B. Overhead Control Levers

The positions of the overhead control levers were found as follows:-

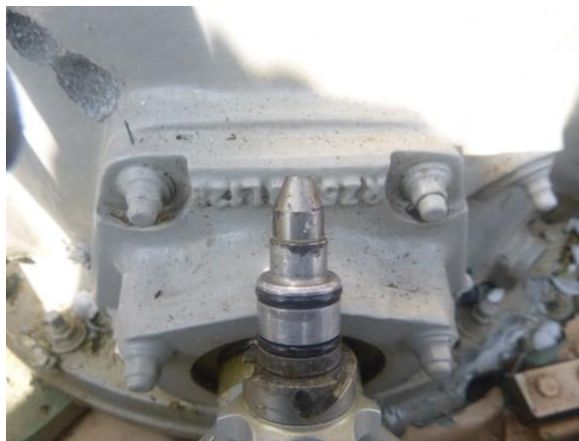
Main Gearbox (MGB)

No metallic particle was found on chip detector. Magnesium corrosion powder (nonmagnetic) was found on detector confirming high level of corrosion inside.

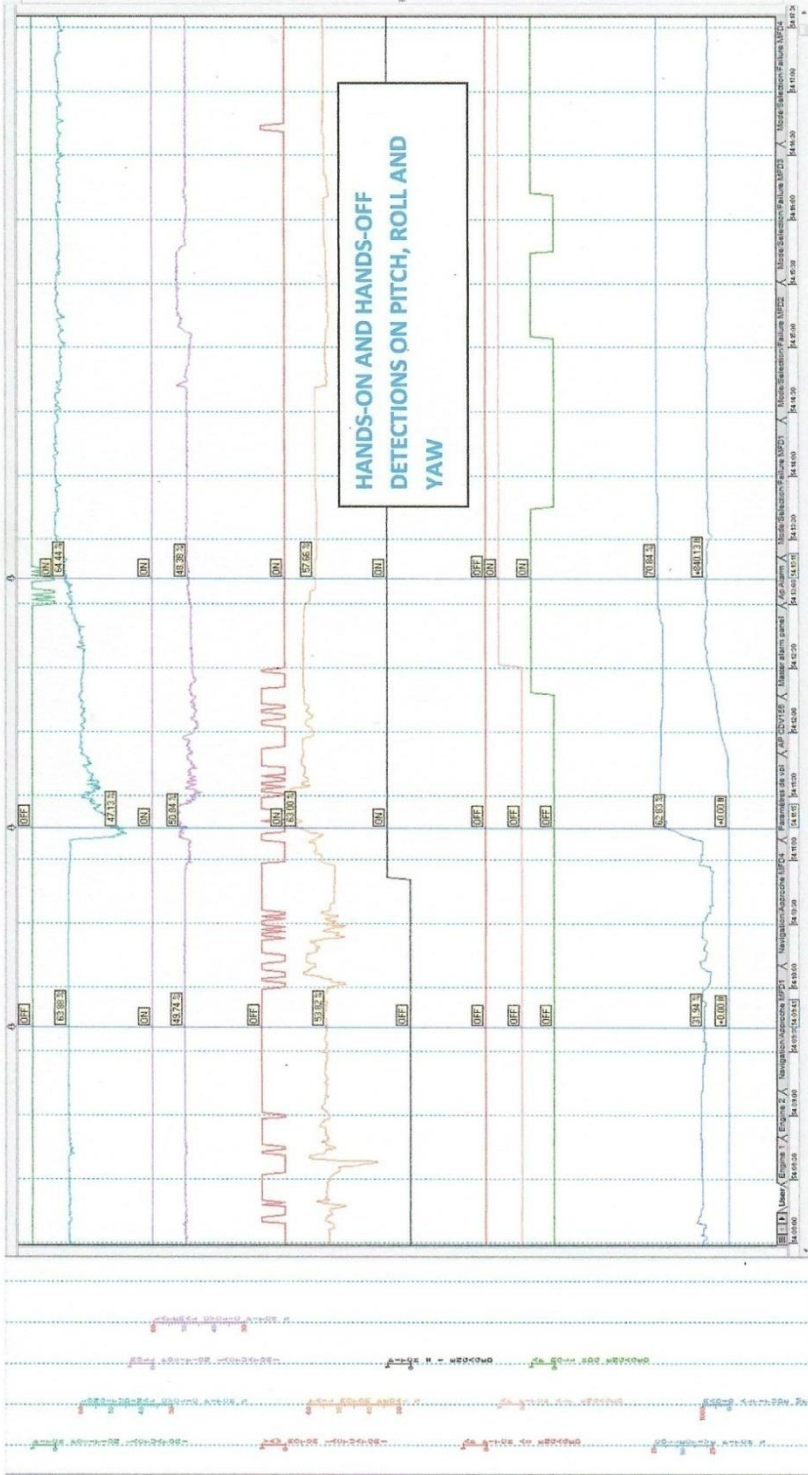
AP STATUS (FULL FLIGHT)
AFCS WARNING STATUS

Pitch #1 & #2 engaged, Roll #1 & #2 engaged, Yaw #1 & #2 engaged are at ON State i.e. AP is in engaged state. No AP warning during flight.

Pitch #1 & #2 engaged, Roll #1 & #2 engaged, Yaw #1 & #2 engaged are at OFF State i.e. AP is in disengaged state. The parameter "C2 yaw" warning was a false warning because autopilot AP155 does not monitor if AP is disengaged.

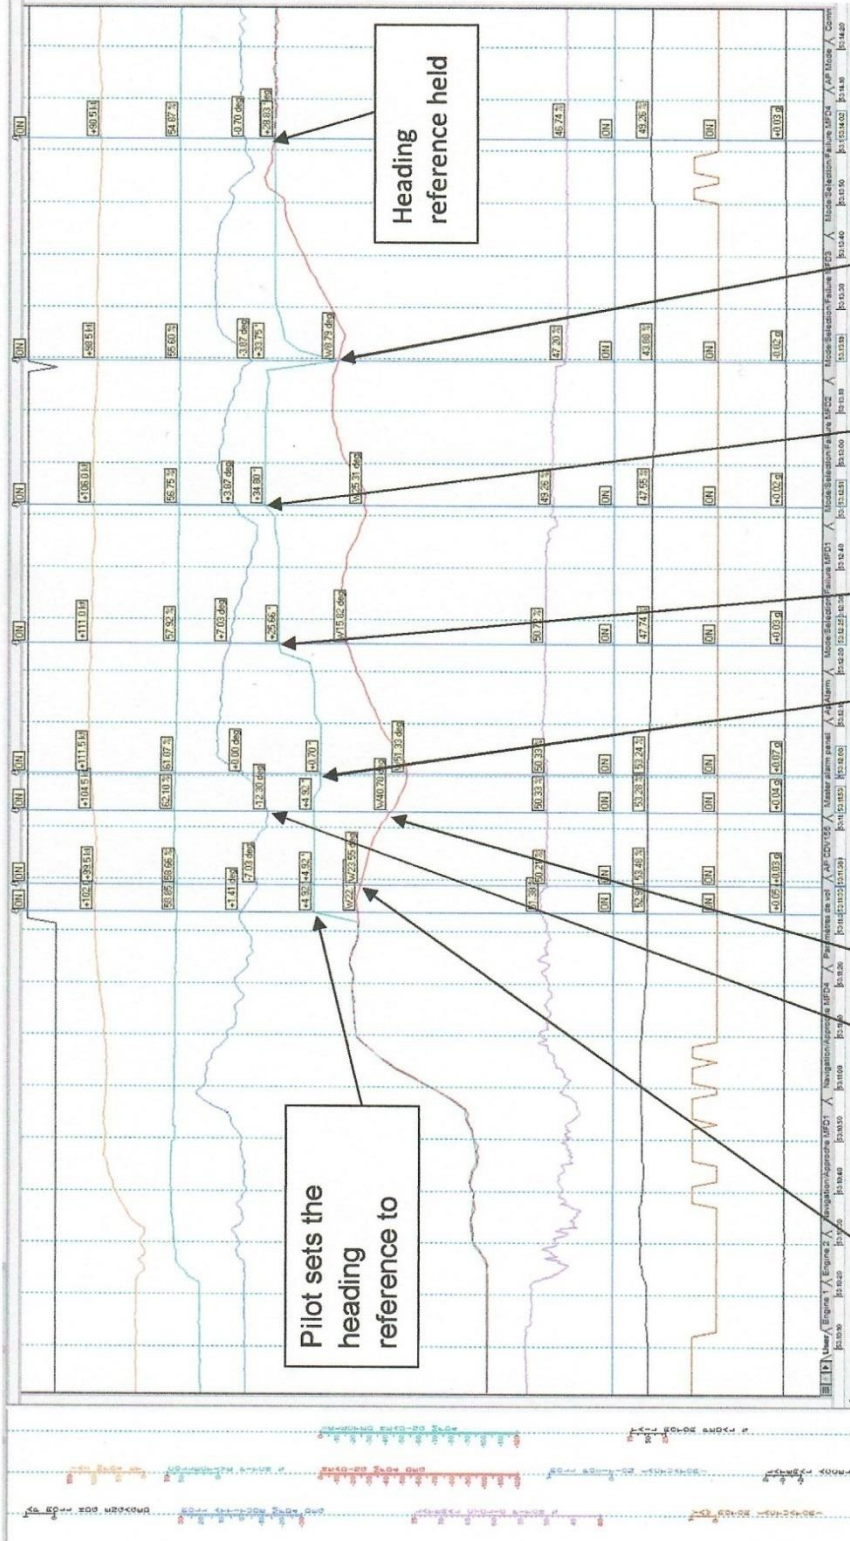
HEADING DEVIATIONS DURING TEST FLIGHT

Pilot sets the heading reference to

Heading reference held

Pilot made a quick setting of heading reference close to +8.79° and then to +28.83°

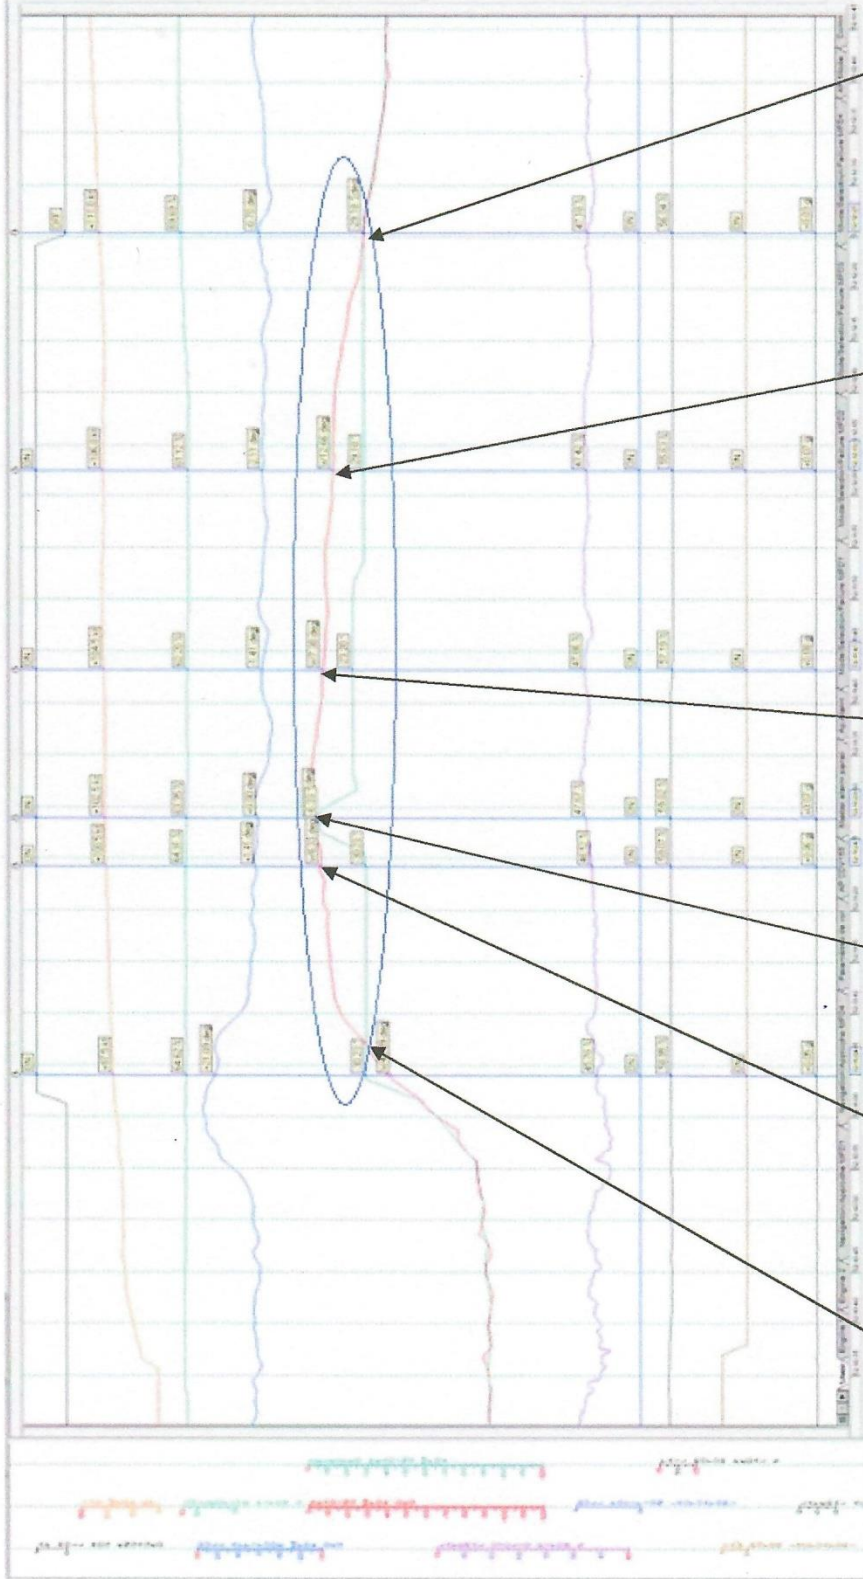
HEADING DEVIATIONS DURING FLIGHT JUST BEFORE 600 HRS. INSPECTION

Pilot engages HDG mode. Reference set to - 30.23°

Heading deviation reaches 23.9° (30.23-6.33)

Airbus Helicopters simulation has not shown any abnormal behavior of the helicopter. It was indicated by them that this problem could come from either MFD4 output defect or CDV85 input defect.

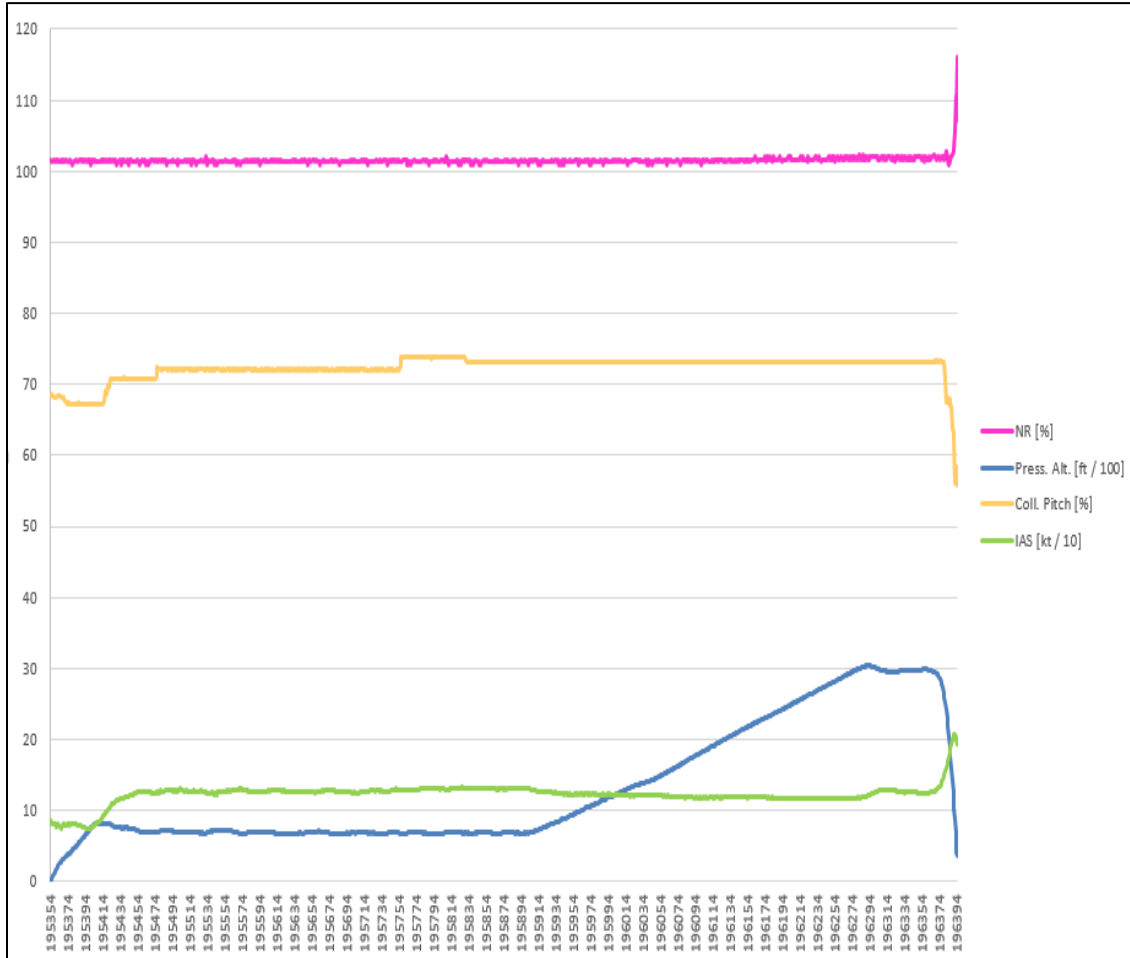
Spectrum analysis of CVR audio recording and FDR analysis was provided by BEA for engine behavior. As per the FDR, the percentage of collective pitch, N_R , IAS and pressure altitude varied as given in the following graph.

N_R was maintained at normal value for most of the flight which began to rise after the aircraft had started to lose altitude and gain speed. N_R increased sharply when the collective pitch went down.

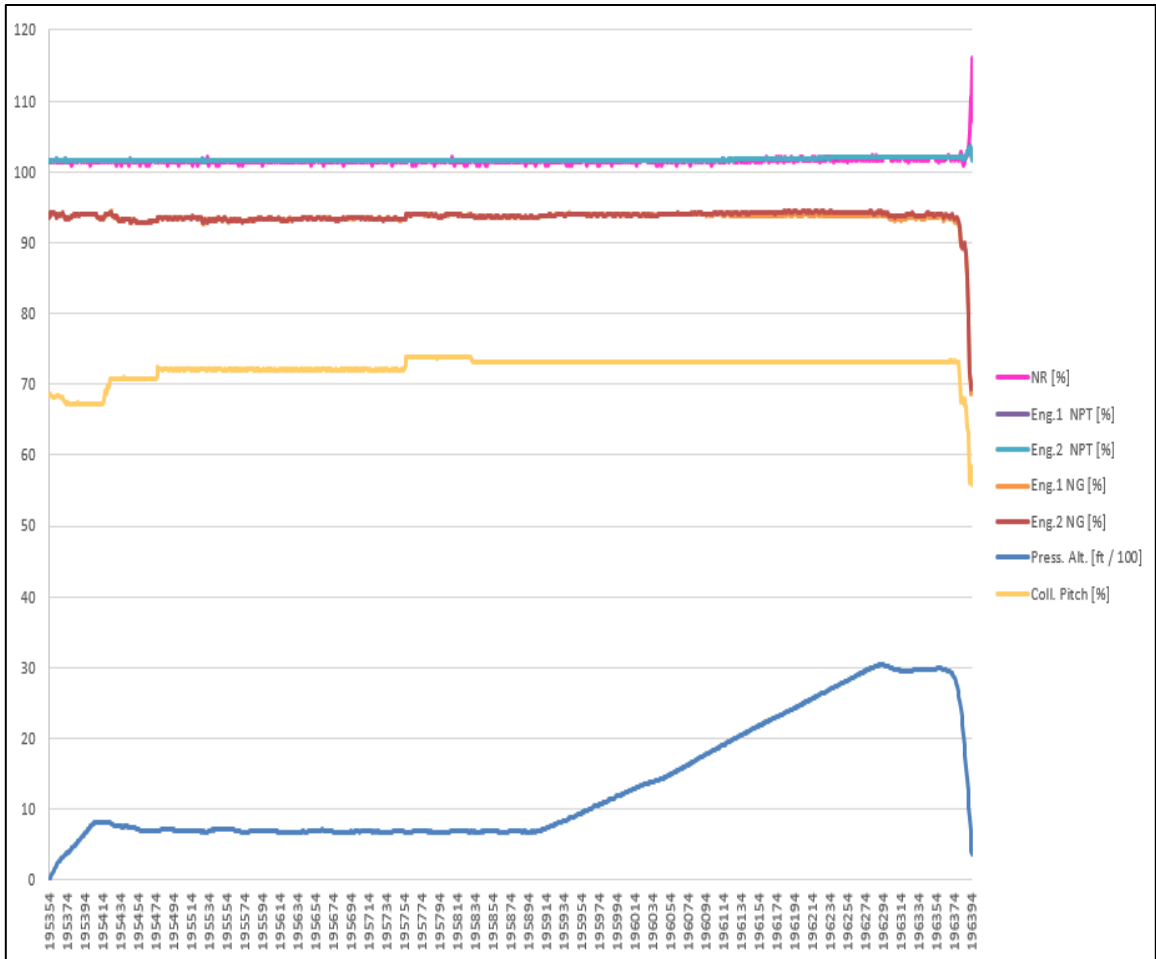
N_{G1} & N_{G2} were stable and well synchronized till the aircraft started to lose altitude and gain speed. When the collective pitch went down, both N_{G1} & N_{G2} decreased sharply though in unison

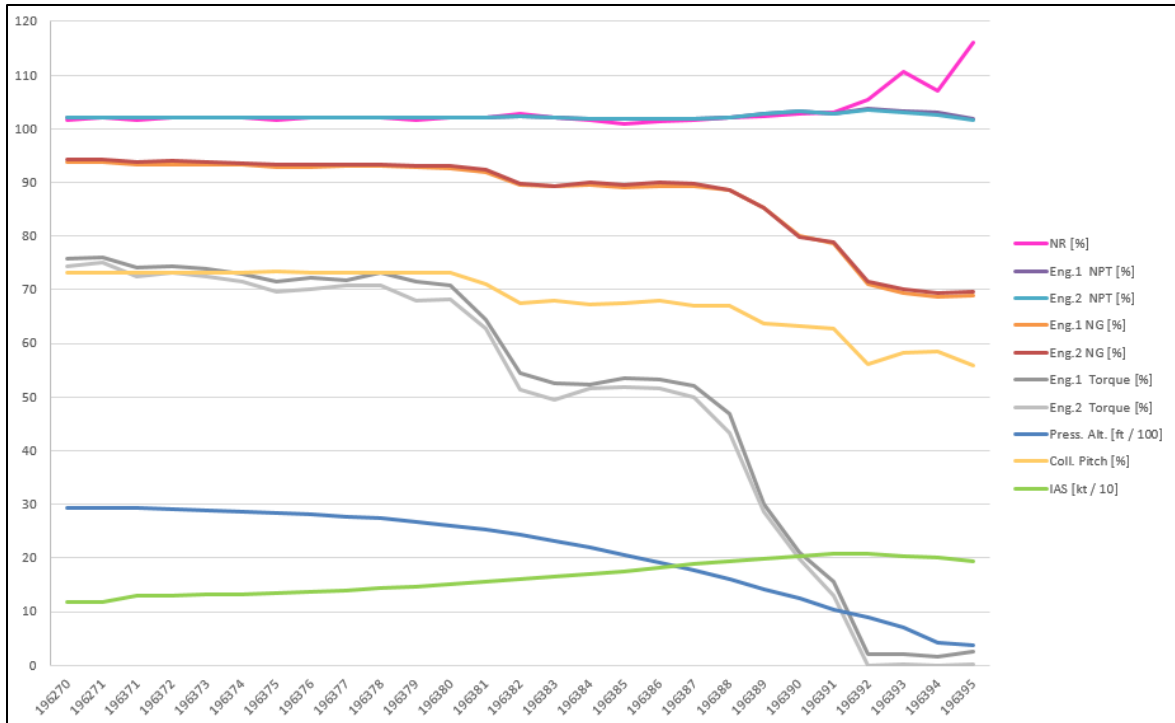
The following graph is of the last 25 seconds of the flight for N_R , N_{PT} , N_G , Torque, IAS, Collective pitch and IAS. It can be seen that during the last 25 seconds of the flight, the helicopter started to lose altitude and gain speed. Power demand was decreasing. Both NG_1 & NG_2 and Torque of engine 1 & 2 started to decrease.

N_R remained normal though there was higher rate of descent coupled with decreasing collective pitch input. Power demand continued to drop. Thereafter, engines slowed down and NG_1 & NG_2 and Torque of engine 1 & 2 decreased significantly. During this time, collective pitch reduced further and N_R went into over speed. With Free wheels disengaged, the engines slowed down to idle and torques decreased to zero.

It was, therefore, concluded that both engines remained well synchronised for the whole flight. Approx. 25 sec before the end of recordings, the aircraft started to descend and gain speed. N_R was maintained at normal value. Consequently, the engines' control systems adapted to the reduced power demand by gradually slowing down the engines. Approx. 10 sec later, the collective pitch input started to decrease thus decreasing the power demand further. Consequently, the engines' control systems adapted again by slowing these down further.

Approx. 10 sec later, N_R exceeded the normal value and went into overspeed mode. This over speed was not generated by the engines because their control systems slowed these down to idle in order to maintain the Power Turbine speeds (N_2) at normal value. The rising gap between N_R and N_2 indicated that the free wheels on the main gearbox's (MGB) input shafts were disengaged. So

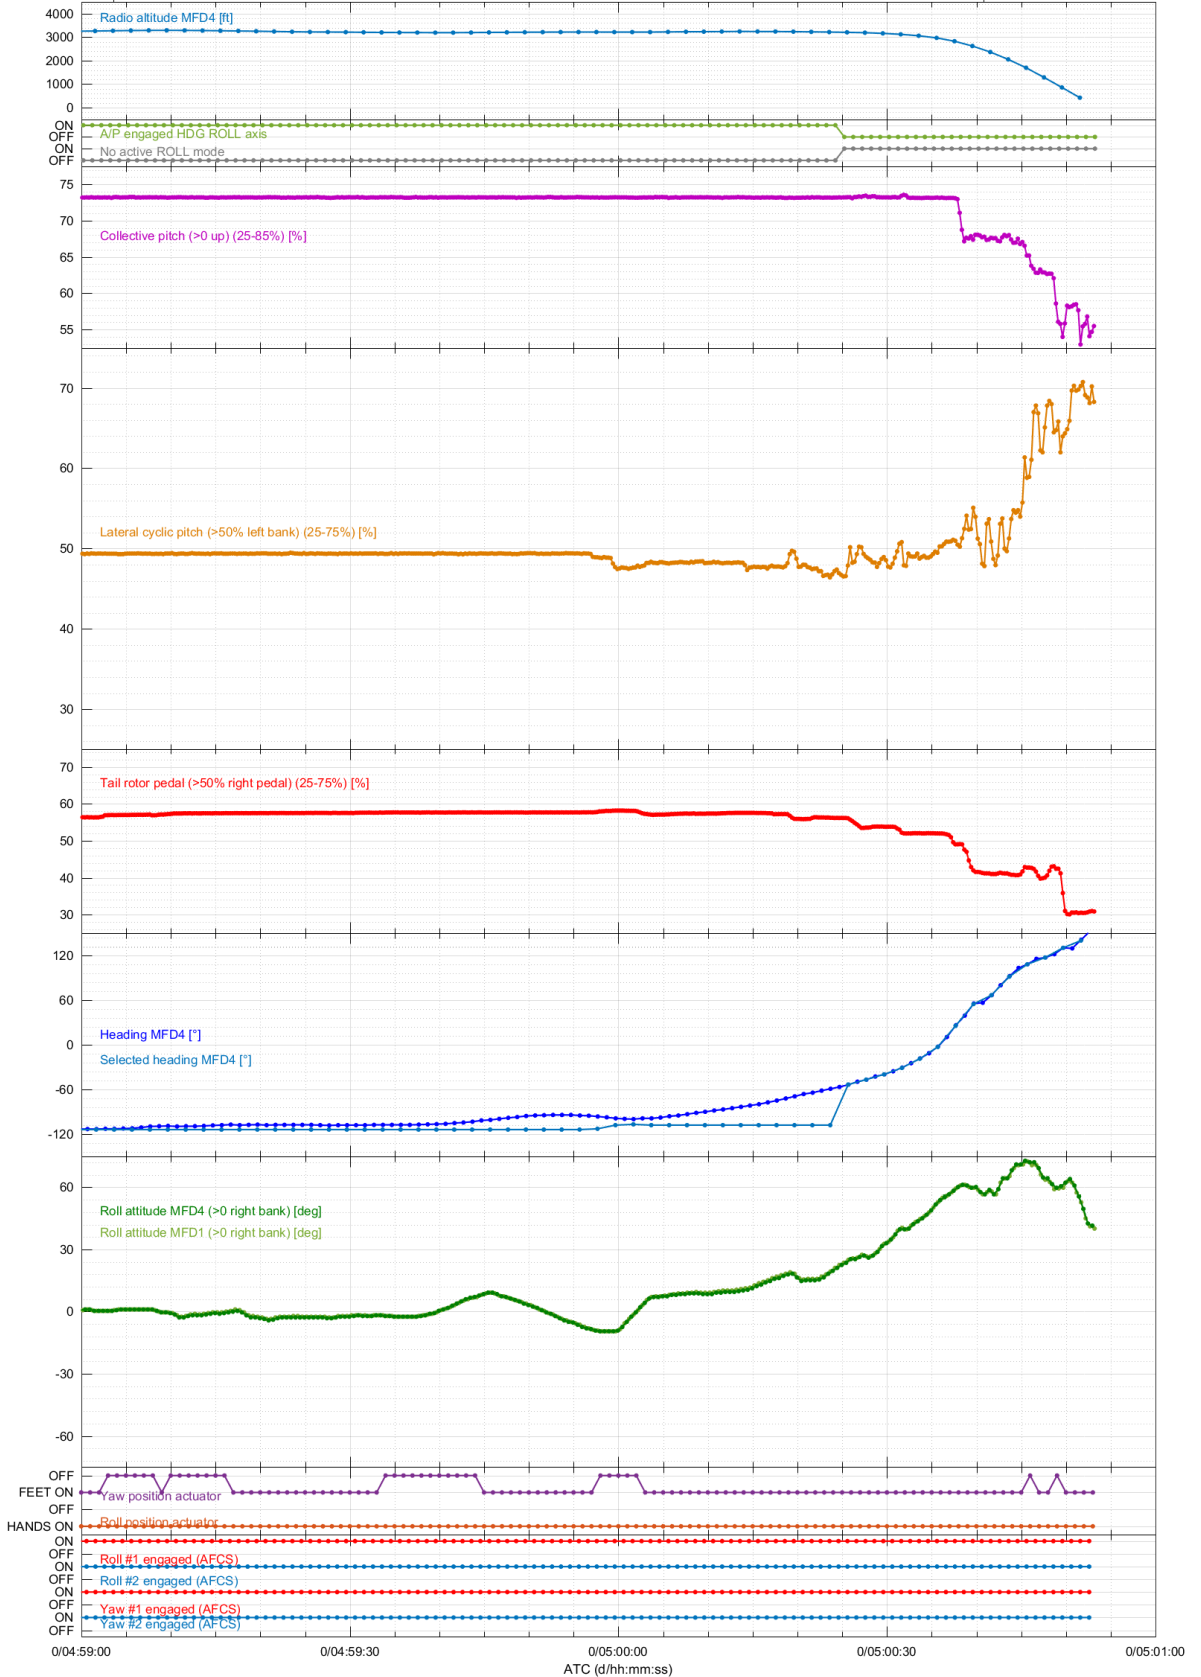
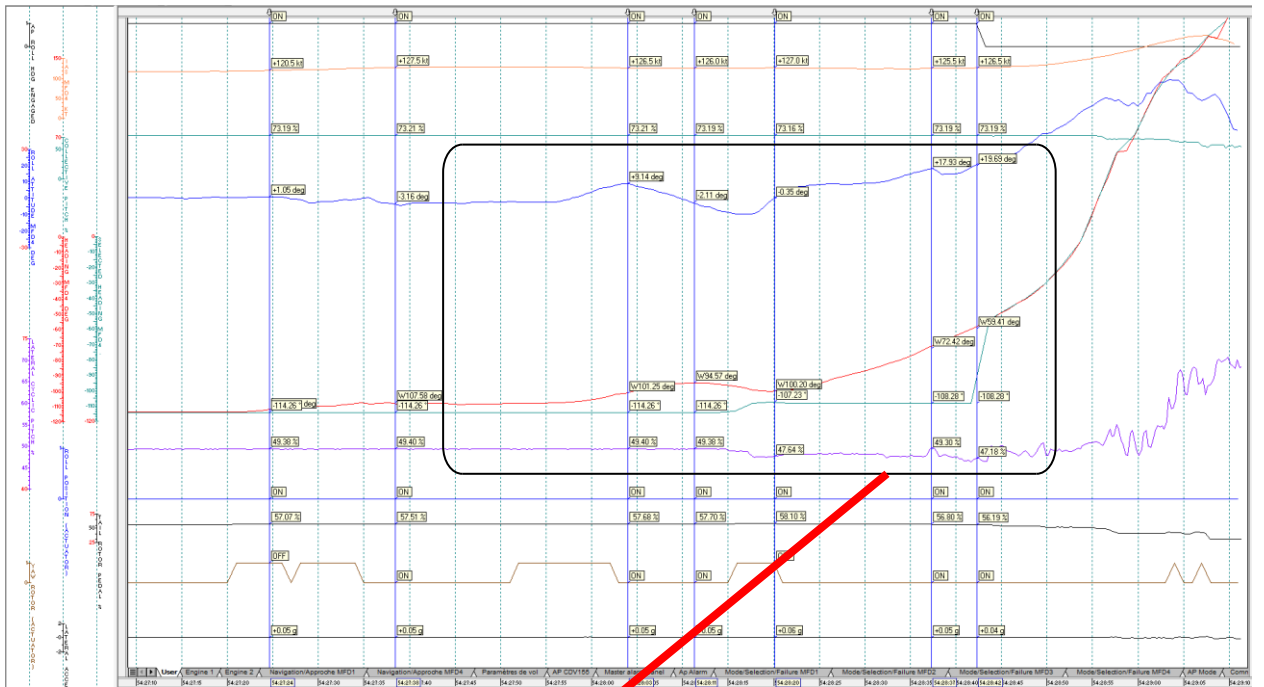
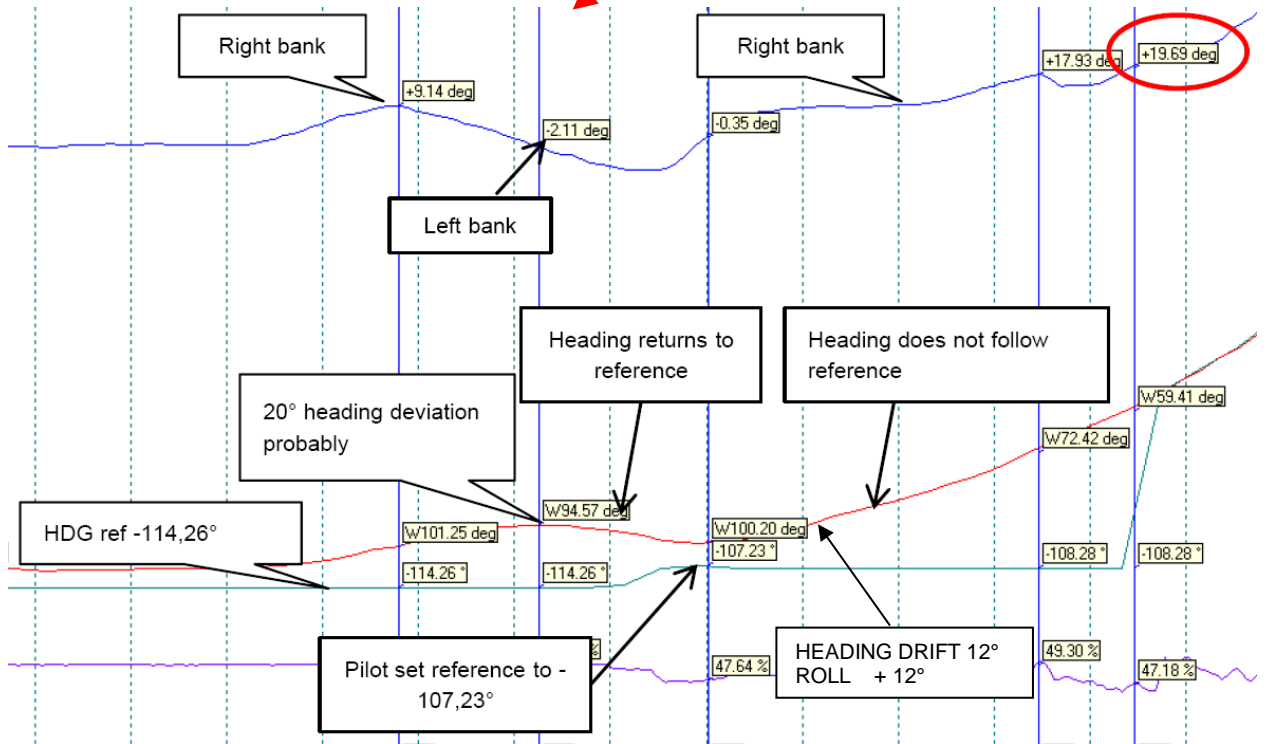
There was no AFCS warning. From the stick lateral movement rate, which was above the maximum speed of actuator (with autopilot engaged), it was inferred that the pilot disengaged the heading mode and took over controls about 22 seconds prior to the accident. At that moment, the roll attitude was between $+19.69^{\circ}$ and 22.5° .

As soon as the pilot took over the controls, the AFCS functioned in SAS mode. After the disengagement of auto pilot upper mode, the bank angle continued to increase. Normally under such situation, the pilot should immediately try to restore the attitude by appropriate control inputs. In the present case, however, this did not happen. The PM has shouted "bank", still there was no corrective action either on the lateral or on the longitudinal controls.

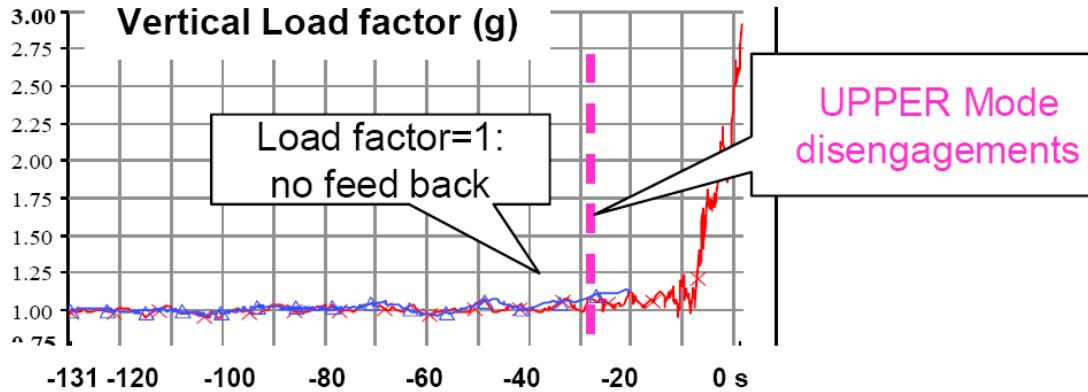
As soon as the controls were taken over, the helicopter started losing height with increasing vertical acceleration.

Coupled with poor slant visibility and no horizon, the PF got disoriented resulting in control freeze. The PM who was not disoriented tried to take over controls which was resisted by the PF. At an altitude of about 1700 ft, 20 seconds after heading mode disengagement, left bank order was commanded, that led to reduction in the bank angle.
