**INVESTIGATION REPORT ON ACCIDENT INVOLVING CESSNA 172 R  
AIRCRAFT VT-RGC OPERATED BY M/S WINGS AVIATION Pvt. Ltd.  
AT MOKILA (SHANKARPALLY) – NEAR HYDERABAD  
ON 21ST NOVEMBER 2018.**

**FINAL INVESTIGATION REPORT ON ACCIDENT OF M/S WINGS  
AVIATION PRIVATE LIMITED CESSNA-172R AIRCRAFT VT-RGC AT  
MOKILA (SHANKARPALLY) – OUTSKIRTS OF HYDERABAD ON 21ST  
NOVEMBER 2018.**

**The Probable cause of the accident was** “Fracture of the crankcase due to breaking of connecting rod caused engine oil loss thereby causing engine seizure”.

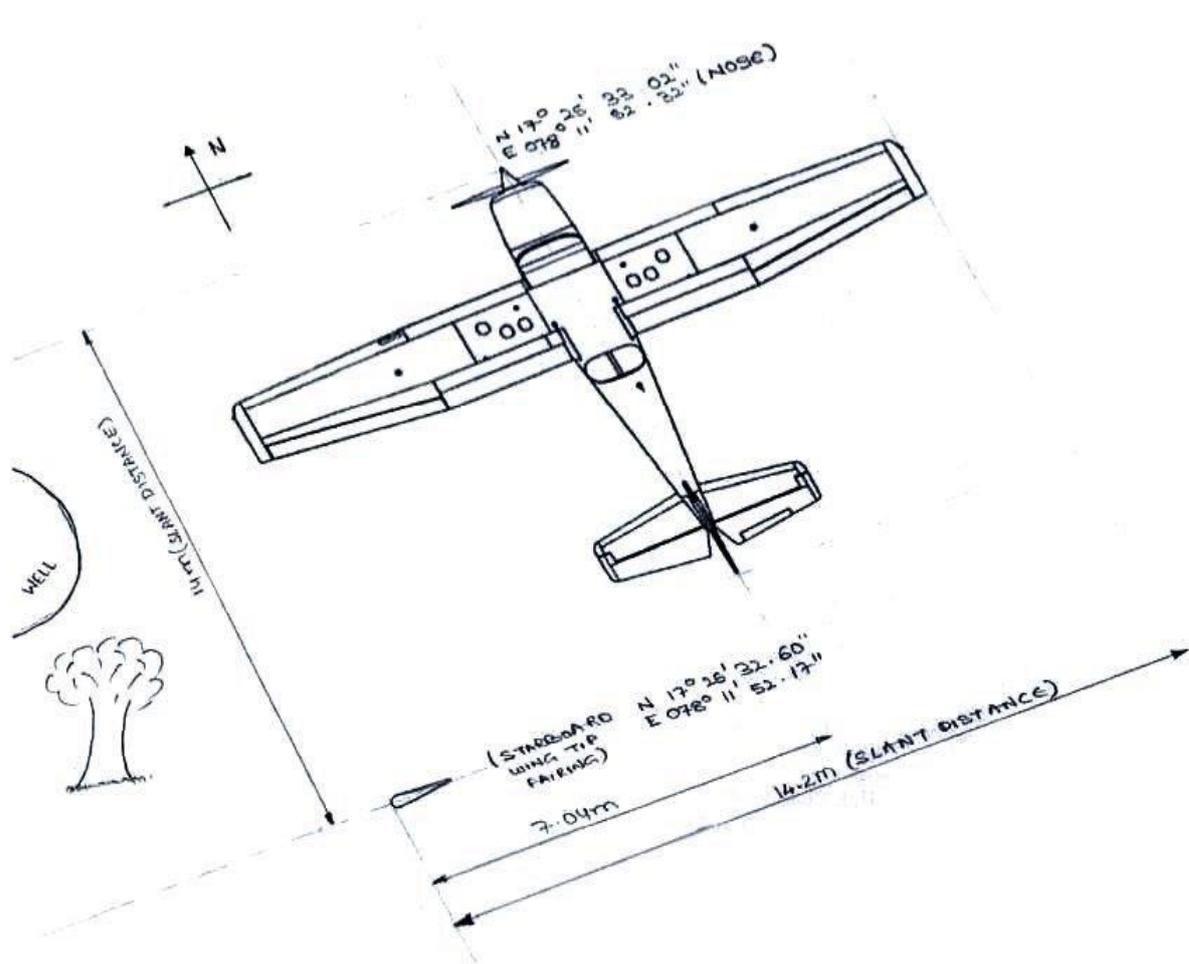
At 0600 UTC, Aircraft forced landed in a paddy field at Mokila (Shankarpally) near Hyderabad. During landing, the aircraft's left wing hit a tree in the field. After forced landing Student Trainee Pilot came out safely from the left door of the aircraft. There was no fire, however, the aircraft were substantially damaged.

As per eyewitness, propeller blades were not running which indicated that the engine was not running at the time Aircraft hit the ground.
