**AIRCRAFT ACCIDENT INVESTIGATION BUREAU
MINISTRY OF CIVIL AVIATION
GOVERNMENT OF INDIA**

**FINAL INVESTIGATION REPORT ON ACCIDENT TO
M/s AIR INDIA EXPRESS B737-800 AIRCRAFT
VT-AYD AT TIRUCHIRAPPALLI (TRICHY)
ON 11 / 10 / 2018**

**FINAL INVESTIGATION REPORT ON ACCIDENT TO M/s AIR INDIA EXPRESS LTD.
BOEING B 737-800 AIRCRAFT VT-AYD AT TIRUCHIRAPPALLI (TRICHY) AIRPORT ON 11-10-2018**

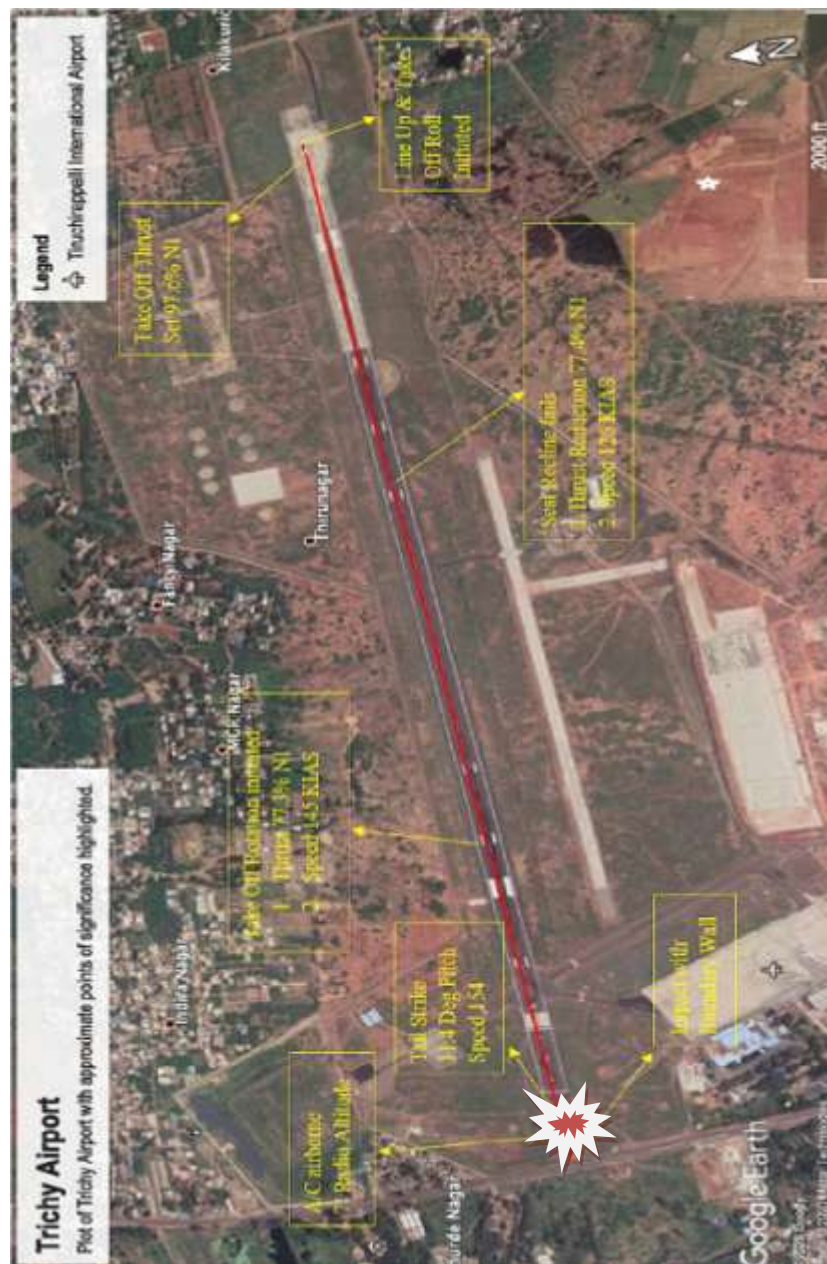
Events during Take Off (Figure 1)

PIC stated that during high-speed segment of take-off roll, at around 110-115 knots (as per DFDR it was 117 Knots), his seat recliner collapsed and he lost his balance. Both his hands were

displaced from the control column as well as thrust levers. The DFDR records thrust reduction from 98% to 77%. The PIC immediately handed over the controls to Co-Pilot by calling out loud 'Your Controls' and as per him it took approx. 5 seconds to regain the correct seating position by adjusting collapsed seat recliner. After PIC recovered from the disbalanced position, he looked outside and realised that they are left with last 2000 feet of runway and aircraft still had not attained V1 speed of 143 Kts. The PIC took over the controls while the speed was close to V1 and aircraft was at 1000 feet to go marker, PIC pulled the control column aft to commence the rotation. Crew felt that aircraft rotation was slower and the force required on the control column was higher than normally required. In addition, they also experienced minor vibration during lift off which was described similar to wake turbulence. Once the aircraft was airborne, Co-Pilot called 'positive rate' and landing gear up command was executed. Figure 1 explains the sequence of events during take off phase.

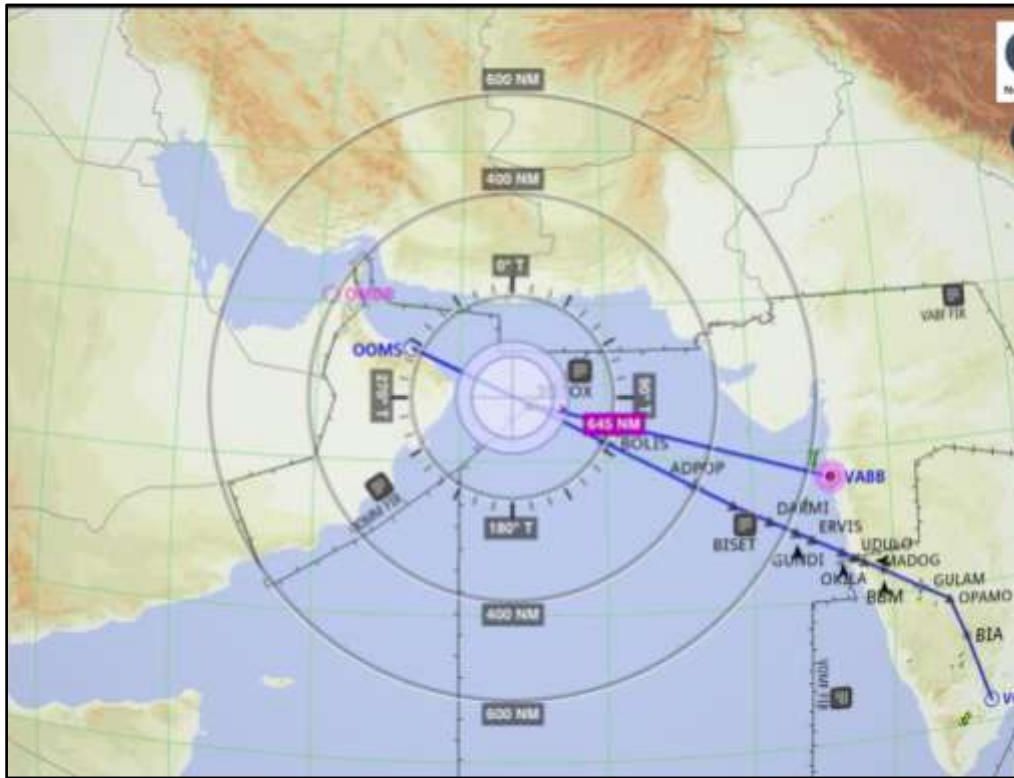
Progression of flight after take off (Figure 2)

While the aircraft was near waypoint TOTOX, Muscat ATC established VHF contact with the crew. Muscat ATC informed the crew that their company wants them to divert to Mumbai. The crew assessed the fuel requirements and checked with Mumbai Area for direct routing to BBB. Muscat ATC confirmed that requested route was assigned and aircraft was directed to descend to FL350 and turn for a direct routing to BBB (Mumbai). Figure 2 indicates progress of flight after take off.

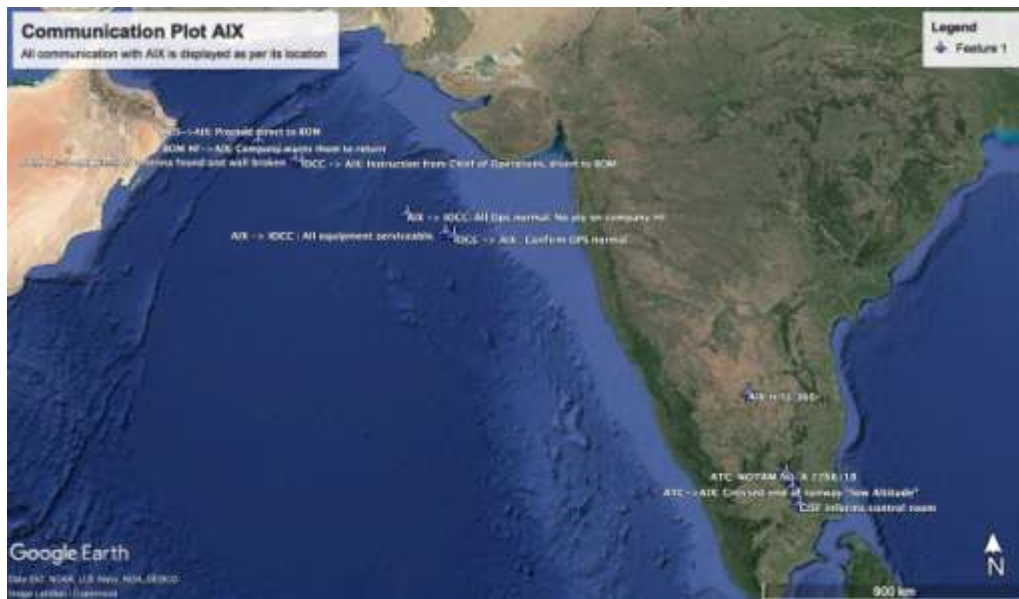
Communication with the crew after take off (Figure 3)

At 2001 UTC, crew requested ATC Trichy *"can you come up with what happened"*. Crew were apprised that *"while you take off, you hit the localizer and boundary wall and localizer antenna broken"*. Thereafter, crew replied that *"ok sir copied thank you"*.

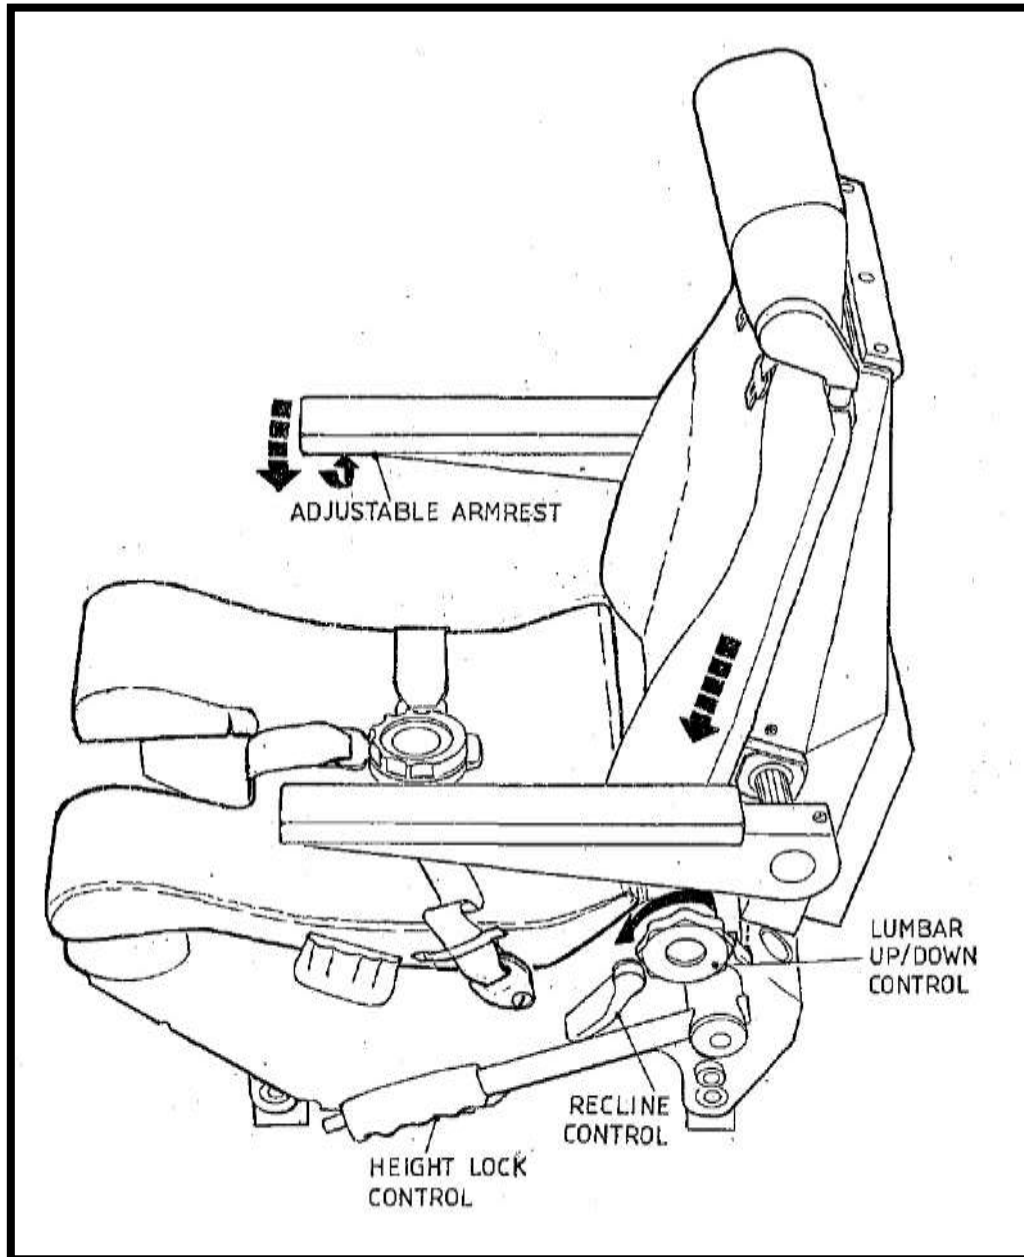
The involved P1 seat was earlier installed on the aircraft VT-AXI and was installed on VT-AYD on 21-04-2018 as the existing P1 seat P/No. 3A296-0007-01-1 s/ No. 58788 vertical handle push button was broken.

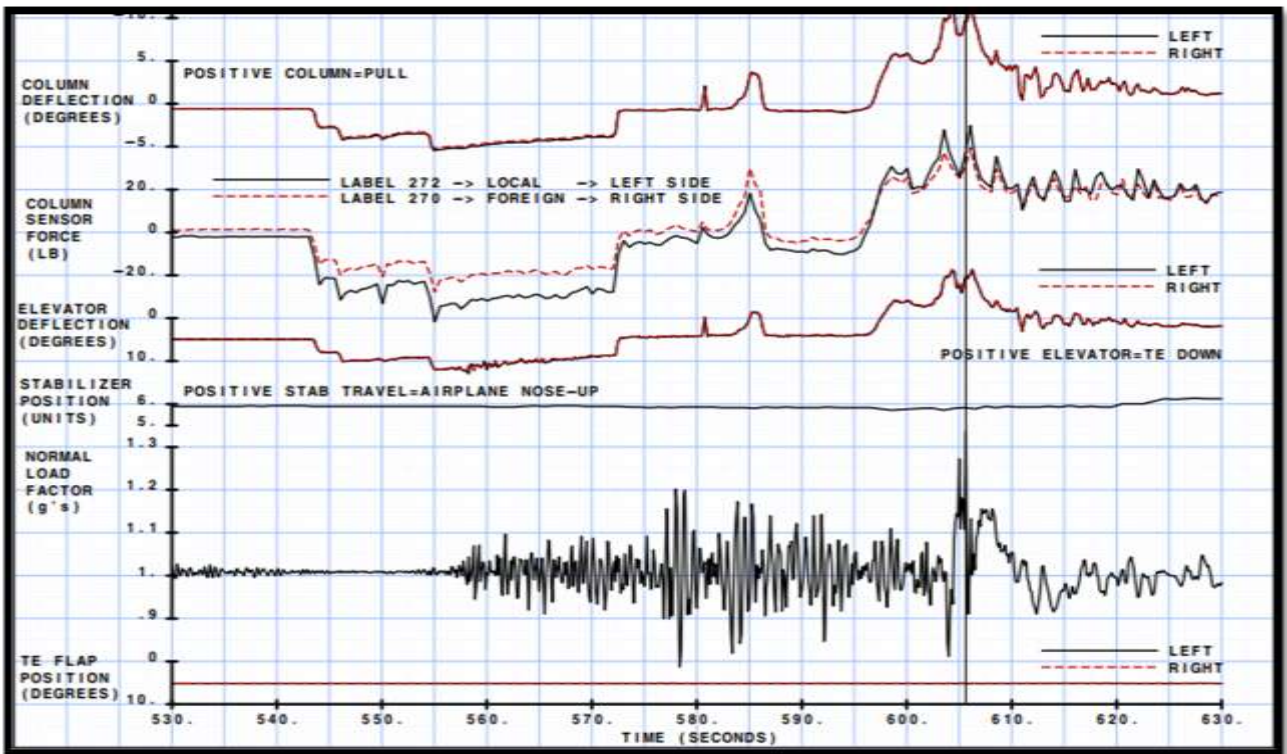
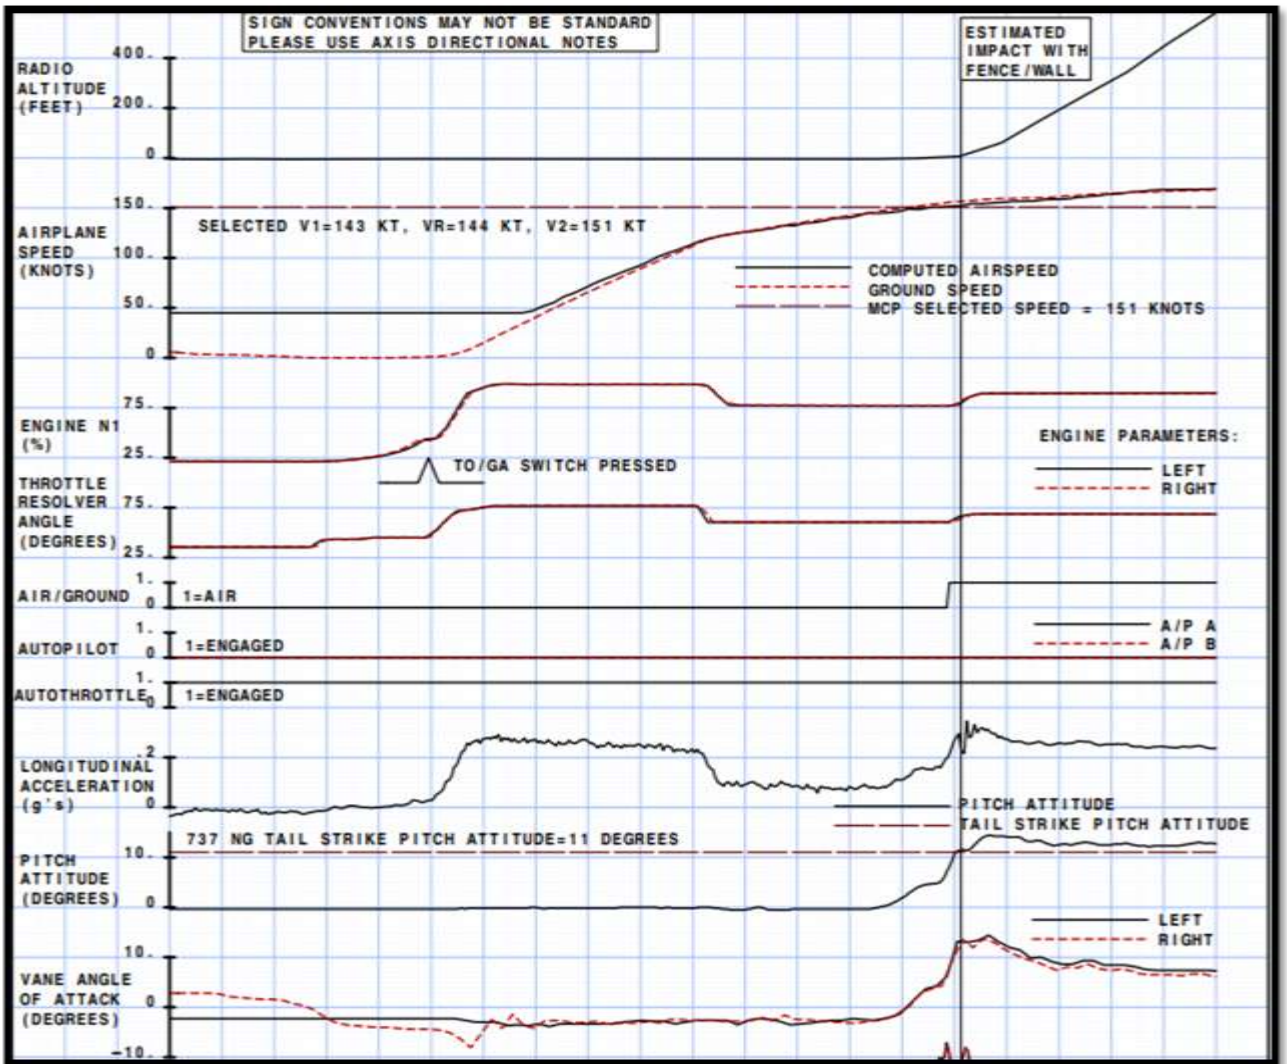
DFDR Plots

Tail-strike	19:49:11	77.0	77.1	66.1	66.1	157	7.9	15.9	10.7	2.29	0.295	1.34

Comment by Occurrence (Events)	UTC	Eng. (1) N1%	Eng. (2) N1%	Left Thrust Resolver Angle	Right Thrust Resolver Angle	Ground Speed	Capt control column	CC-1 force LBS	Pitch Attitude	Pitch Rate	Long Acceleration	Vert Acceleration
Thrust levers advanced to below takeoff setting	19:49:12	89.5	88.8	68.2	68.6	158	10.857	30.6	12.1	0.53	0.346	1.13
Aircraft Hit the wall	19:49:13	89.5	89.4	68.7	68.6	158.5	6.9	---	12.7	---	0.299	1.114

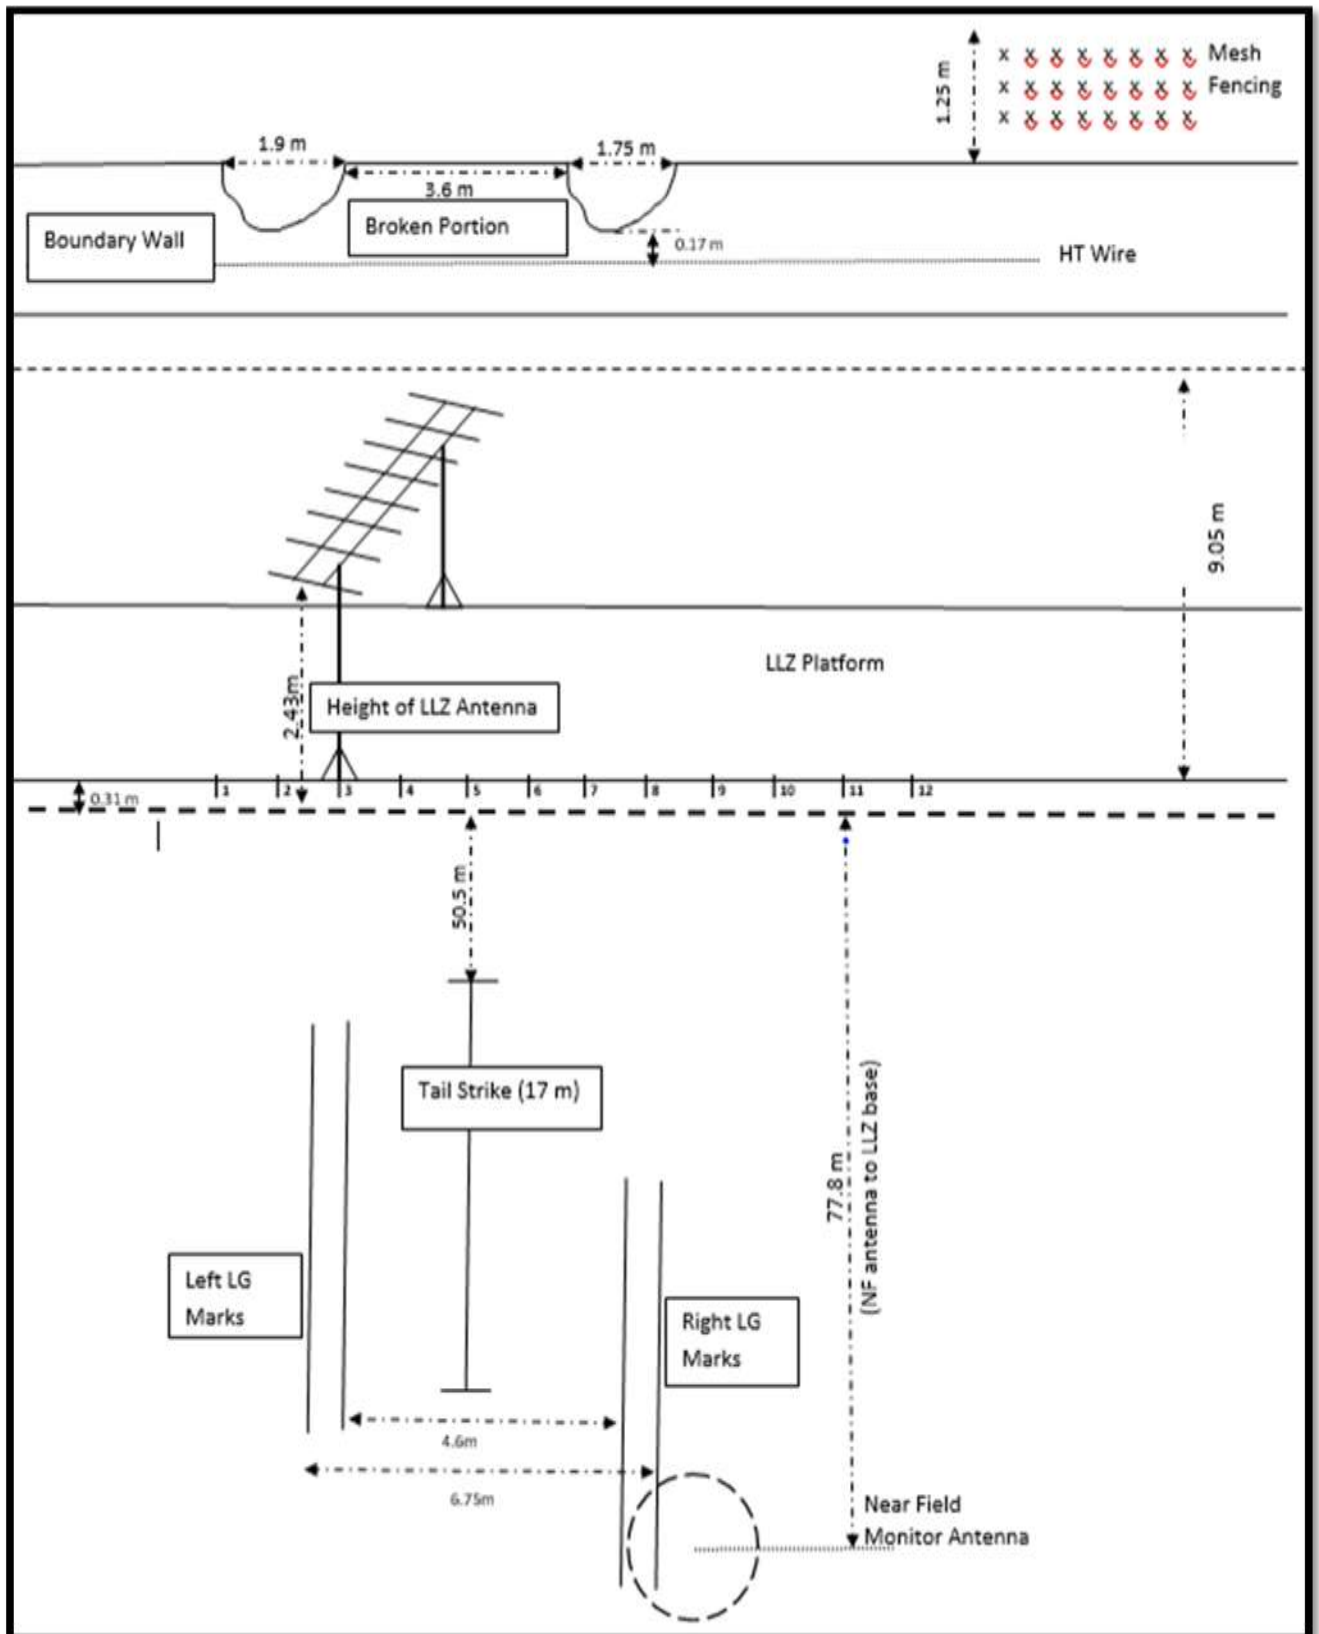
Distances measured after the first Impact

The length of Runway was 2423 Meters (7949 feet), height of Localizer Antenna was 7.97 feet and height of boundary wall was 07 feet with 04 feet of fence. The Localizer antenna was situated at 449.50 feet from runway end & Boundary wall was situated at 475.70 feet from runway 27 end. The localizer monitoring antenna height of 5 feet was situated at 77.80 m from localizer.

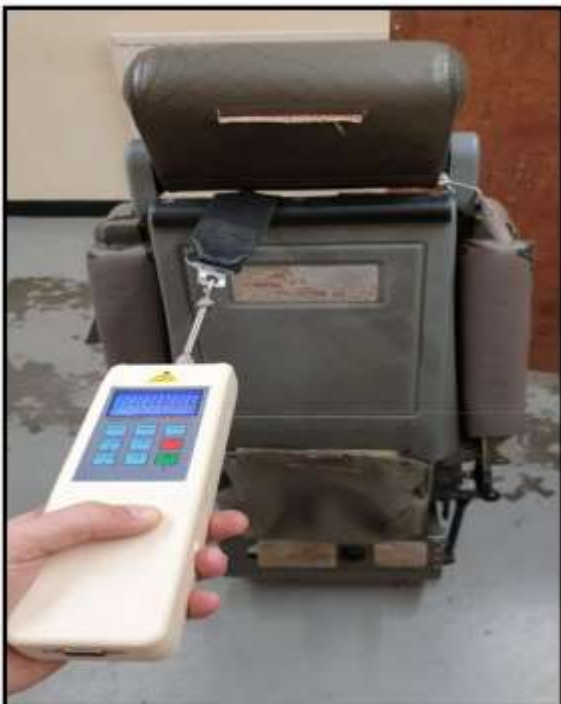
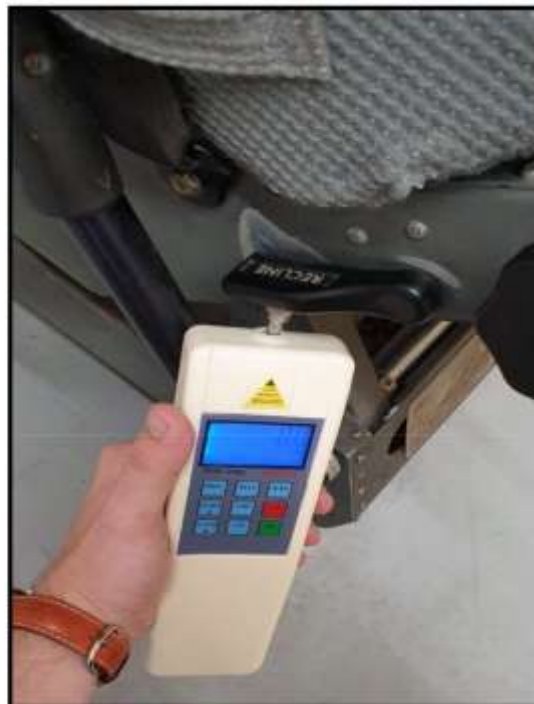
**Measurement of Force required on Seat Recliner and Control Lever
and Measurement of Force**

- I. Forward / Aft movement – Result was unsatisfactory
- II. Vertical adjustment – Heavy to operate and clicking noise when moving
- III. Comfort checks
 - a. Headrest check was found satisfactory
 - b. Lumbar operation check was found satisfactory
 - c. Armrests check was found satisfactory
 - d. Thigh pads check was found satisfactory
- IV. Restraint – minor fray on shoulder strap webbing but locking was satisfactory
- V. Recline – seat back was not locked in position and could be moved with minimal force.

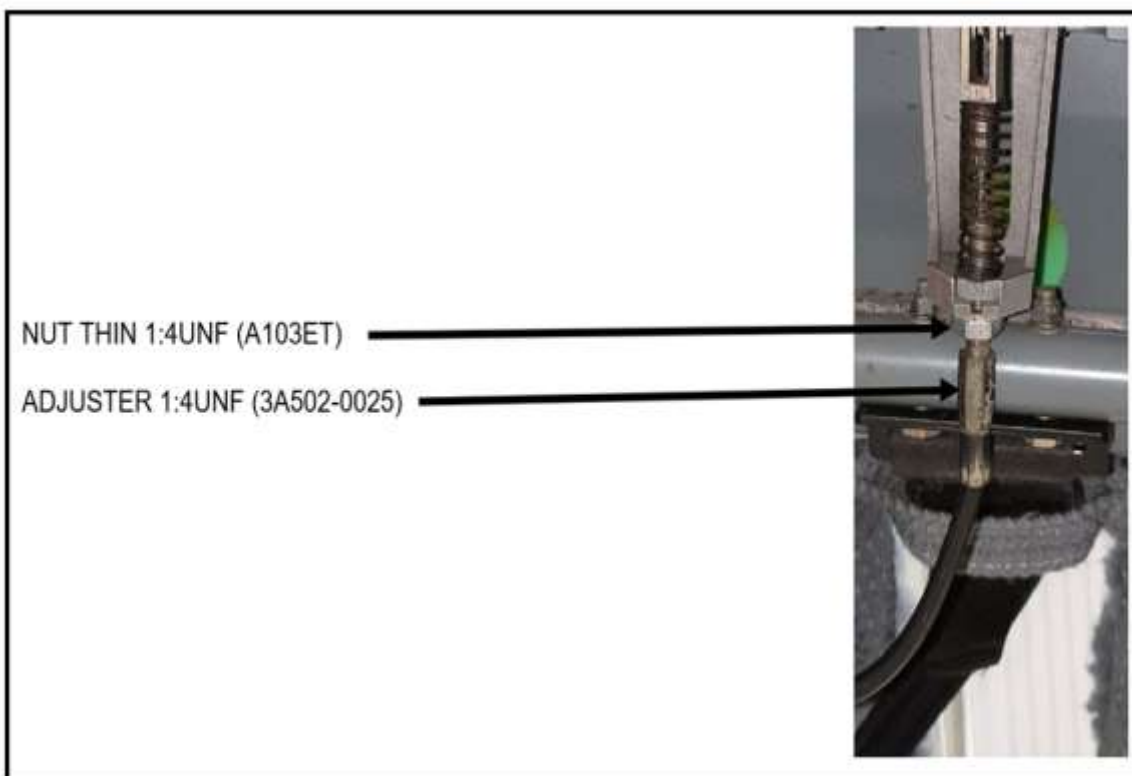
Seat Nut and Adjuster position

1. A spanner was used to loosen the nut thin 1:4UNF signifying that the cable assembly – recline could not have come out of adjustment on its own and that the nut thin 1:4UNF was secured to more than a finger tight amount of force.
2. The adjuster 1:4UNF was then rotated anti-clockwise to extend the length of the cable to allow the latch plate – recline unit to lock fully into position.
3. The amount of movement in the control lever – recline was then checked and the adjuster 1:4UNF adjusted slightly until the control lever – recline had a small amount of movement.
4. The nut thin 1:4UNF was then tightened to secure the recline adjustment.

The functional check on recline was then repeated. The seat back moved fully and freely between stops and when the control lever – recline was released, seat locked in position. Thereafter, functional check was repeated several times.

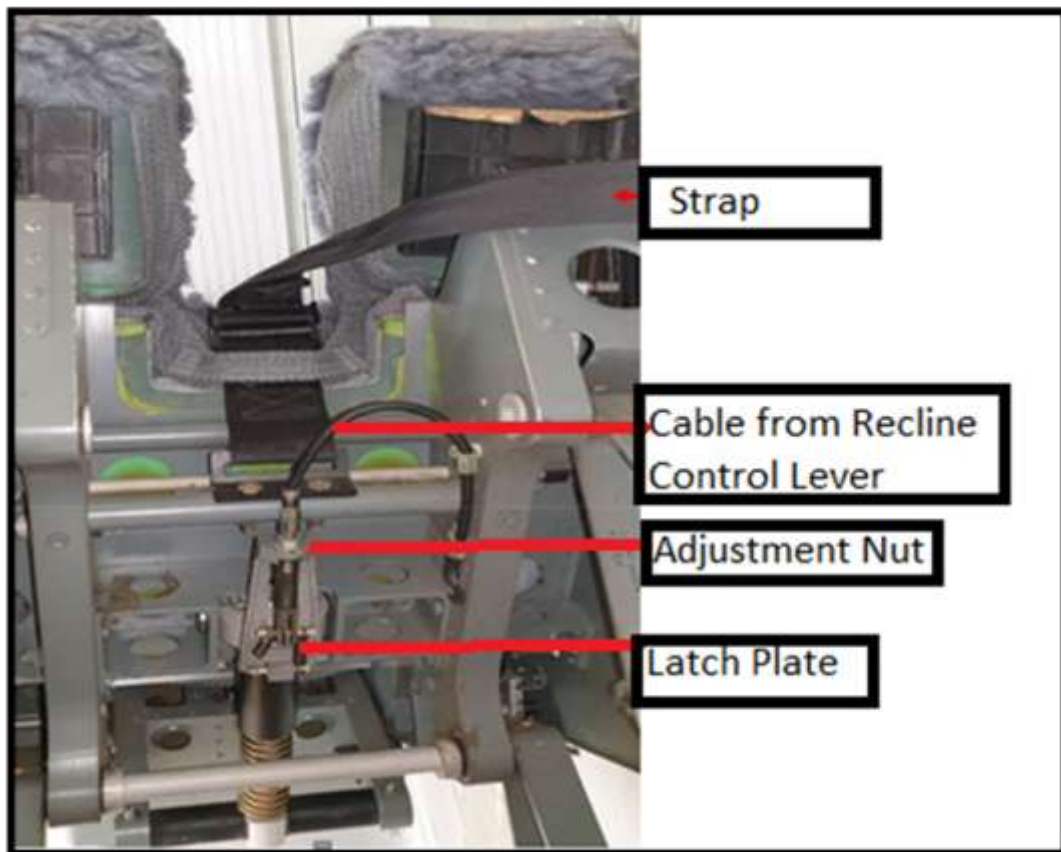
Recliner Assembly

- The routing of the cable assembly – recline is secured out of the way of any potential pulling when reaching for the crotch strap as shown in below Fig. An attempt was made to operate recline by pulling on the cable assembly – recline whilst sitting in the seat, this was unsuccessful.
- This spring extension is used in several positions not solely associated with this recline unit assembly, OEM have used in excess of 69,000 spring extension since 2009.
- The nut thin 1:4UNF that holds the adjustment of the recline in position is a standard nut.
