**FINAL INVESTIGATION REPORT
ON ACCIDENT TO BELL 206 L4
HELICOPTER VT-PHD
AT KURGIAKH ON 03 OCTOBER 2018.**

**GOVERNMENT OF INDIA
MINISTRY OF CIVIL AVIATION
AIRCRAFT ACCIDENT INVESTIGATION BUREAU**

**FINAL INVESTIGATION REPORT ON ACCIDENT TO
Pawan Hans Limited BELL 206 L4 HELICOPTER VT-PHD
AT KURGIAKH ON 03 OCTOBER 2018**

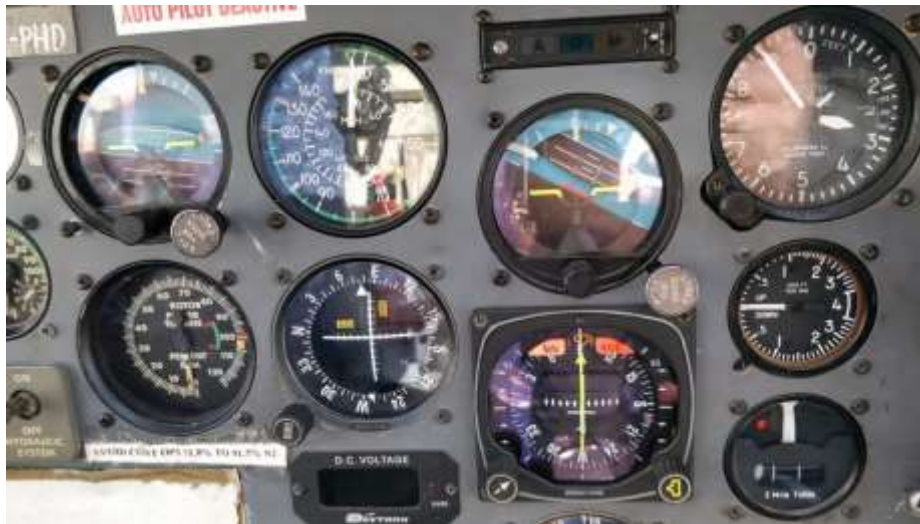
- Pressure Altitude - 12,900 ft

- OAT - -4°C , (269.17 K)

Density Altitude, therefore was 13666 feet. For temperature of 0 and 5°C , the density altitude comes out to be 14122 & 14680 feet respectively.

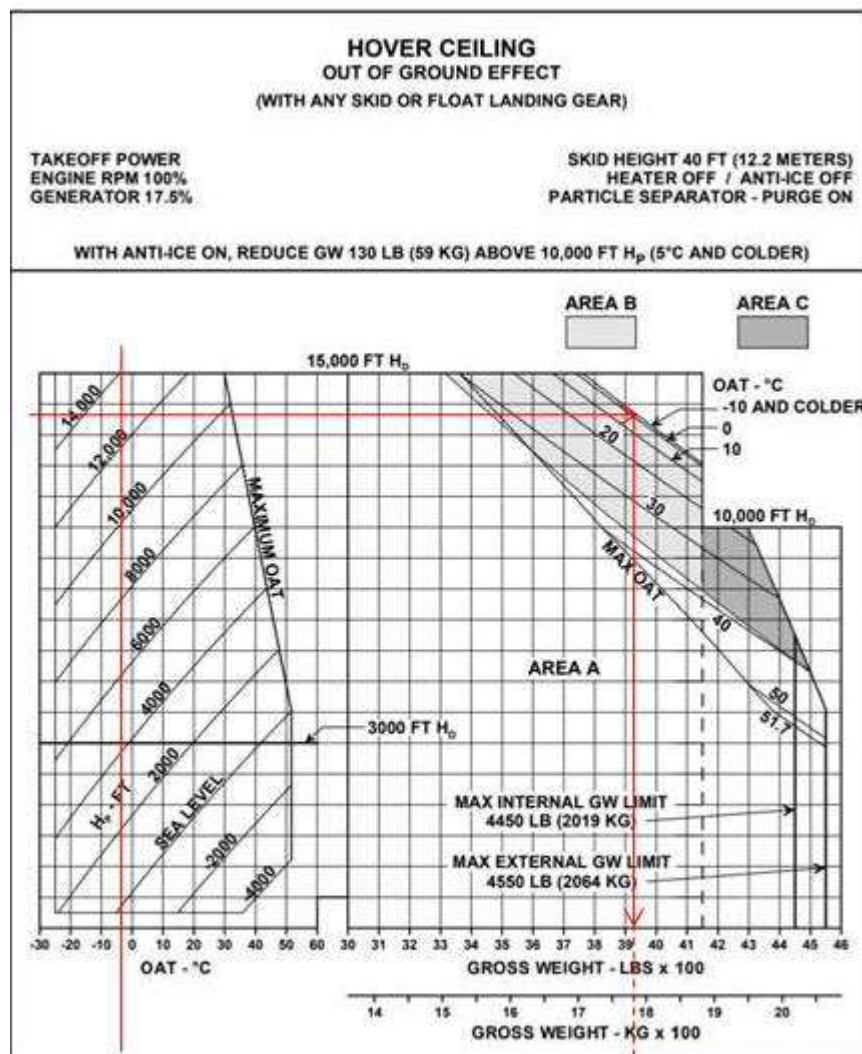
Figure 4-7. OGE Hover Ceiling (Sheet 2 of 2)

Maximum Gross Weight permissible (as per graph) comes out to be 1,780 Kgs.

Max Permissible Gross Weight = 1,732 Kgs

The pressure altitude of the landing place is 12,900 feet and for an OAT of -4 deg C, the calculated density altitude is 13,665.9. The landing weight was 1642 kgs. Maximum Gross Weight permissible was 1780 Kgs with anti ice OFF. Assuming that the anti ice was ON, the permissible landing weight becomes 1721 kgs. There is not much reduction in the permissible landing weight, assuming the temperature variation of +5 deg C. Accordingly the hover altitude, in the extreme case could have been 14680 feet which was within the hover limit of 15000 feet

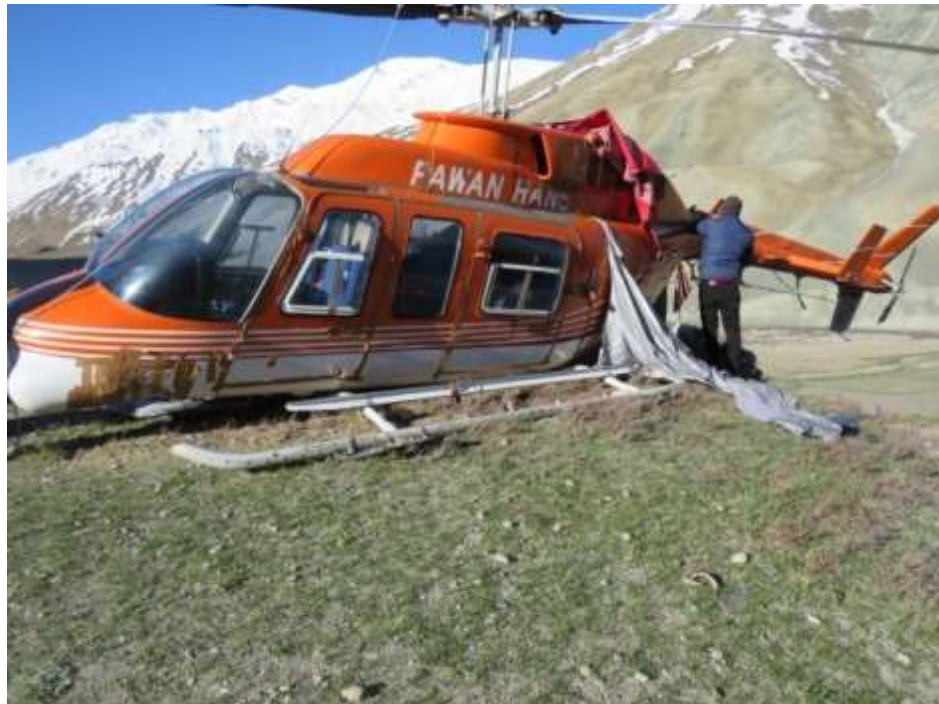
Barring the shearing off of the tail rotor blade portions as mentioned in the “Damage to Aircraft”, the wreckage was self contained. Both skids had buckled sideways. Both cross tubes bowed down leaving very less ground clearance of the cabin floor. The damage indicates that the helicopter had impacted the ground very heavily (falling vertically) though in a straight & horizontal attitude. The sheared off tip portion of the tail rotor blades were found around the helicopter. It appears, whatever damage has occurred was during the landing phase. There was no inflight breakup of structure.

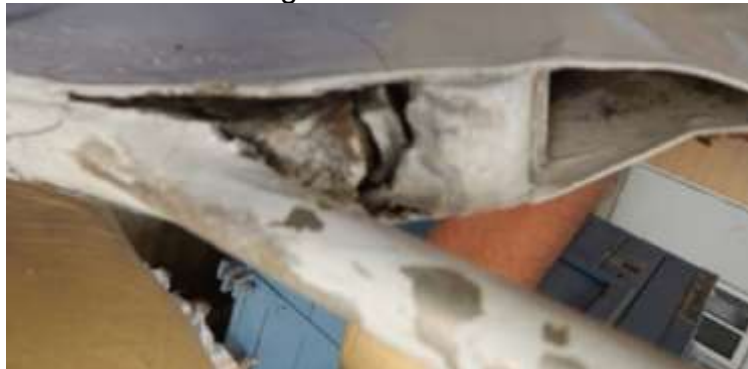
Damage to the Vertical fin
