**FINAL INVESTIGATION REPORT  
OF  
AIRPROX INCIDENT BETWEEN  
FLIGHT HK053 and IGO647 IN  
CHENNAI ACC  
ON 21/05/2018**

**AIRCRAFT ACCIDENT INVESTIGATION BUREAU  
MINISTRY OF CIVIL AVIATION  
GOVERNMENT OF INDIA**

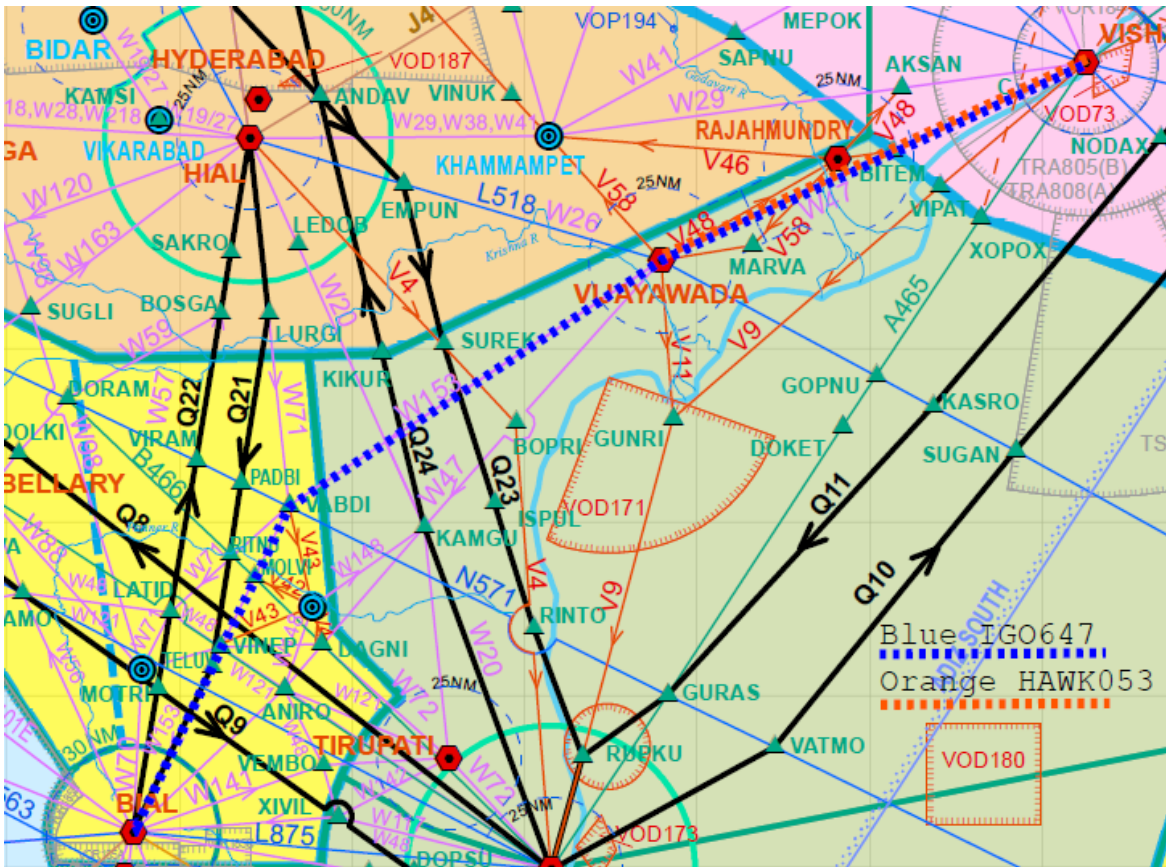
The flight IGO647 had taken off from Vizag with Bangalore as destination. HK053 after carrying out ILS approach at runway 26 of Vijayawada was returning to Vizag. The airspace jurisdiction and the flight paths are as shown below.

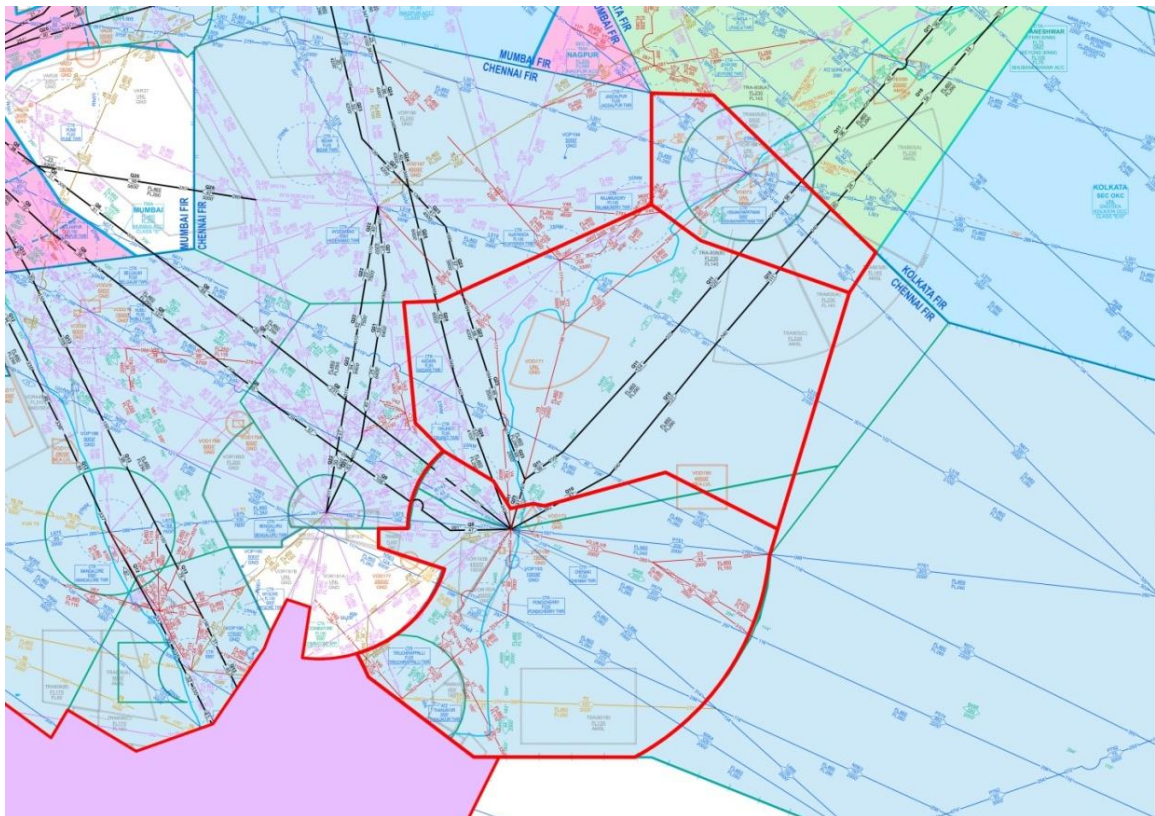
### 1.18.3 UMM Sector Bifurcation

AAI after carrying out due process of Safety Assessment & Validation started UMM sectorization trials. Temporary Local Instructions (TLI) 13/2016 was issued by which UMM sectorization was carried out by making two Sectors UMM (North)

and UMM (South) named UMN and UMS respectively. The two sectors UMN and UMS with the lateral and vertical boundaries were described in the NOTAM and depicted in the maps displayed in the ATC units. As per the TLS, UMN and UMS sectors shall be manned by one Radar controller and one Planner each.
