**FINAL INVESTIGATION REPORT
OF
AIRPROX INCIDENT BETWEEN
FLIGHT VT-WGE and VT-IGK IN
VARANASI ACC ON 23/04/2018**

**AIRCRAFT ACCIDENT INVESTIGATION BUREAU
MINISTRY OF CIVIL AVIATION
GOVERNMENT OF INDIA**

FINAL INVESTIGATION REPORT OF AIRPROX INCIDENT BETWEEN FLIGHT VT-WGE and VT-IG IN VARANASI ACC ON 23/04/2018

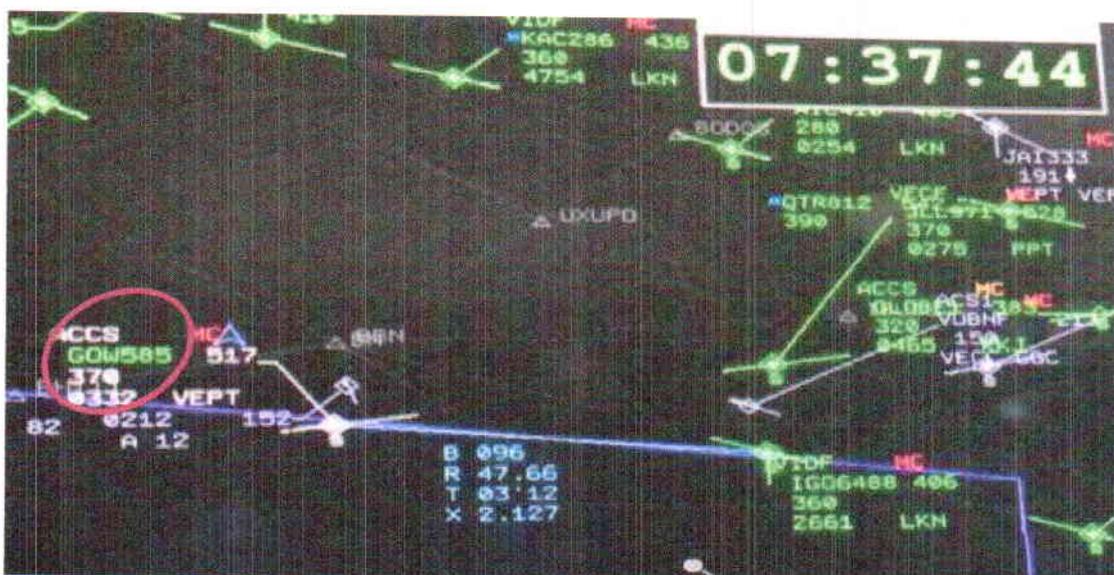
RSR (North) Controller was having positive control of the aircraft under his jurisdiction, i.e. IGO6488, A320 from Kolkata to Delhi at cruising level FL360. At time 07:37:44, GOW585, crossed the path of IGO6488 though GOW585 was under the jurisdiction of RSR (South Controller).

GOW585 with Jurisdiction mismatch crossing the path of IGO6488
