FINAL INVESTIGATION REPORT ON
SERIOUS INCIDENT TO M/s ALLIANCE AIR
ATR-72 AIRCRAFT VT-AIX AT SHIRDI
AIRPORT ON 21/05/2018

| 6. Place of Incident | : Shirdi Airport |
| 7. Date & Time of Incident | : 21 st May 2018, 1118 UTC |
| 14. Type of incident | : Runway overrun |

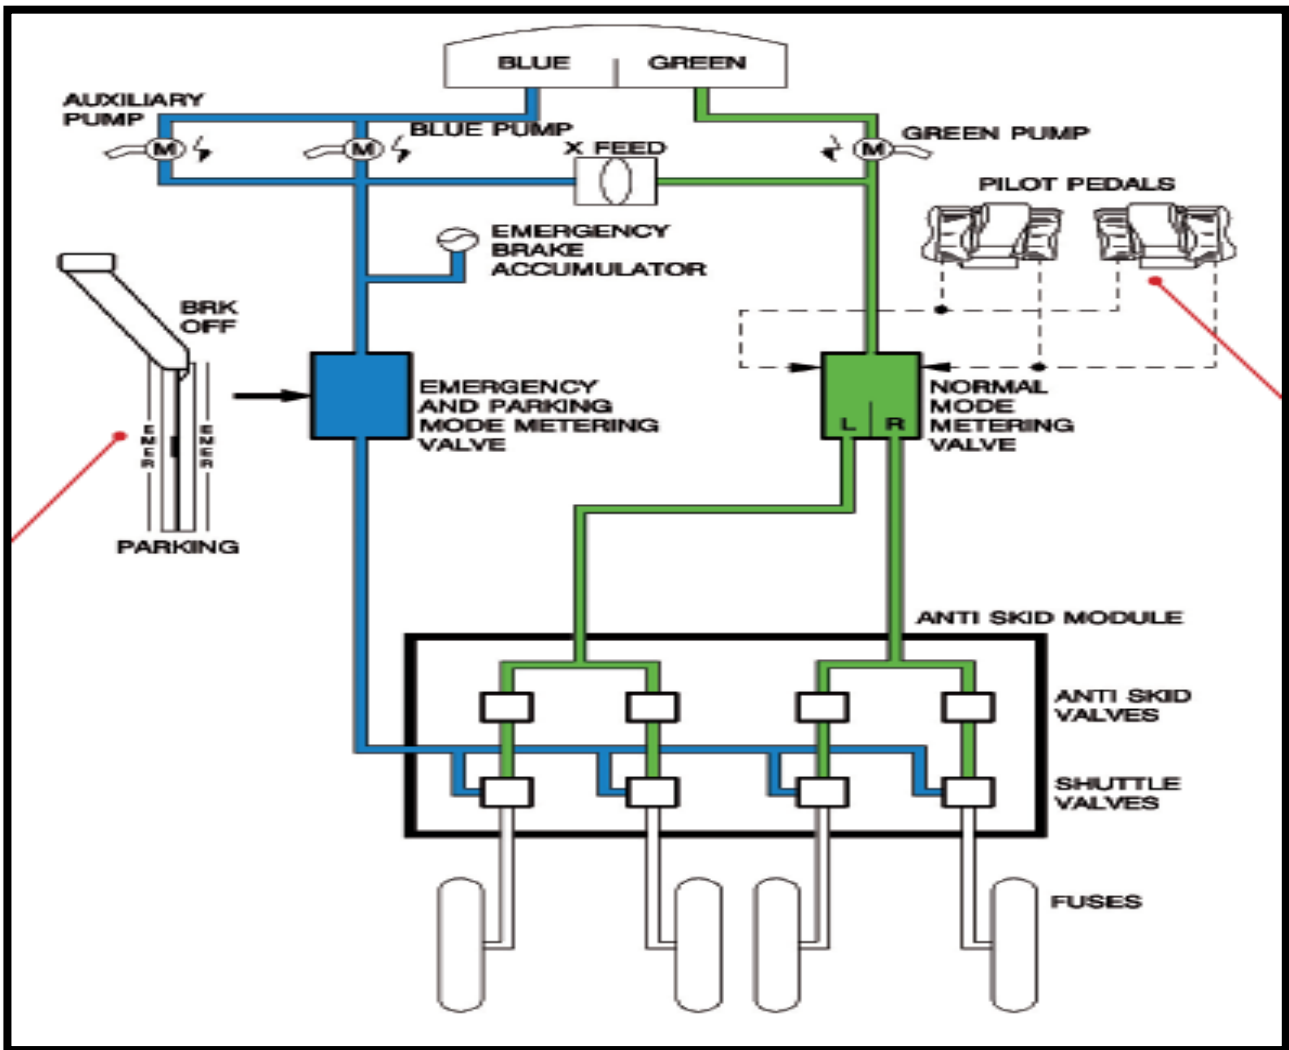
Fig: Brakes schematic

At main gear compression, the braking action is inhibited as long as wheel speed is below 35 kt or for 5s, in order to preclude inadvertent brake application prior to wheel spin up on low friction pavements or with light wheel vertical loading.

For proper braking action, tyre pressure should be in limit along with the tyre bead conditions. Physical condition of both main landing gears and the tyres were checked and found satisfactory. Moreover, calculated pressure in each tyre was in the permissible limits. Calculated pressure for each tyre was as follows:-

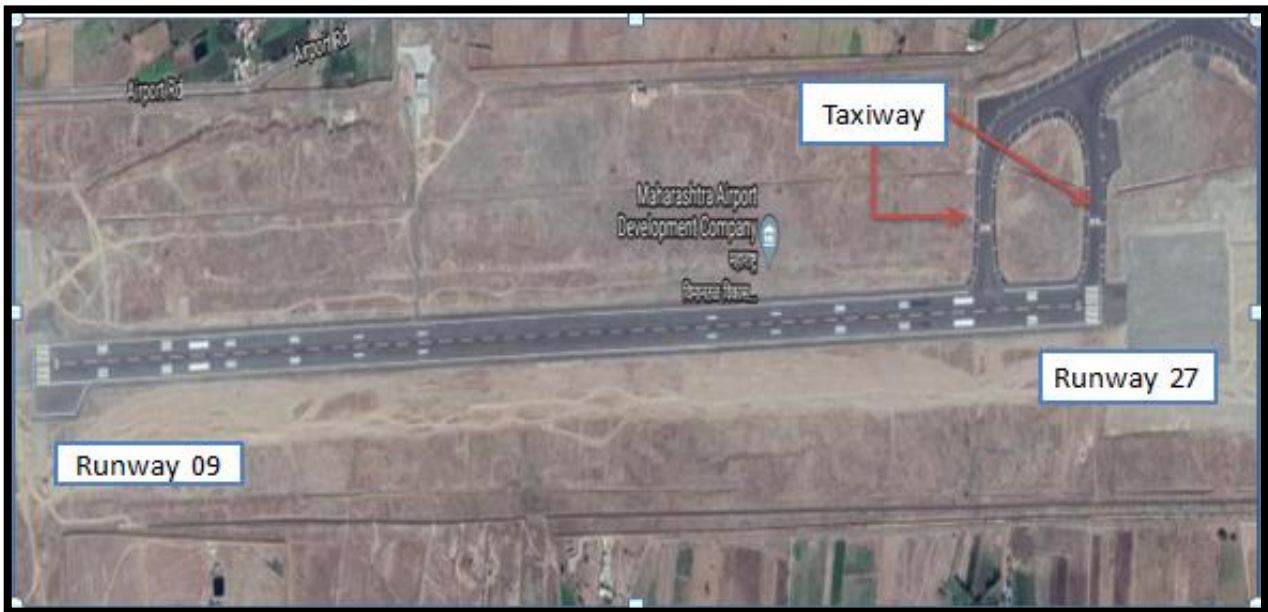
The flight 9I-653 was scheduled for departure to Mumbai at 0950 UTC, however the flight eventually departed Mumbai at 1037 UTC and was running behind the schedule. For landing on runway 27, the crew had to follow the circuit which is longer in path and would have increased the flight time.

Further, if an aircraft lands on runway 09, aircraft is not required to backtrack and it reaches the apron area which is at end of the runway 09.
