**FINAL INVESTIGATION REPORT
OF
SERIOUS INCIDENT TO M/S INDIGO
ATR 72-600 AIRCRAFT VT-IYD
AT HYDERABAD ON 28th MARCH 2018**

**AIRCRAFT ACCIDENT INVESTIGATION BUREAU
MINISTRY OF CIVIL AVIATION
GOVERNMENT OF INDIA**

FINAL INVESTIGATION REPORT OF SERIOUS INCIDENT TO
M/s INDIGO ATR 72-212A (600) AIRCRAFT VT-IYD AT HYDERABAD
ON 28/03/2018

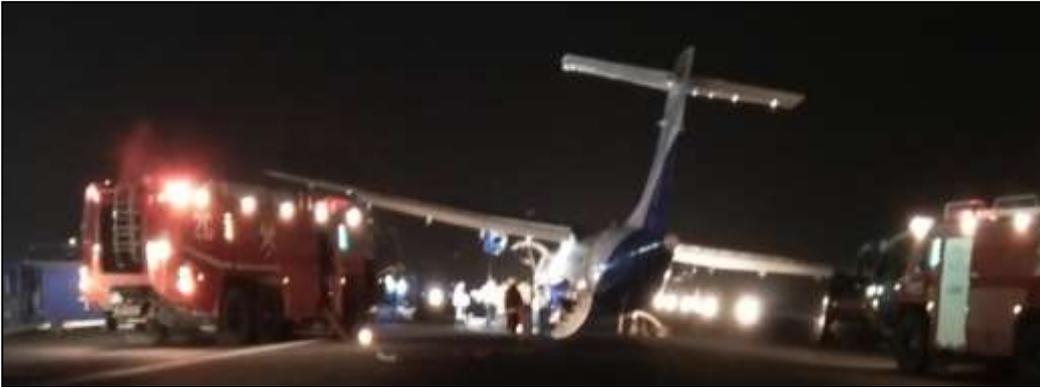
DAMAGE TO PORT MAIN WHEEL ASSEMBLY

- No. 1 main wheel tyre worn out till the hub from the bottom and No. 2 main wheel tyre got burst completely.
- No. 3 & 4 main wheel tyres worn out from the bottom including approx. 20% of hub.
- Brake hydraulic line LH side above the axle got deformed.
- LH side main landing gear door had a dent in the aft edge at root.

The final rest position of the aircraft was diagonal to the runway center line. All four wheels of the main under carriage had burst and the tyres were shredded.
