**FINAL INVESTIGATION REPORT
ON ACCIDENT TO AIRBUS AS350 B3 HELICOPTER
VT-HDX
AT MOLDI VILLAGE ON 21st AUGUST 2019.**

**GOVERNMENT OF INDIA
MINISTRY OF CIVIL AVIATION
AIRCRAFT ACCIDENT INVESTIGATION BUREAU**

**FINAL INVESTIGATION REPORT ON ACCIDENT TO
M/s HERITAGE AVIATION PVT. LTD. AS350 B3 HELICOPTER VT-HDX
AT MOLDI ON 21st AUGUST 2019**

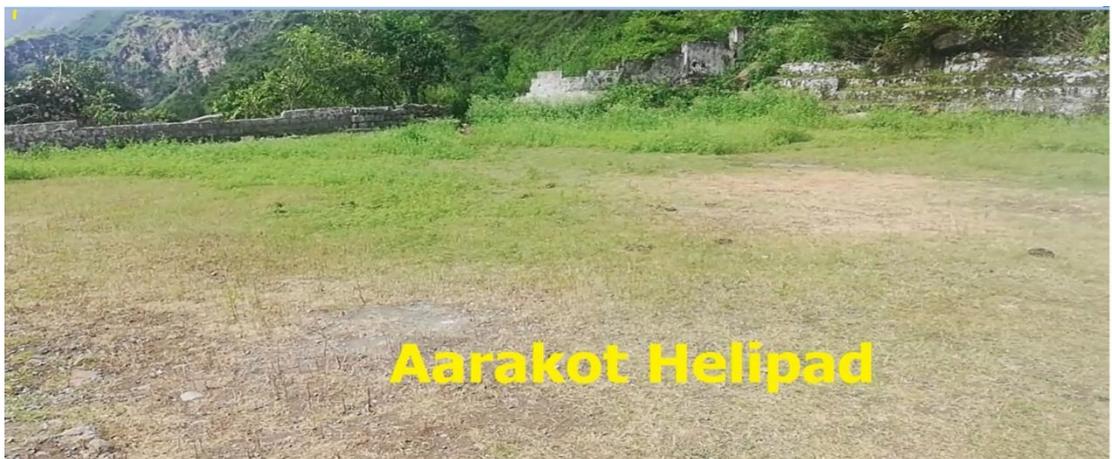
The helipads were used to supply flood relief items to the flood affected areas and also for ferrying passengers mostly people who required immediate

medical attention. The co-ordinates of the Arakot helipad are 31°02'29" N, 077°49'46" E with elevation of approx. 4300 feet.

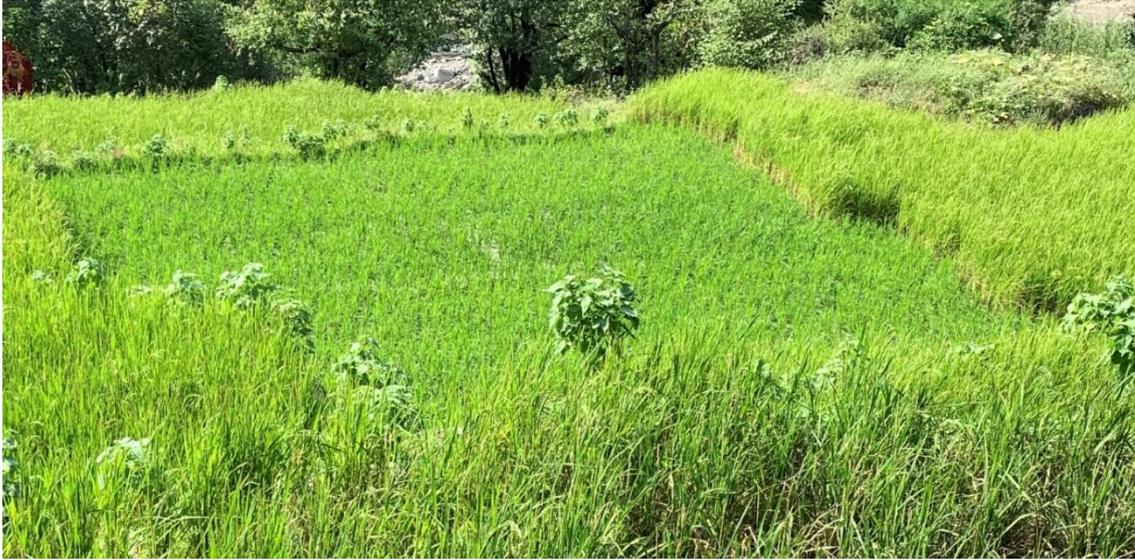
MOLDI HELIPAD

The co-ordinates of the Moldi helipad are 31°03'17" N & 77°51'30" E
