**FINAL INVESTIGATION REPORT
OF
ACCIDENT TO AS350 B3e
HELICOPTER VT-UTC
AT SHRI KEDARNATH JI
ON 23/09/2019**

**AIRCRAFT ACCIDENT INVESTIGATION BUREAU
MINISTRY OF CIVIL AVIATION
GOVERNMENT OF INDIA**

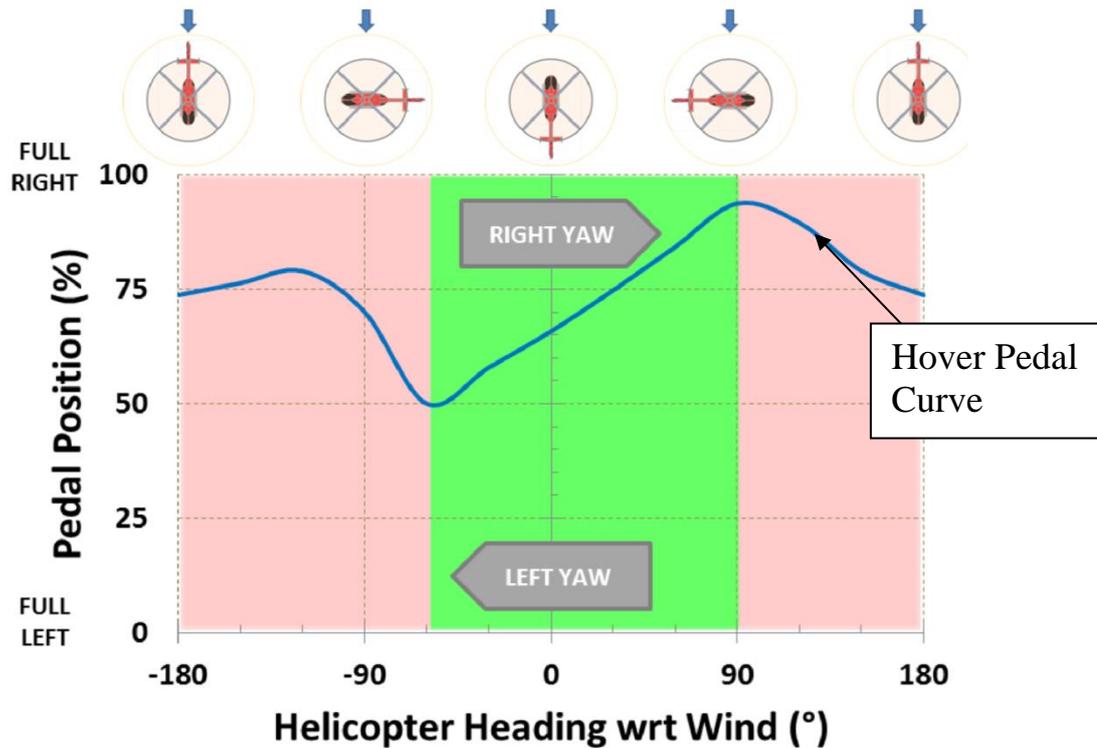
Hover pedal curve

The blue curve corresponds to hover trim conditions. From there, when right pedal is added (i.e. the pedal position moves above the blue curve) the helicopter turns to the right, and when left pedal is added it turns to the left (the pedal position moves below the curve).

Where a headwind is present (green area), the helicopter is stable in yaw. If now, the heading of the helicopter, alters, say, from 0° to -10°, the pedal position reaches above the curve. The helicopter, therefore, turns to the right until it reaches 0° on trim curve.

The pink area represents an area of a yaw instability. When the helicopter is shifted from its trim position, it moves further away until a stable headwind condition is found. This tailwind instability is known to helicopter pilots who are aware that yaw must be very carefully controlled when the wind approaches from behind (tailwind).

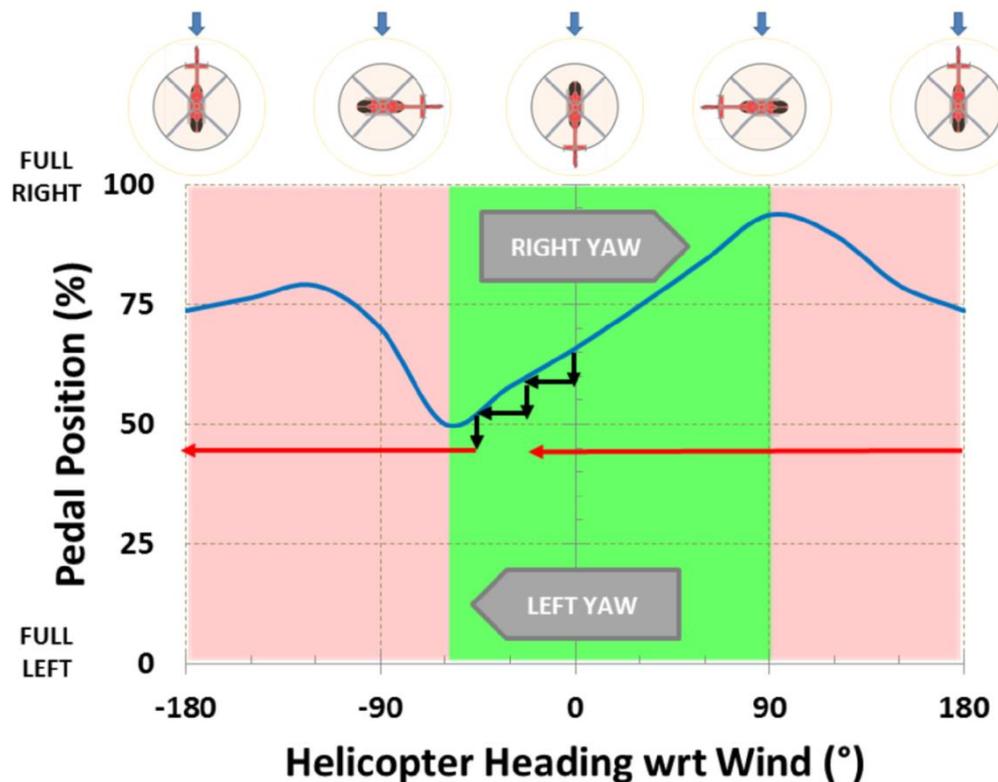
Starting of an unanticipated left yaw

Starting from 0° head wind, a left pedal forward step is made (indicated by a vertical black arrow). This brings the control position below the trim curve and the helicopter therefore rotates to the left and stops at the trim curve. In headwind conditions, pedal movement therefore produces a heading step.

A second left pedal step has a similar effect and produces a second heading step.

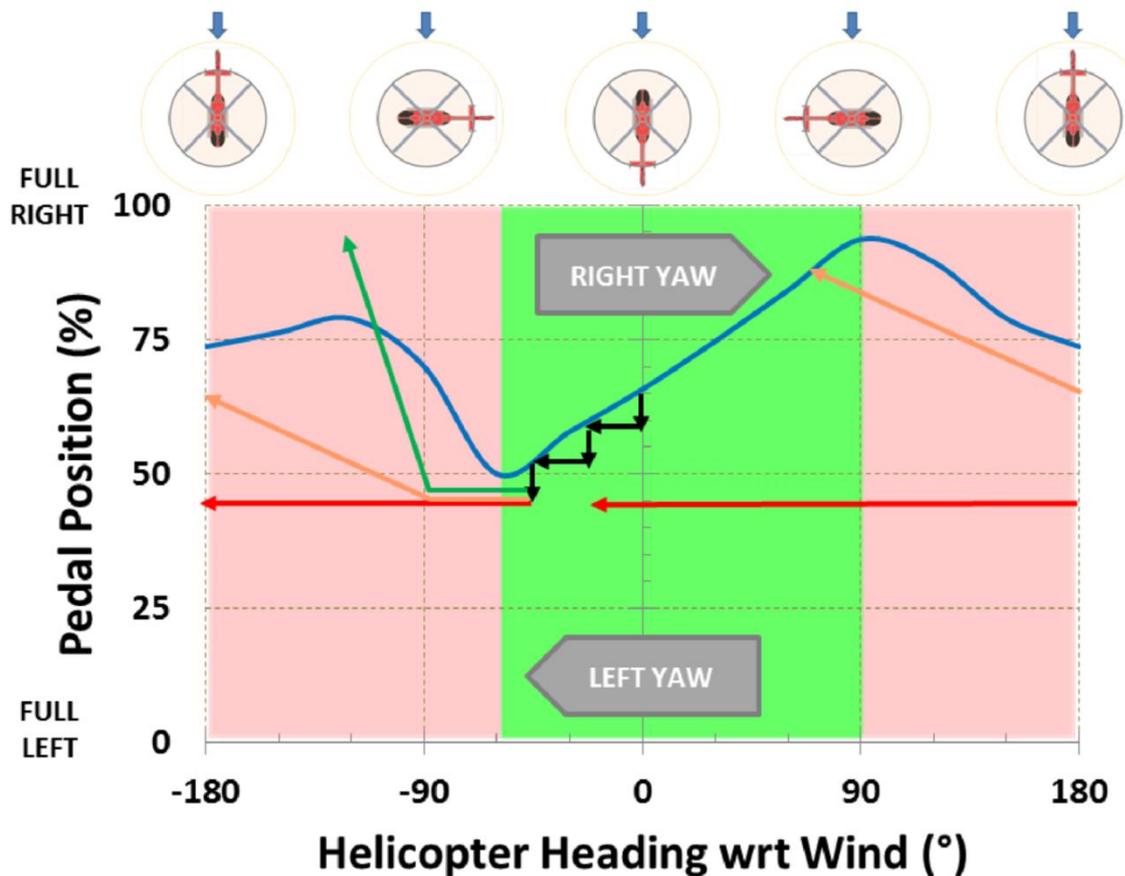
Controlling unanticipated Yaw

Unanticipated left yaw occurrence, where pilot is caught unaware by the helicopter's behavior and he has reacted late say in the vicinity of a -90° heading.

Red line shows no control input or a very small control input (based on the tail rotor efficiency perceived), is not an option for the pilot and the helicopter continues to yaw.

Green line shows a large and rapid input which stops the yaw much more quickly, but the trim remains in the unstable tailwind range. So the heading must be closely monitored and headwind conditions recovered as soon as
