# FINAL INVESTIGATION REPORT ON

# ACCIDENT TO M/S ARYAN AVIATION PVT. LTD.

# **BELL 407 HELICOPTER VT-SVK**

# AT TIKOCHI VILLAGE ON 23rd AUGUST 2019.

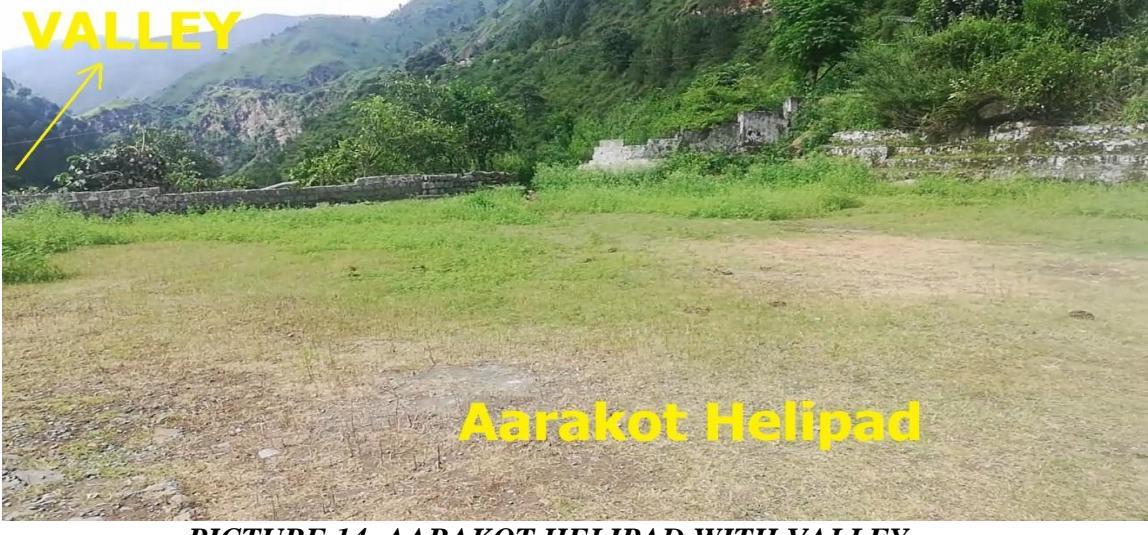
PICTURE 14: AARAKOT HELIPAD WITH VALLEY

The co-ordinates of the Arakot & Chiva helipads are  $31^{\circ} 02' 29''$  N,  $077^{\circ} 49' 46''$  E with elevation of approx. 4300 feet and  $31^{\circ} 05' 32''$  N,  $077^{\circ} 53' 52''$  E with elevation of approx. 5600 feet respectively. The helipads are surrounded by hills and have only one direction for landing and take-off. The valley starts immediately after the helipad.
