FINAL INVESTIGATION REPORT ON ACCIDENT TO

M/s WINGS AVIATION PVT. LTD.,

CESSNA 172S AIRCRAFT, VT-RGF ON 06-10-2019

AT SULTANPUR VILLAGE, TELANGANA.

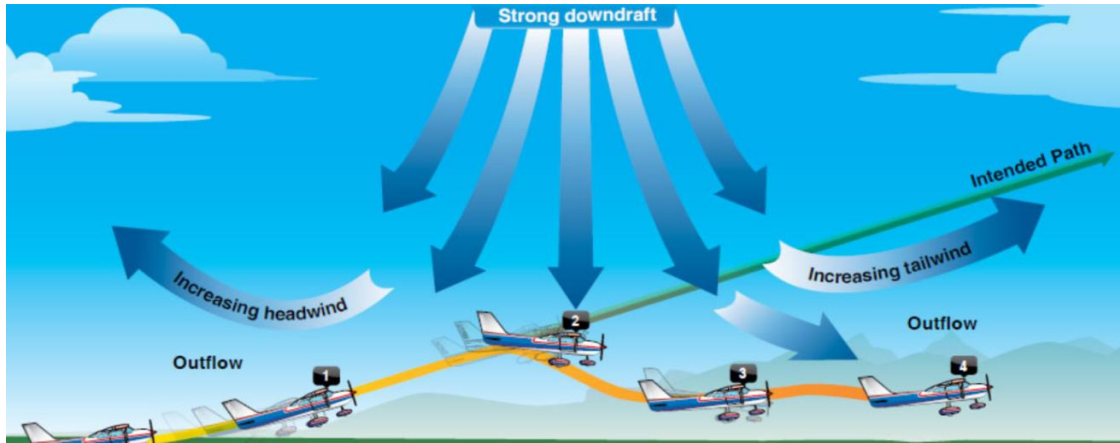
AIRCRAFT UNDER STRONG DOWNDRAFT

Wind shear has significant affects on control of an aircraft. It causes rapid change in lift, and thus the altitude, of the aircraft. Strong outflow from thunderstorms causes rapid changes in the three-dimensional wind velocity just above ground level. Initially, this outflow causes a headwind that increases airspeed, which normally causes a pilot to reduce engine power if they are unaware of the wind shear. As the aircraft passes into the region of the downdraft, the localized headwind diminishes, reducing the aircraft's airspeed and increasing its sink rate. Then, when the aircraft passes through the other side of the downdraft, the headwind becomes a tailwind, reducing lift generated by the wings, and leaving the aircraft in a low-power, low-speed descent.

The damage to aircraft and scatter of the wreckage also fully conform to the aircraft entering very bad weather. There was no indication of aircraft disintegrating in air. Because of getting engulfed into a heavy downdraft, it had impacted the ground with heavy force, while in forward motion and little nose down attitude.
