**FINAL INVESTIGATION REPORT ON SERIOUS INCIDENT
TO AIRBUS H 130 HELICOPTER VT-GVO
OPERATED BY M/S GLOBAL VECTRA HELICORP LTD,
ON 21 MARCH '2019 AT KATRA HELIPAD**

**FINAL INVESTIGATION REPORT ON SERIOUS INCIDENT TO M/S
GLOBAL VECTRA HELICORP LTD H130 HELICOPTER VT- GVO ON
21-03-2019 AT KATRA, JAMMU.**

| 13. | Type of incident | | Window Ceiling Glazed Panel sheared off and flew In-flight. |

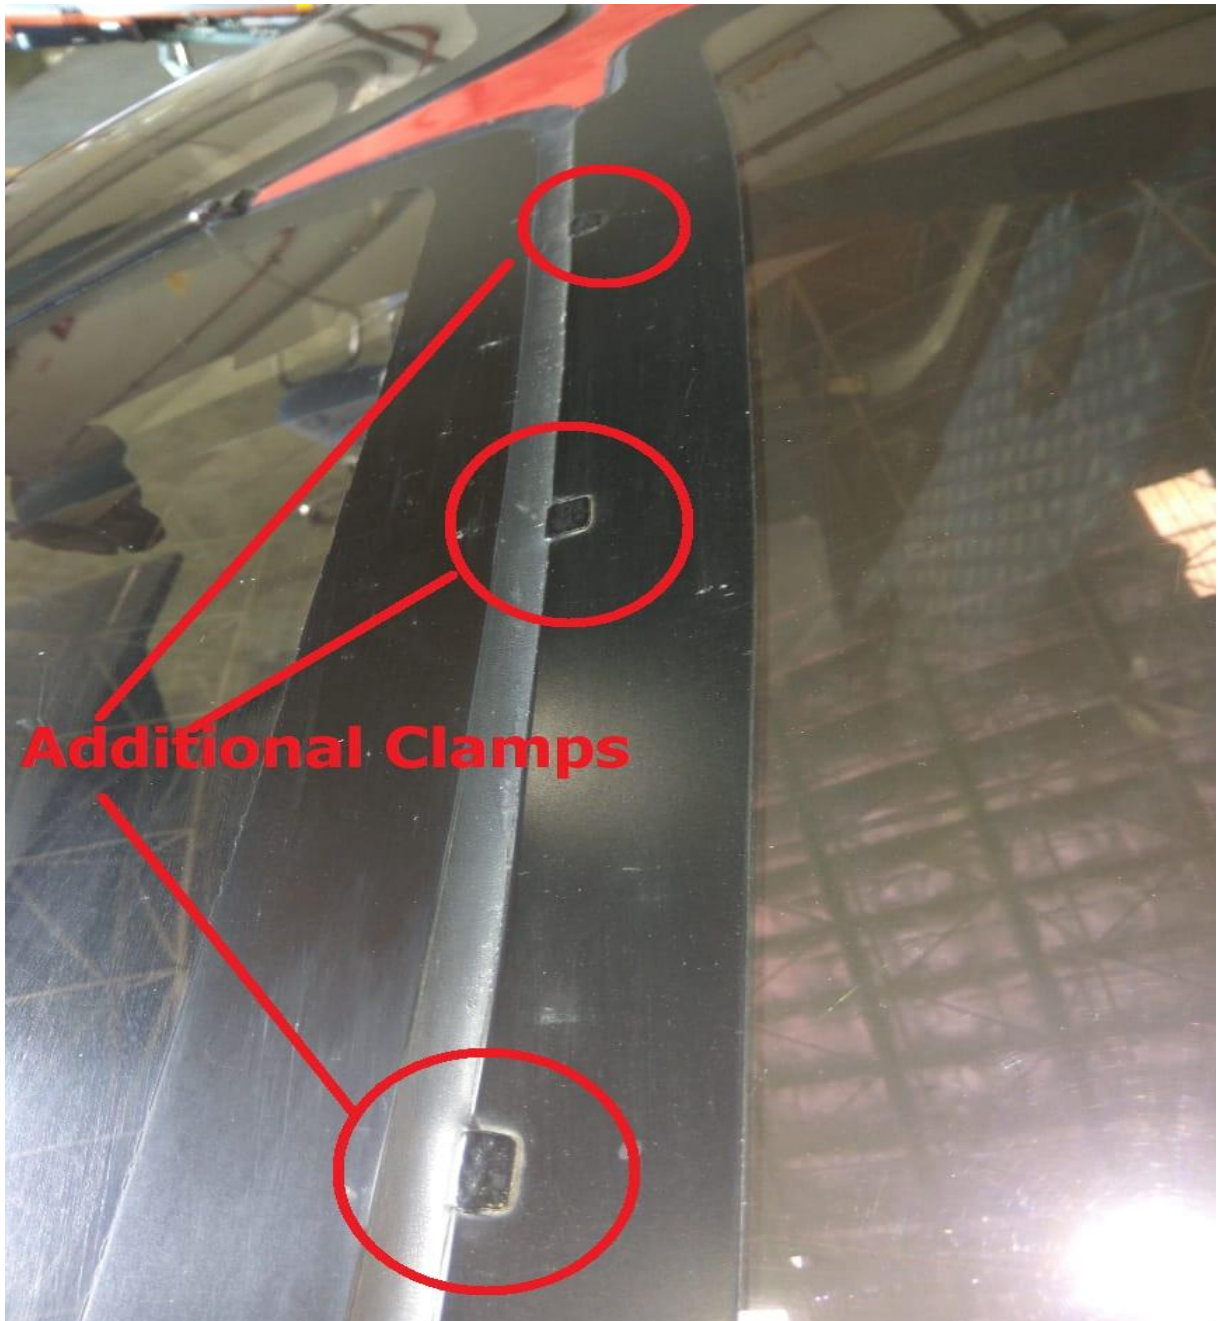
Photograph # 9: Multilayer glazed window ceiling with additional clamps

However, as an option, windows ceiling with a multi-layer heatshield to protect the cabin from the rays of the sun can also be installed. The latest version of H130 T2 helicopters are installed with this multi-layer glazed window ceiling panel having different part number from that of single layered one i.e. SGSEGEC1301120 is the part number for LH side (pilot side) & SGSEGEC1301220 for RH side. This multi-layer ceiling window glazed panel consists of additional layer of heatshield along with plexiglass and is fitted to its position with additional holding clamps positioned circumferentially (Refer Photograph # 9). Replacement and Installation procedure for both type of window ceiling glazed panel is mentioned in AMM 56-11-00 of Helicopter. *Further, no service bulletin or Modification had been issued by OEM till the date of incident on installation / replacement of glazed panel. Relevant copy of AMM is annexed to this report as Annexure I.*
