# FINAL INVESTIGATION REPORT ON SERIOUS INCIDENT OF M/s G0-AIR , REGISTRATION VT-WGR AT BENGALORE AIRPORT, ON <u>11/11/2019</u>

A Serious incident occurred at Bangalore airport on 11/11/2019 at 0152 UTC of M/s Go-Air (Type -A320, Registration- VT-WGR).

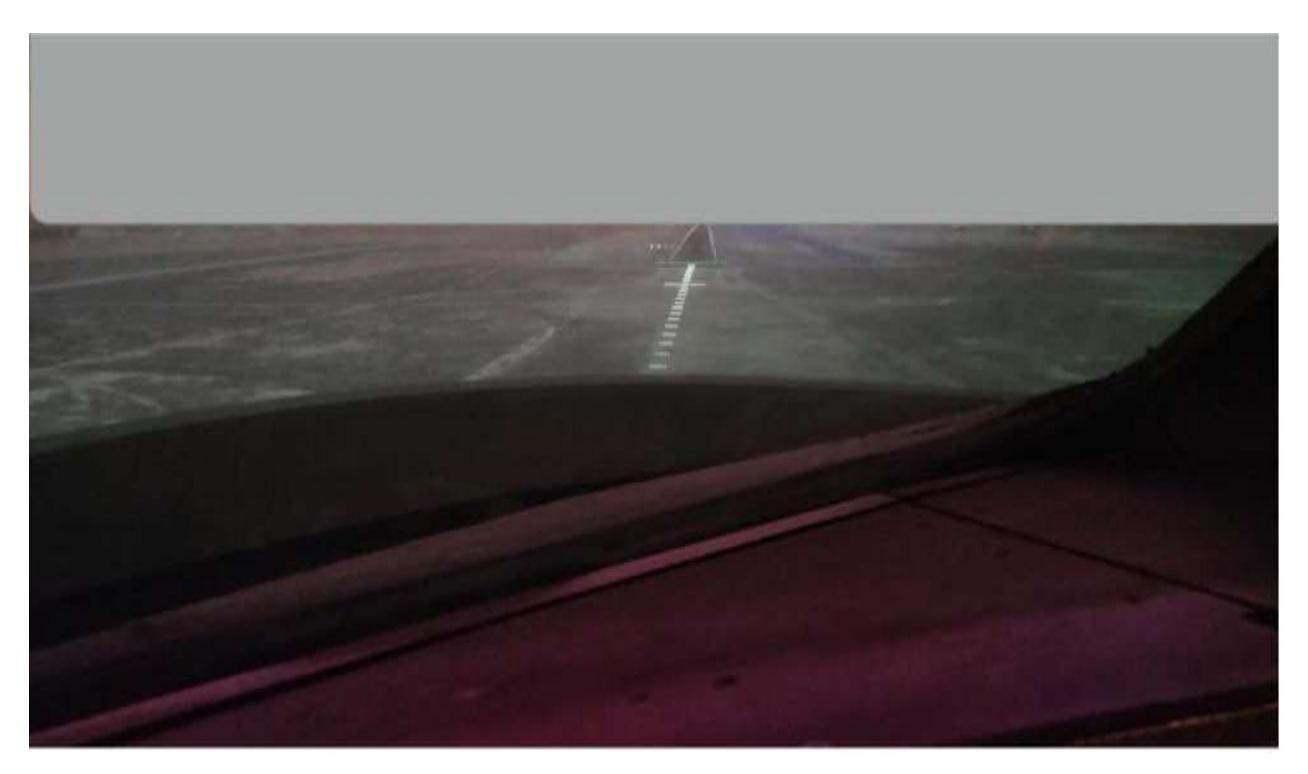
200 feet Altitude and 1200 meters visibility

The images below are replicated using visuals from a flight simulator. It is pertinent to note that the visuals in flight simulators would not be as accurate as the crew experienced from the flight deck due to the simulator limitations. The simulator would not be able to accurately factor the position of the sun with reference to the aircraft and also the degree of fog and its refractive index. However, the images have been used to aid the reader in understanding the general variation between what was expected vs. what the crew saw (on approximation)

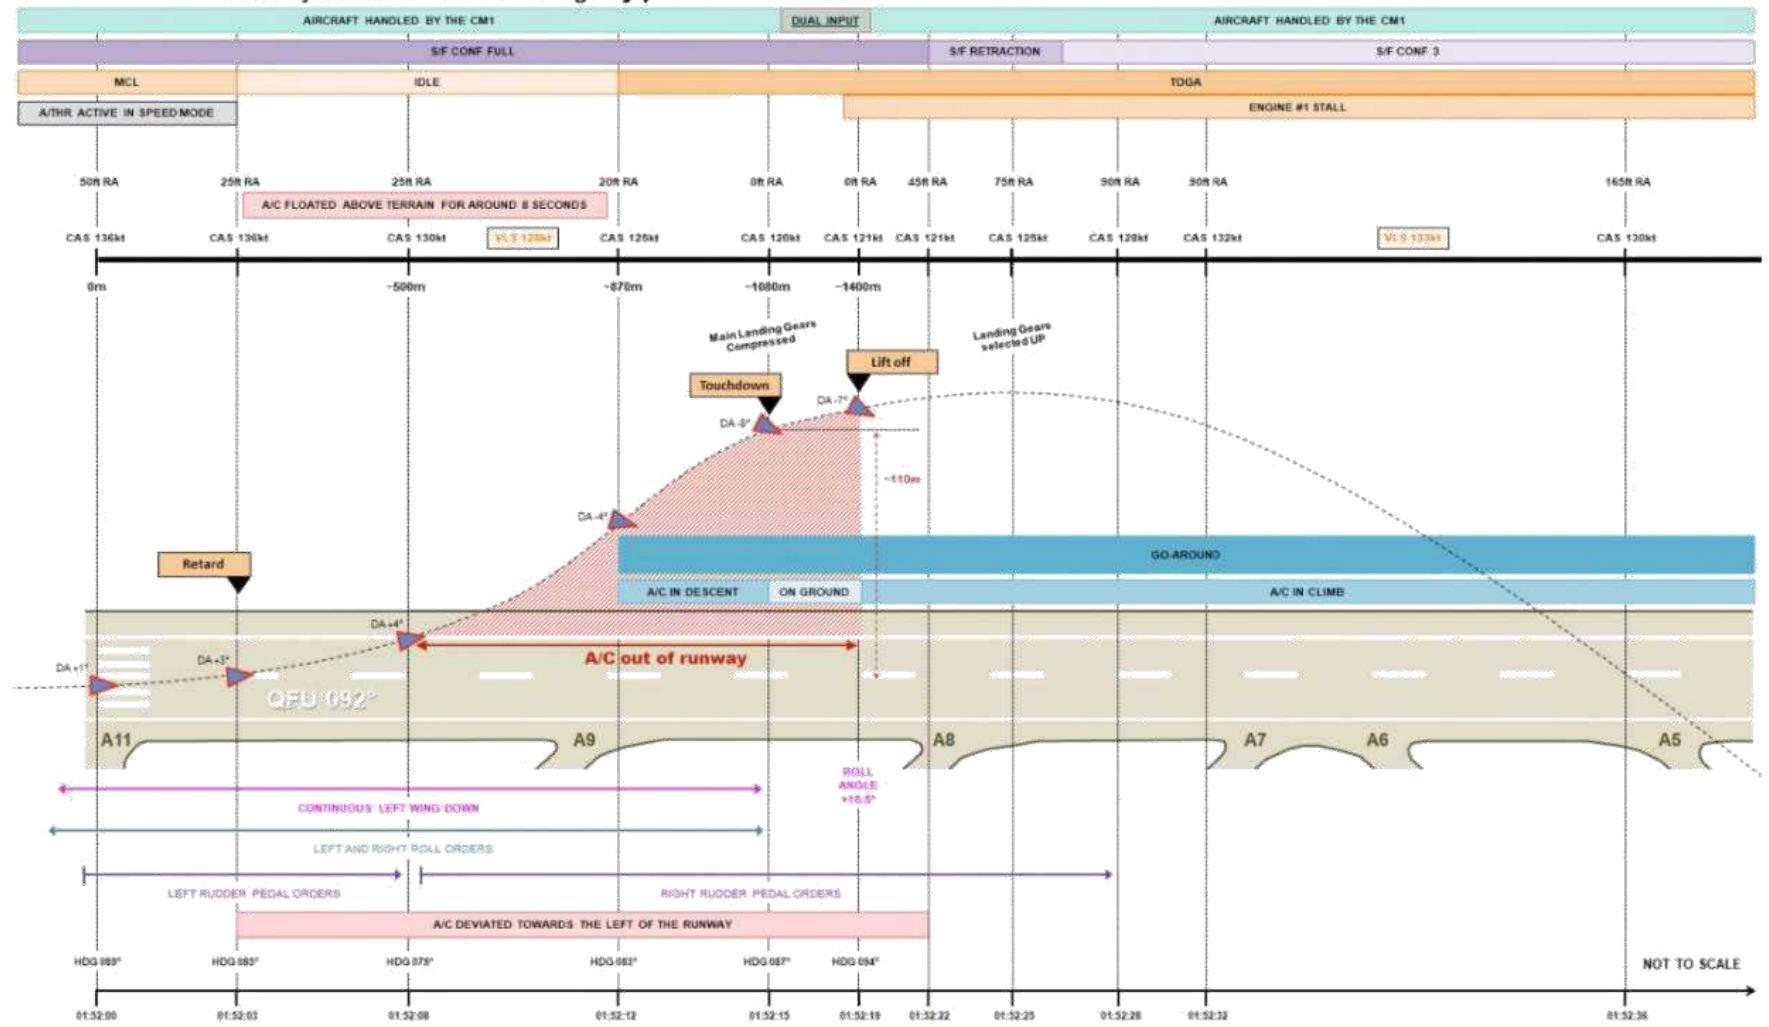
The aircraft begins a gradual bank toward the left after autopilot is disconnected. The PIC then reduces the descent rate (flying almost level) while increasing left bank to align with the left runway edge lights (which he believes are the center line lights). At the point of touchdown, the wings are near level. During the 5 seconds the aircraft has touched down, the PIC initiates an aggressive right bank which reaches 12 degrees. It reaches 17 degrees just after lift-off. The key points of FDR analysis are shown on the figure below (from OEM report)

The above plot shows the aircraft flight path over the runway (Airbus handling report).
