FINAL INVESTIGATION REPORT ON OVERRUN INCIDENT INVOLVING FEDEX EXPRESS MD-11 AIRCRAFT FDX5033 AT MUMBAI ON 03rd June 2020

AIRCRAFT ACCIDENT INVESTIGATION BUREAU MINISTRY OF CIVIL AVIATION GOVERNMENT OF INDIA

FINAL INVESTIGATION REPORT ON OVERRUN INCIDENT TO FEDEX EXPRESS MD-11 AIRCRAFT FDX5033 AT MUMBAI ON 03 JUN 2020

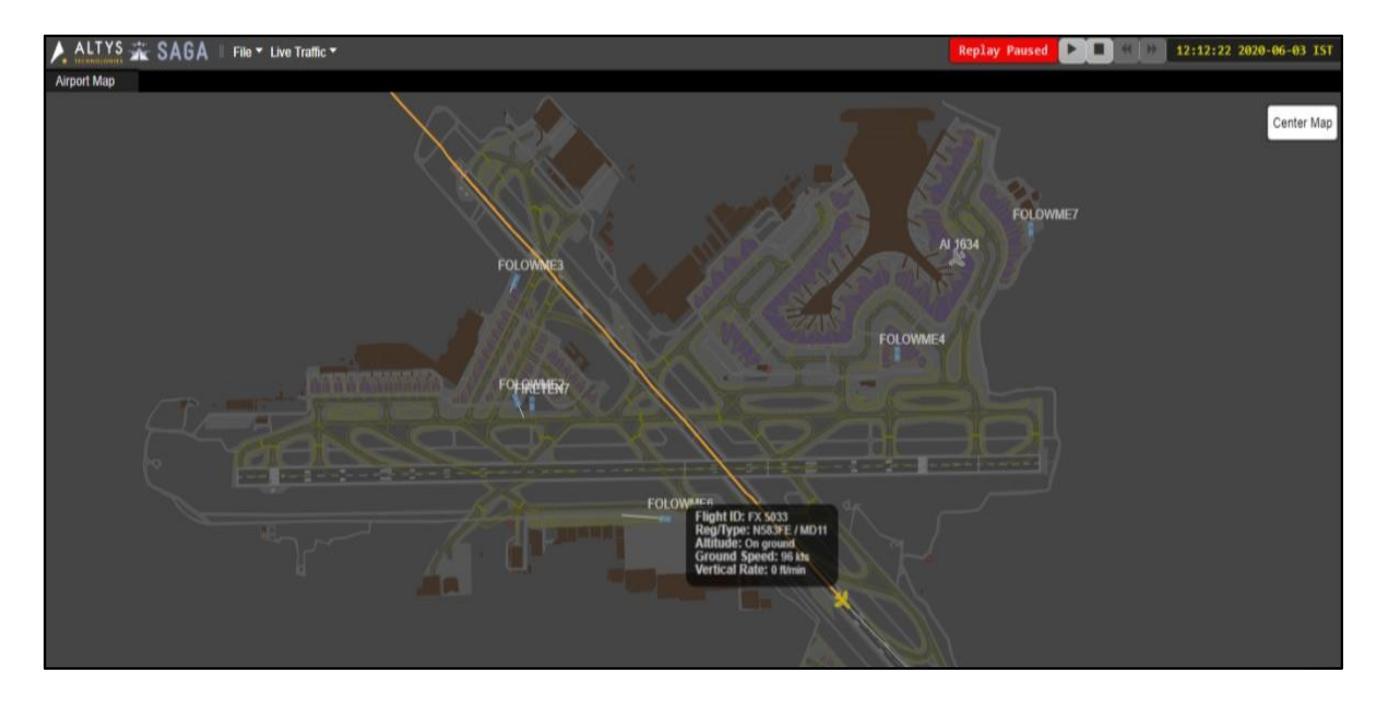
Fig-12: The above SAGA Radar image shows the position of aircraft after crossing taxiway E4. ALT 0' / GS 96 Kts / Vertical Speed - 0 fpm

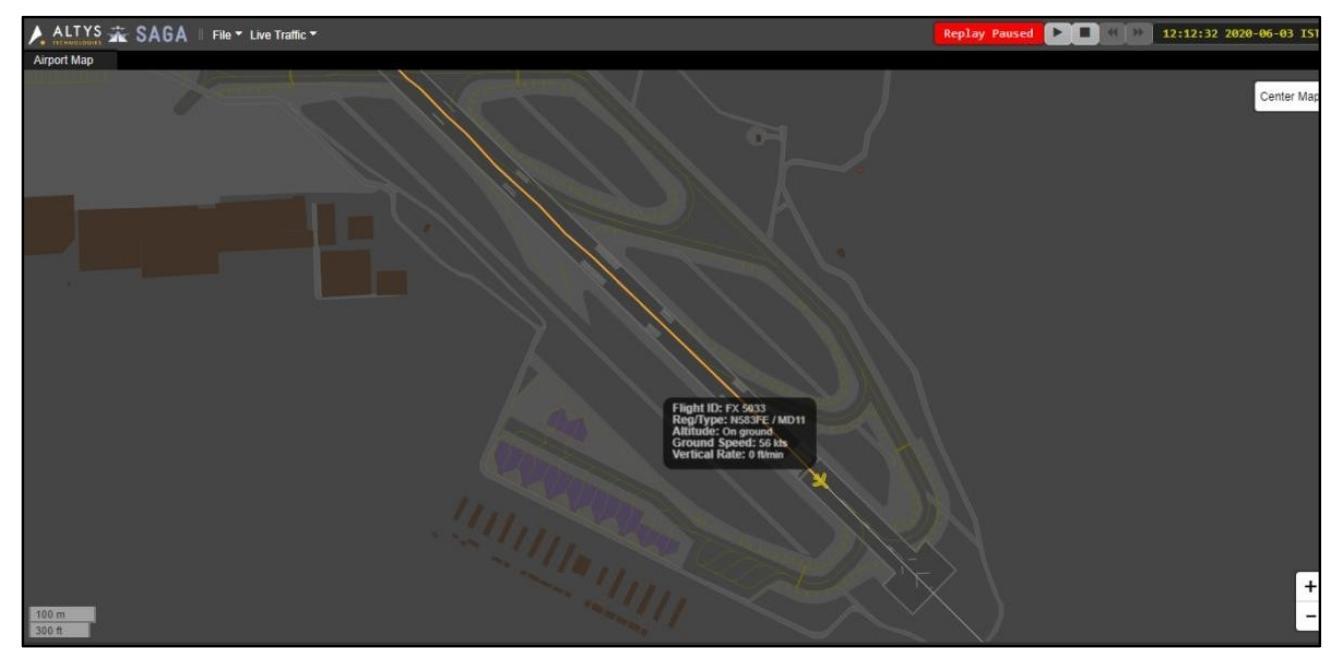
Fig-13: The above SAGA Radar image shows the position of the aircraft crossing the Runway 32 Threshold (ALT 0' / GS 56 Kts / Vertical Speed 0 fpm).

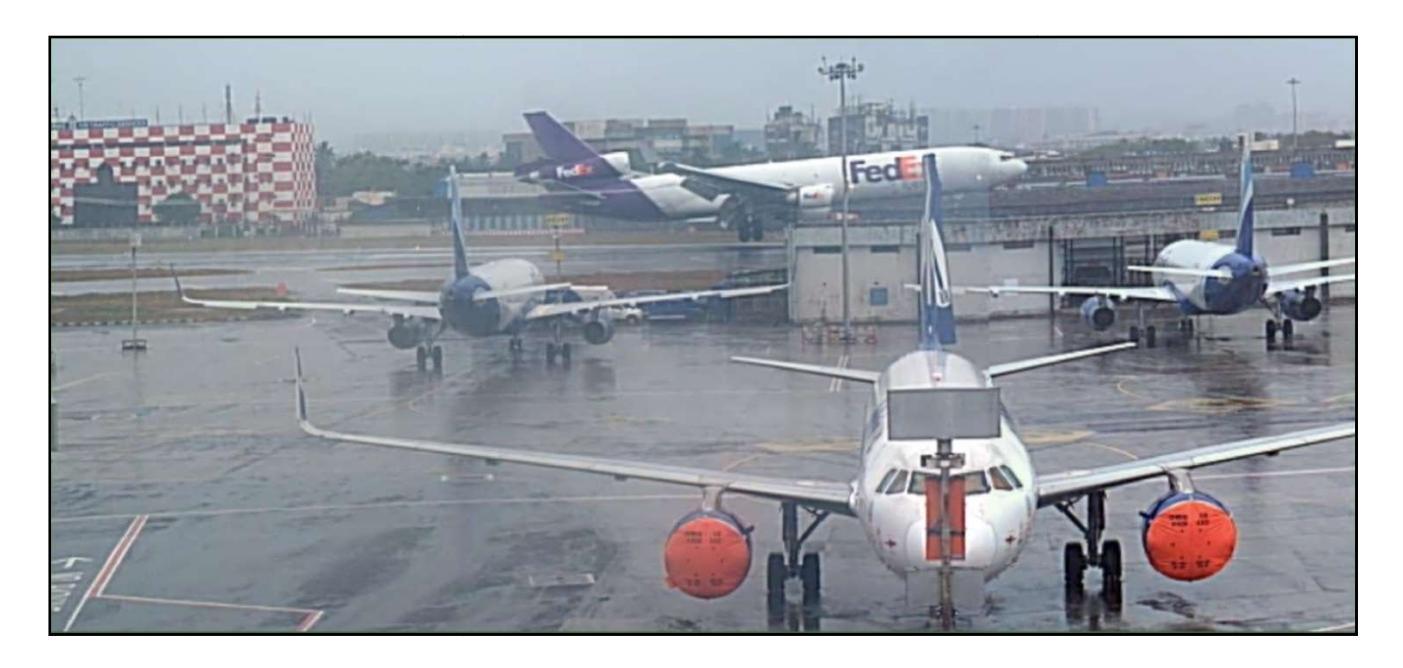
Fig-17: (CCTV 1 Image 3): Shows the aircraft has not yet touched down on the main gear. This is the approximate location of the touchdown markings.

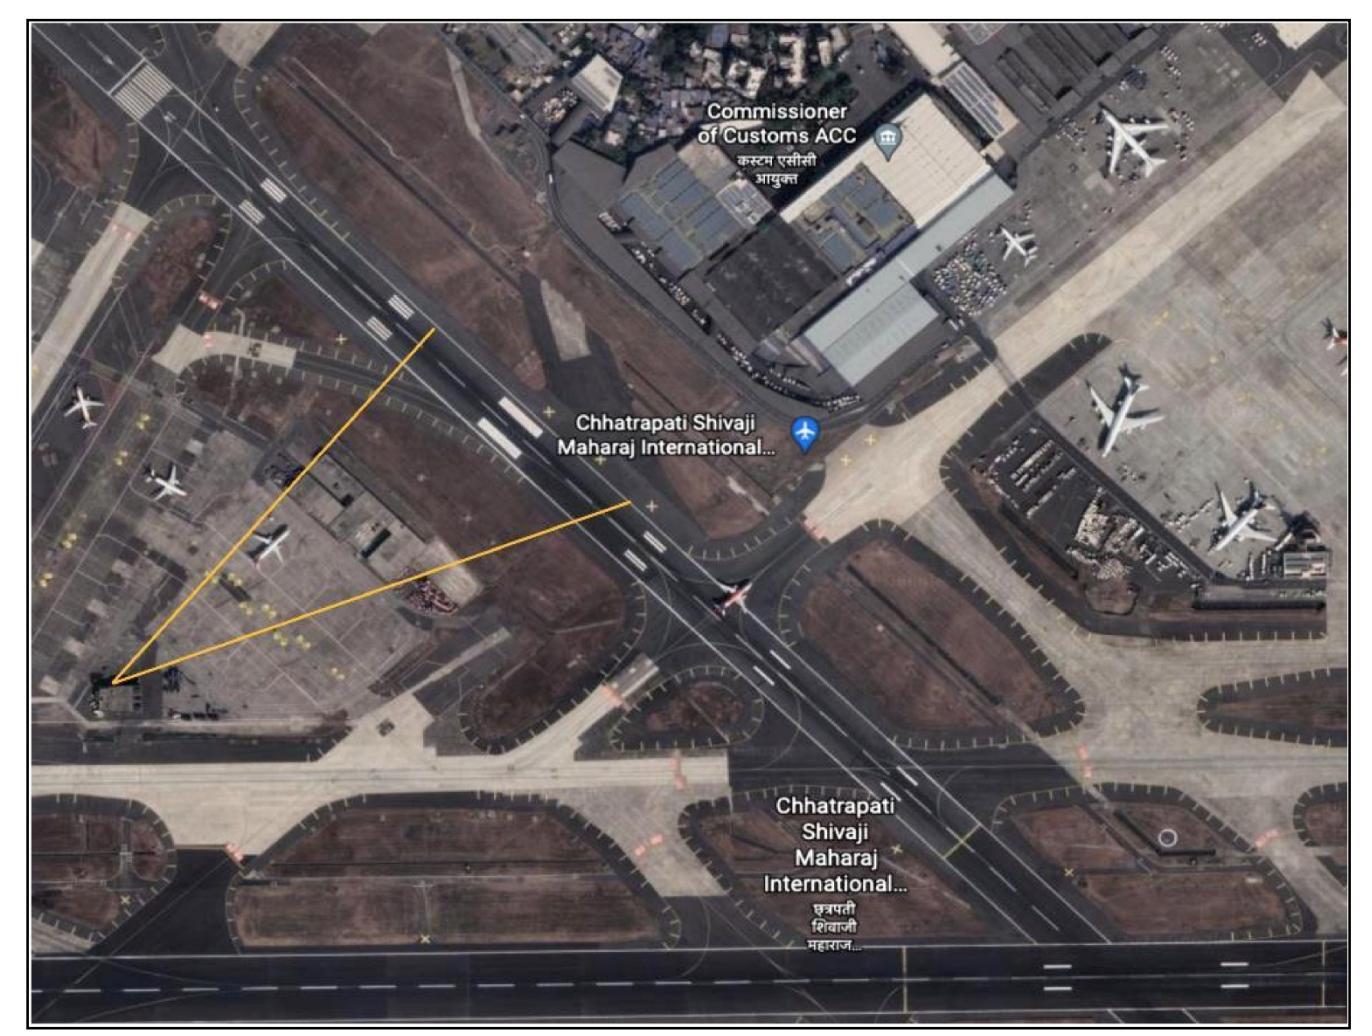
Fig-18: The Google earth plot (Screenshot) shows the area that is obstructed for runway surface view due to building structures

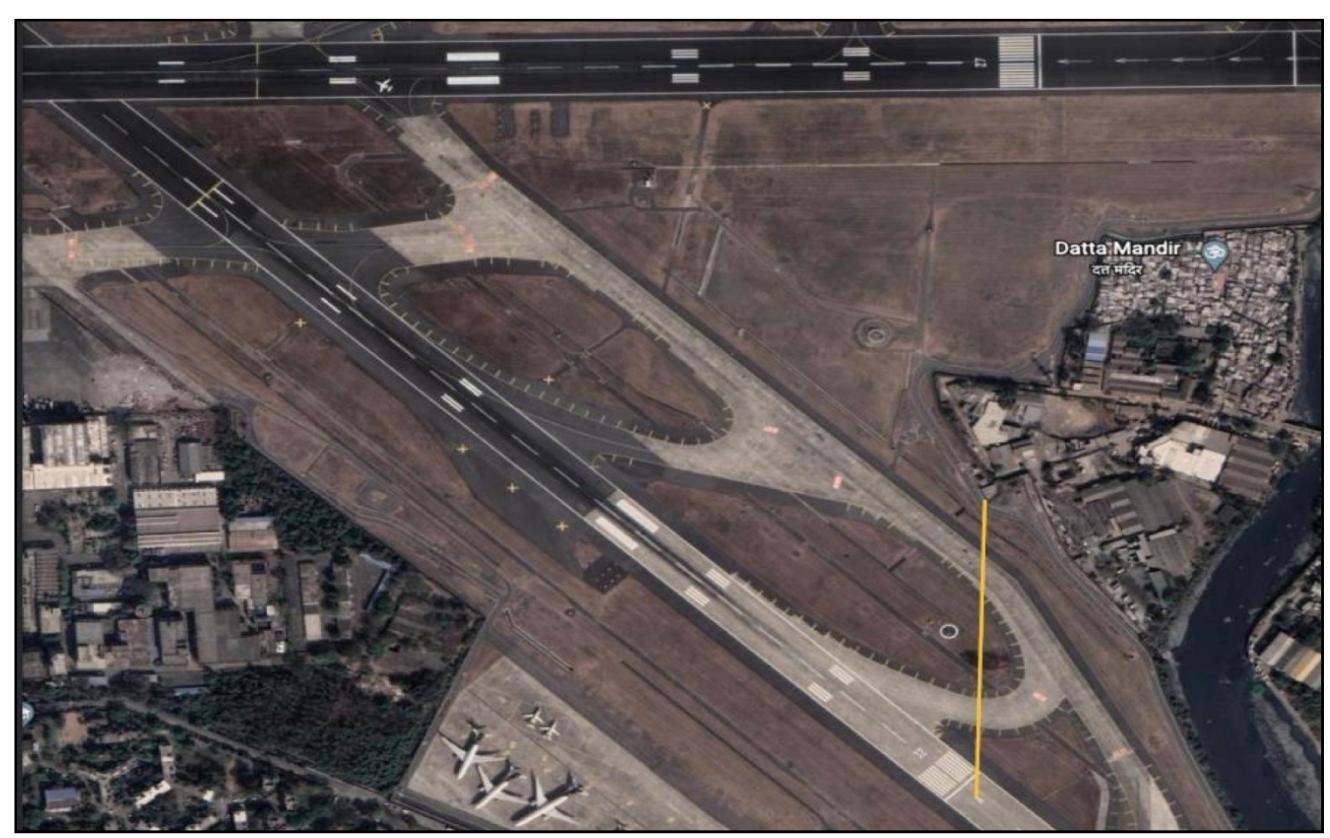
Fig-22: The Google earth plot (Screenshot) shows the aircraft location when the 1st flame is visible

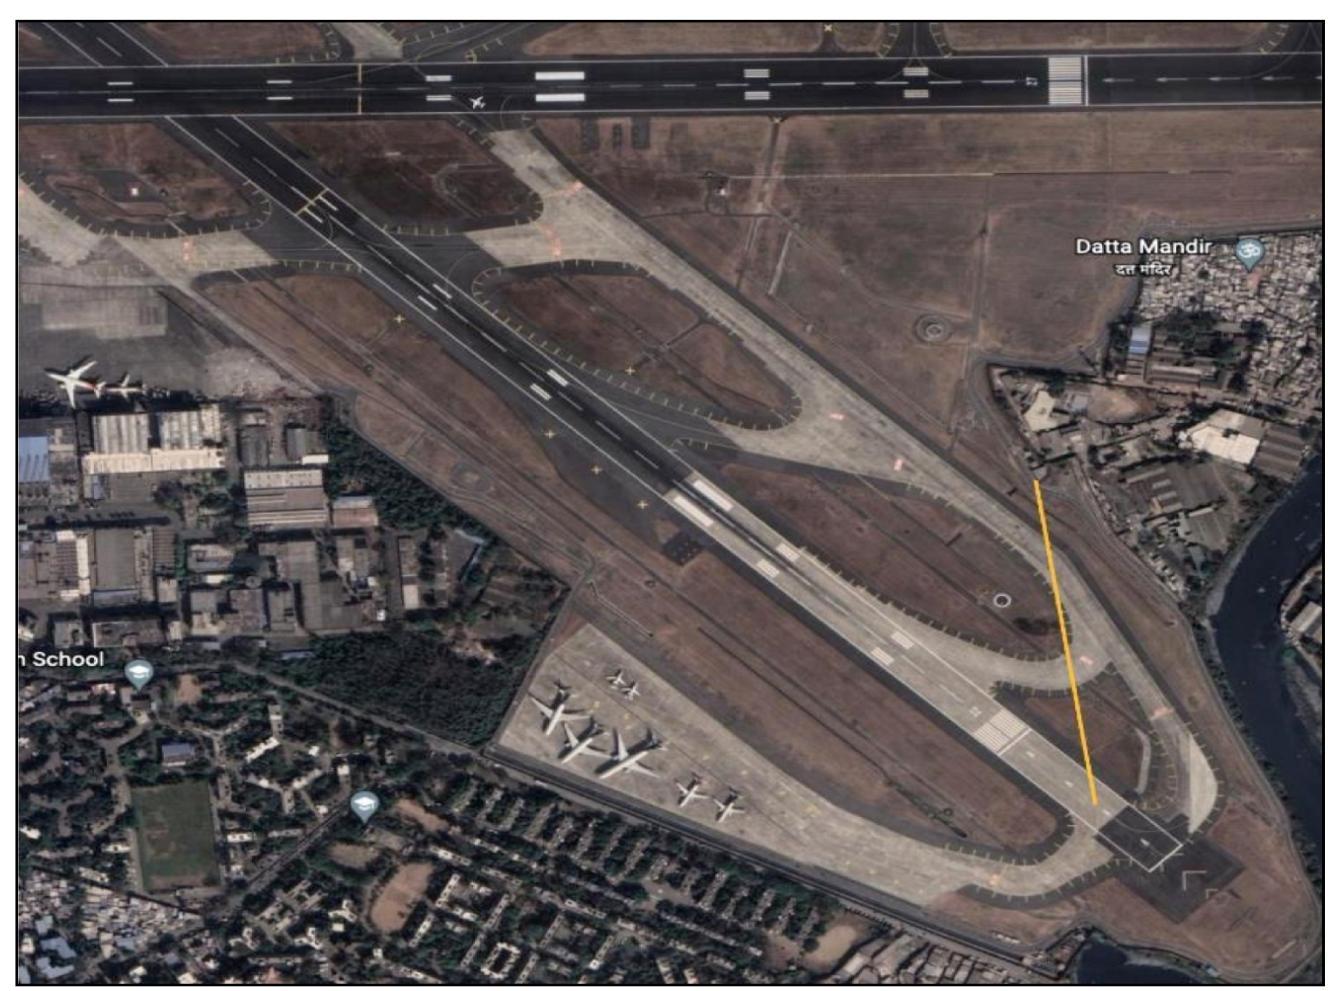
Fig-24: The Google earth plot (Screenshot) image of the aircraft when the number 1 engine flame is visible for the second time.

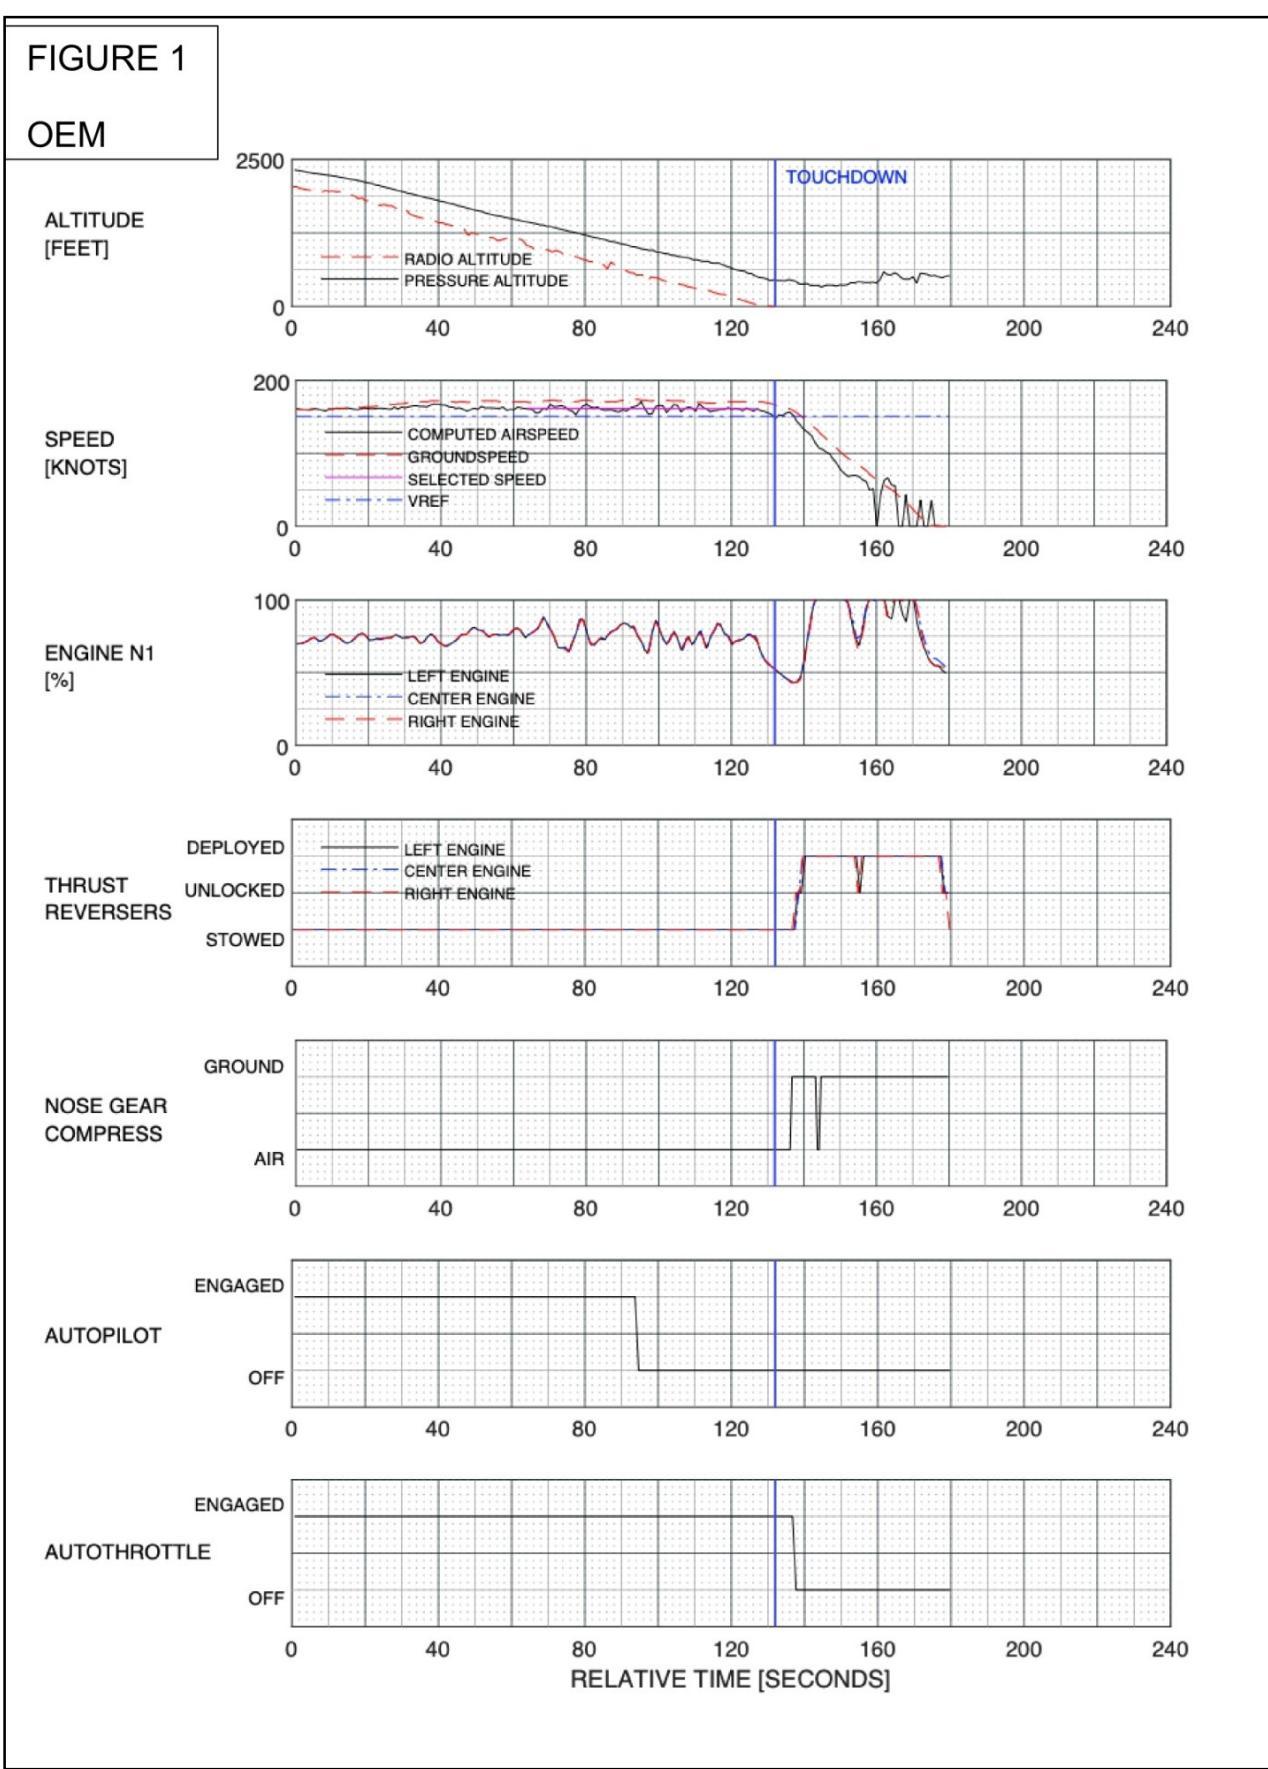
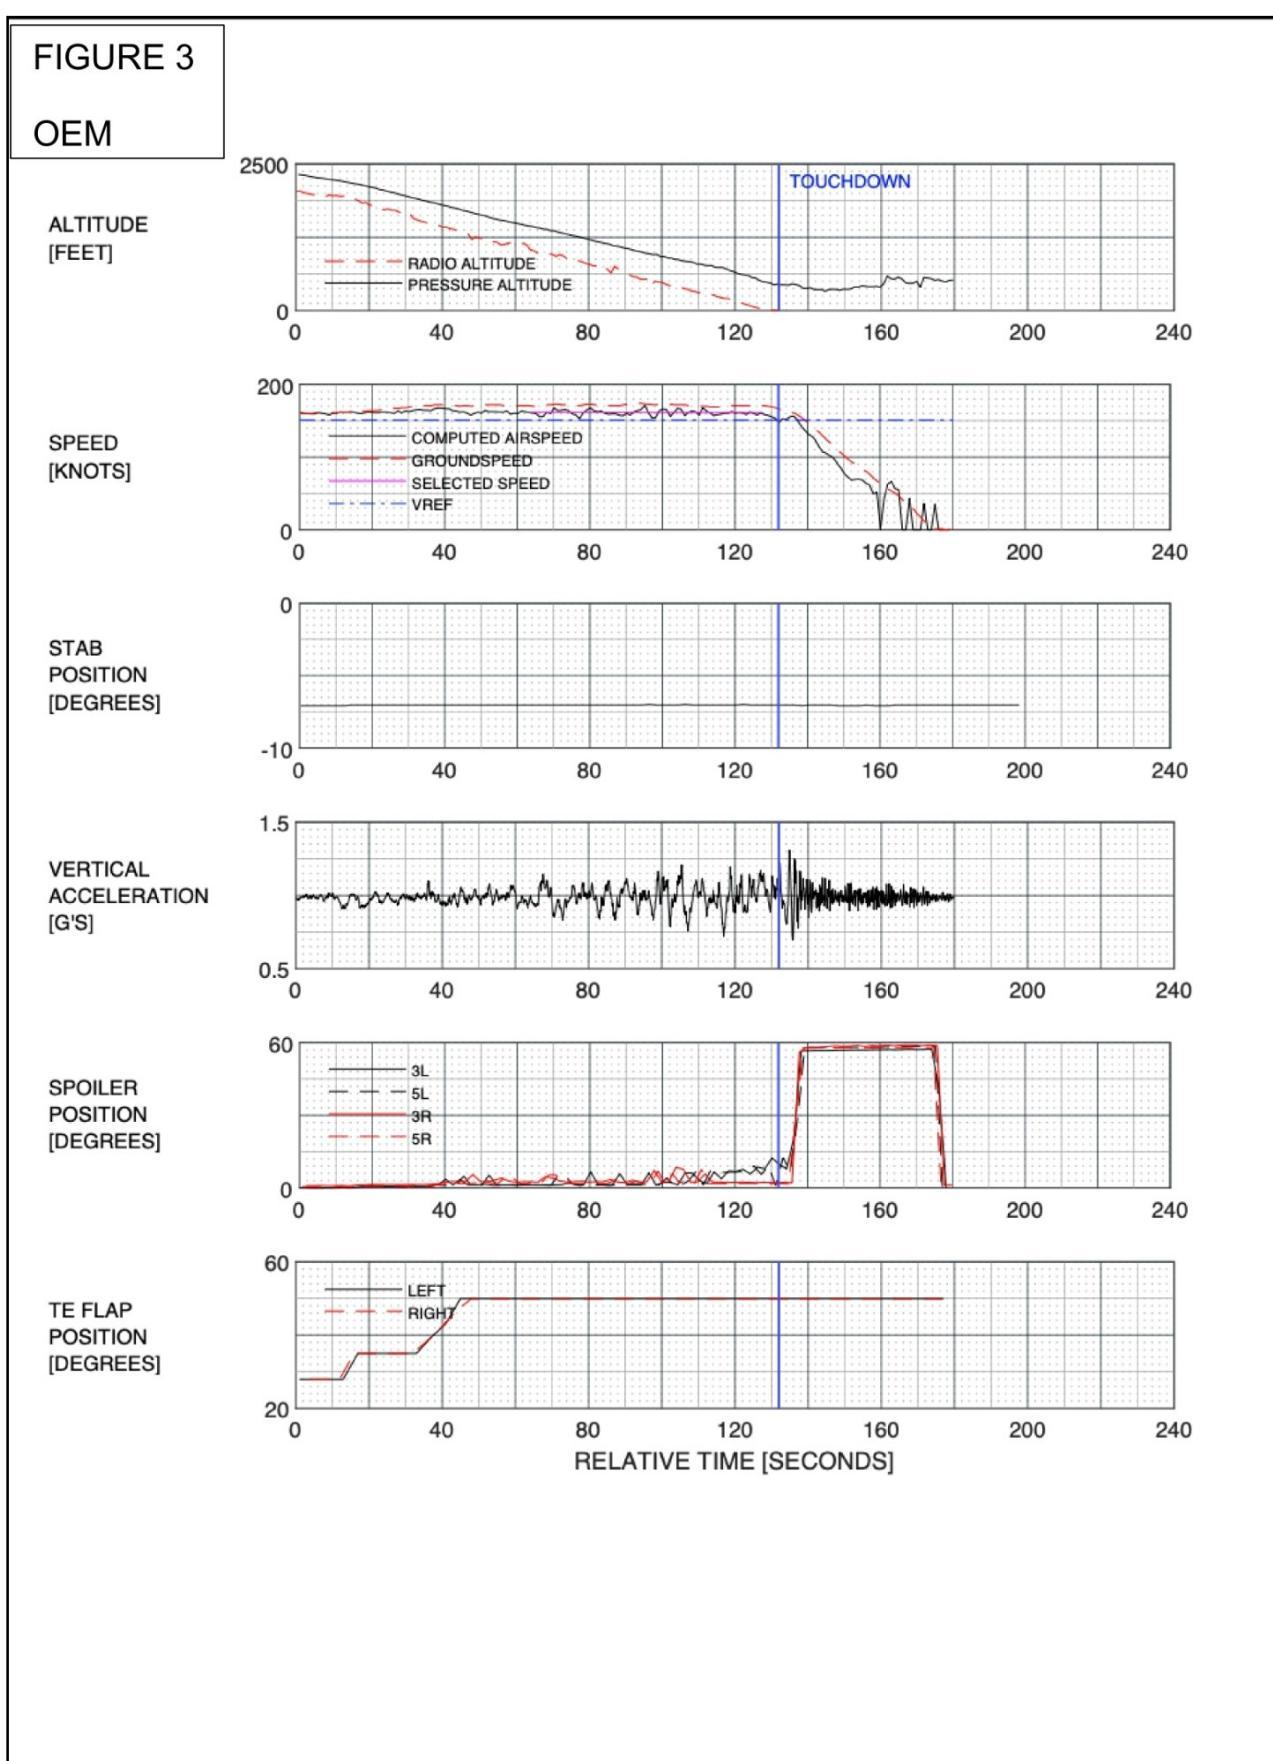
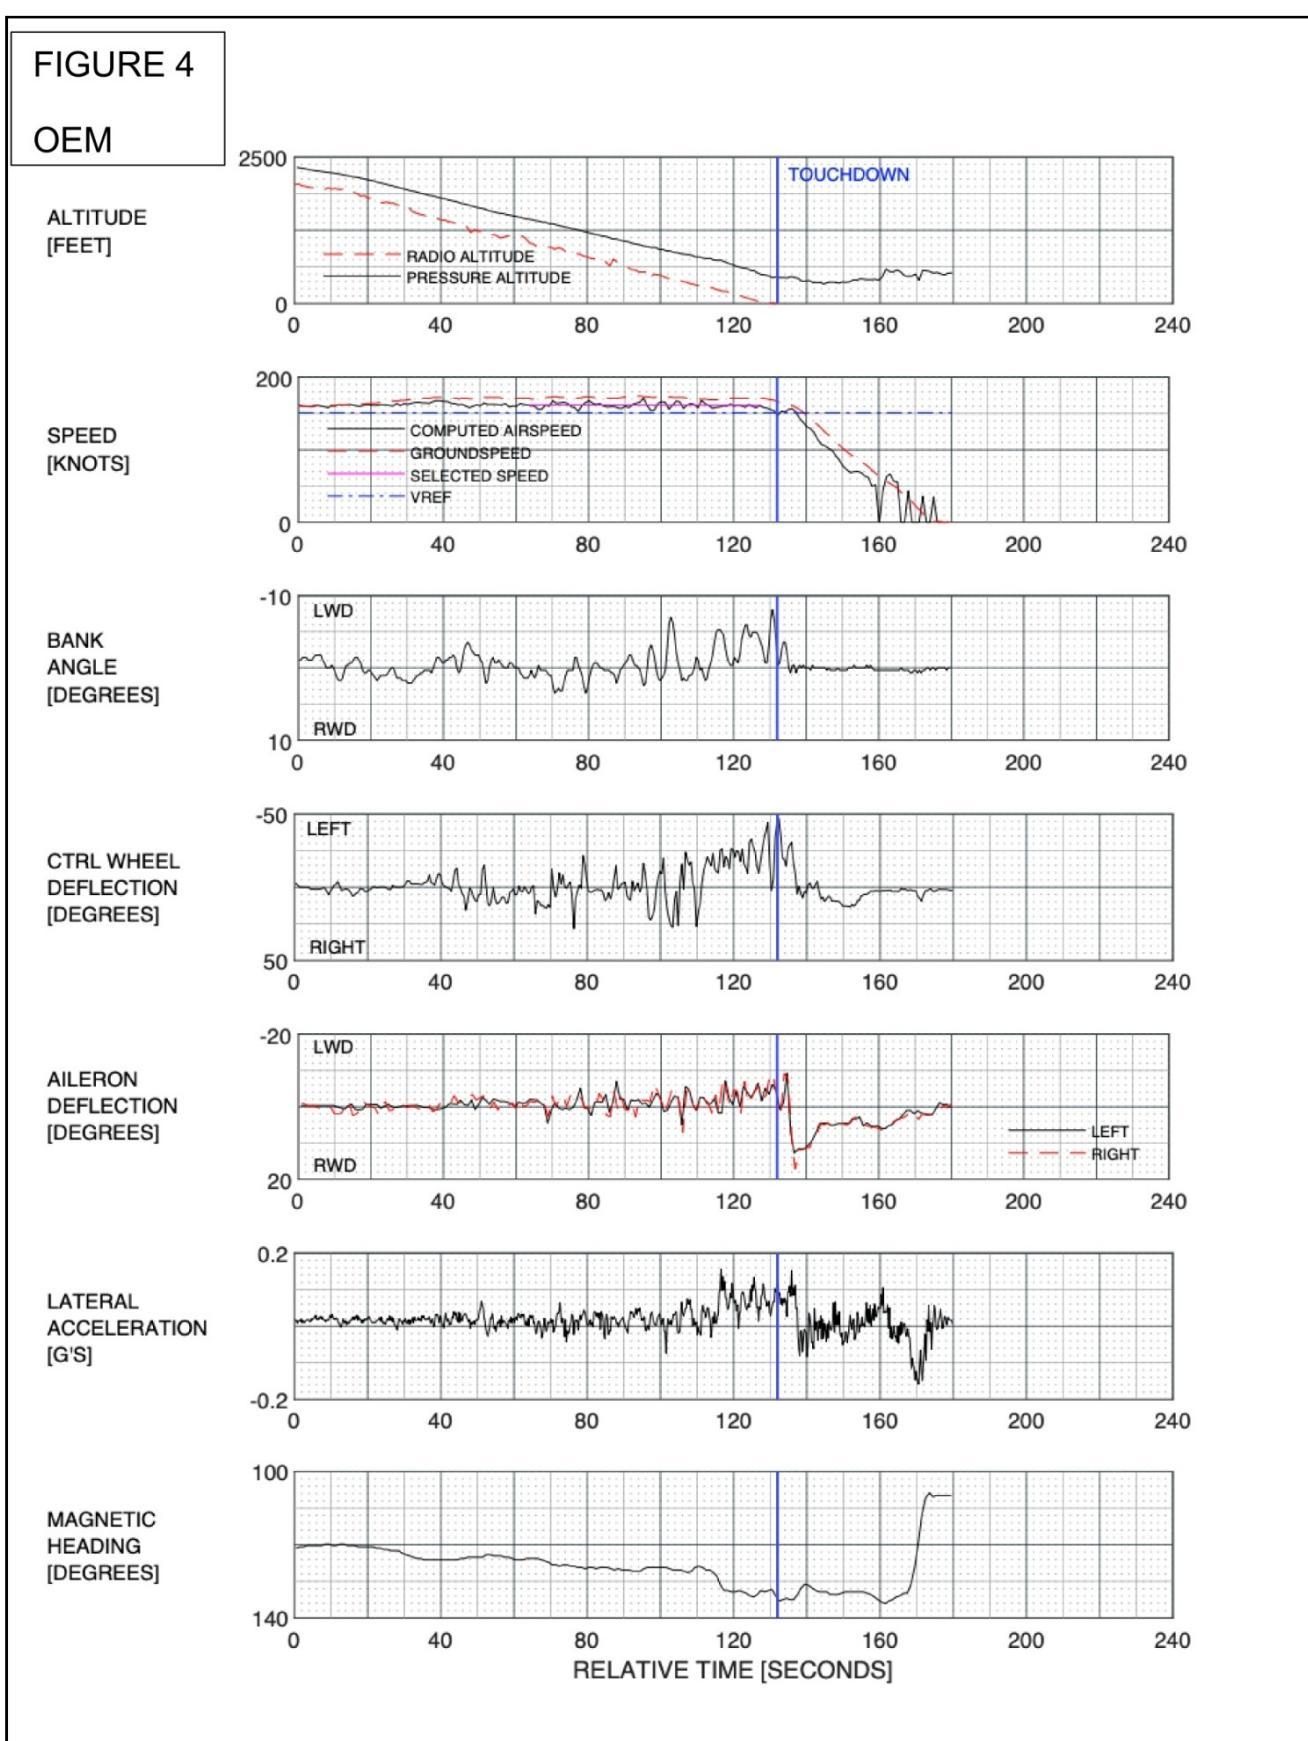
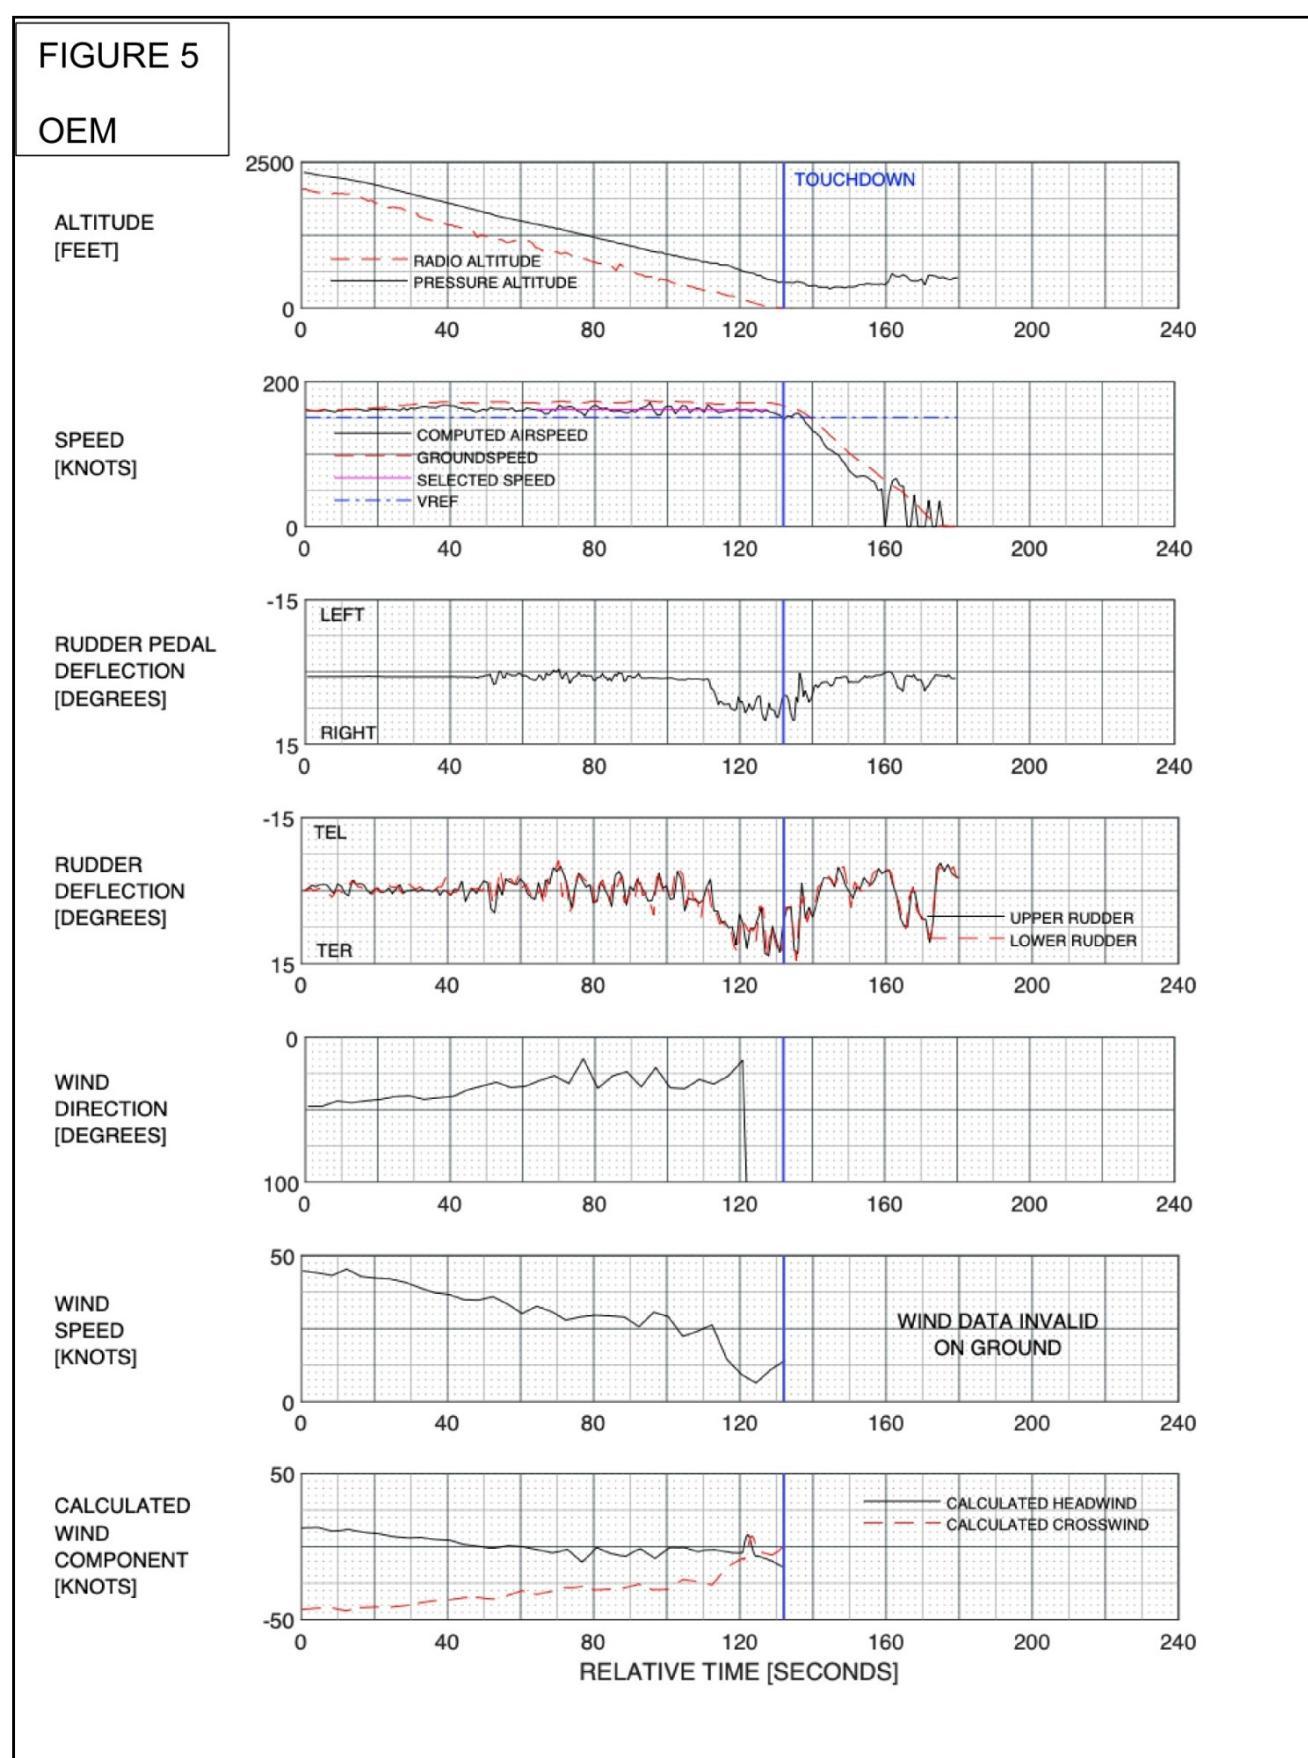
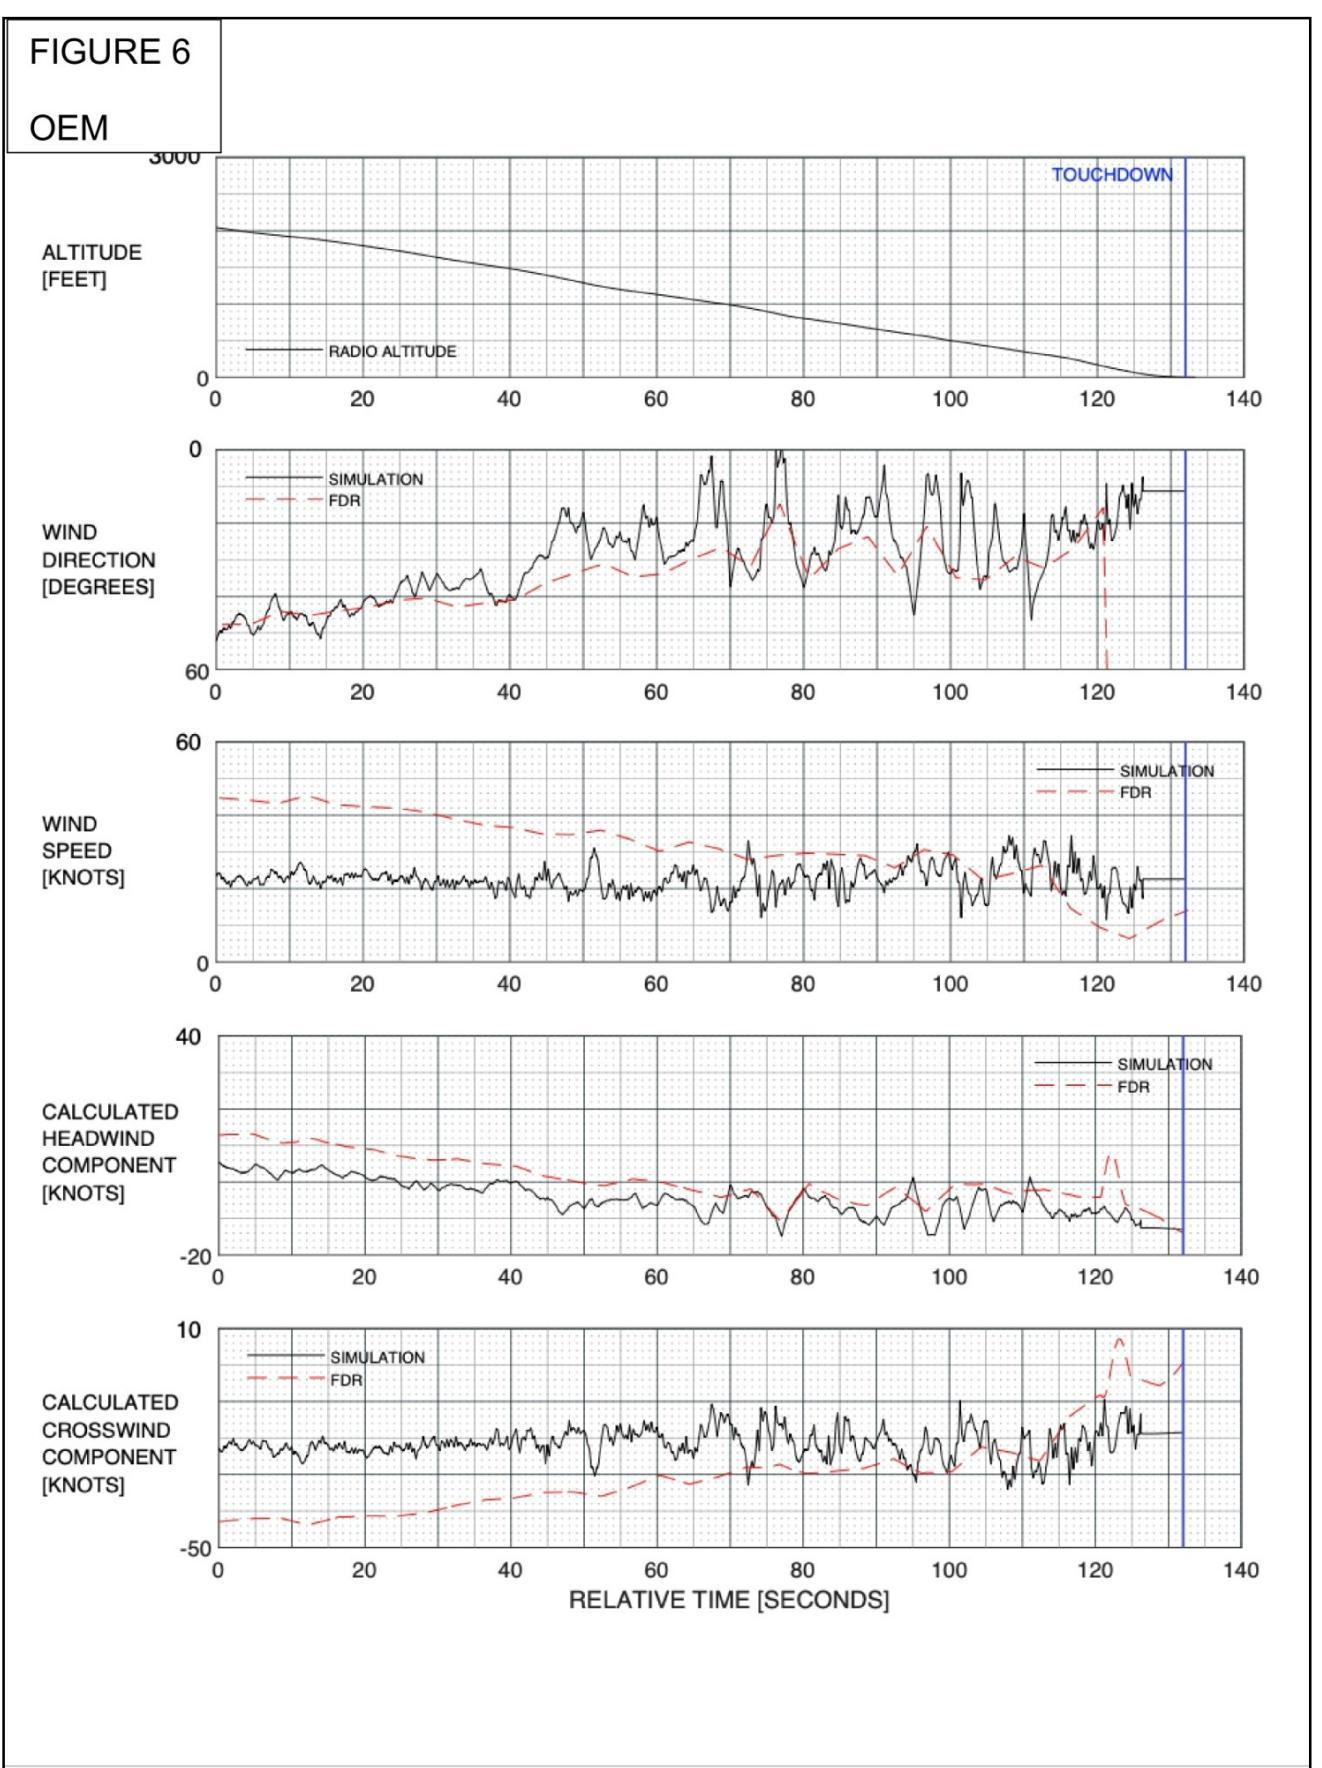
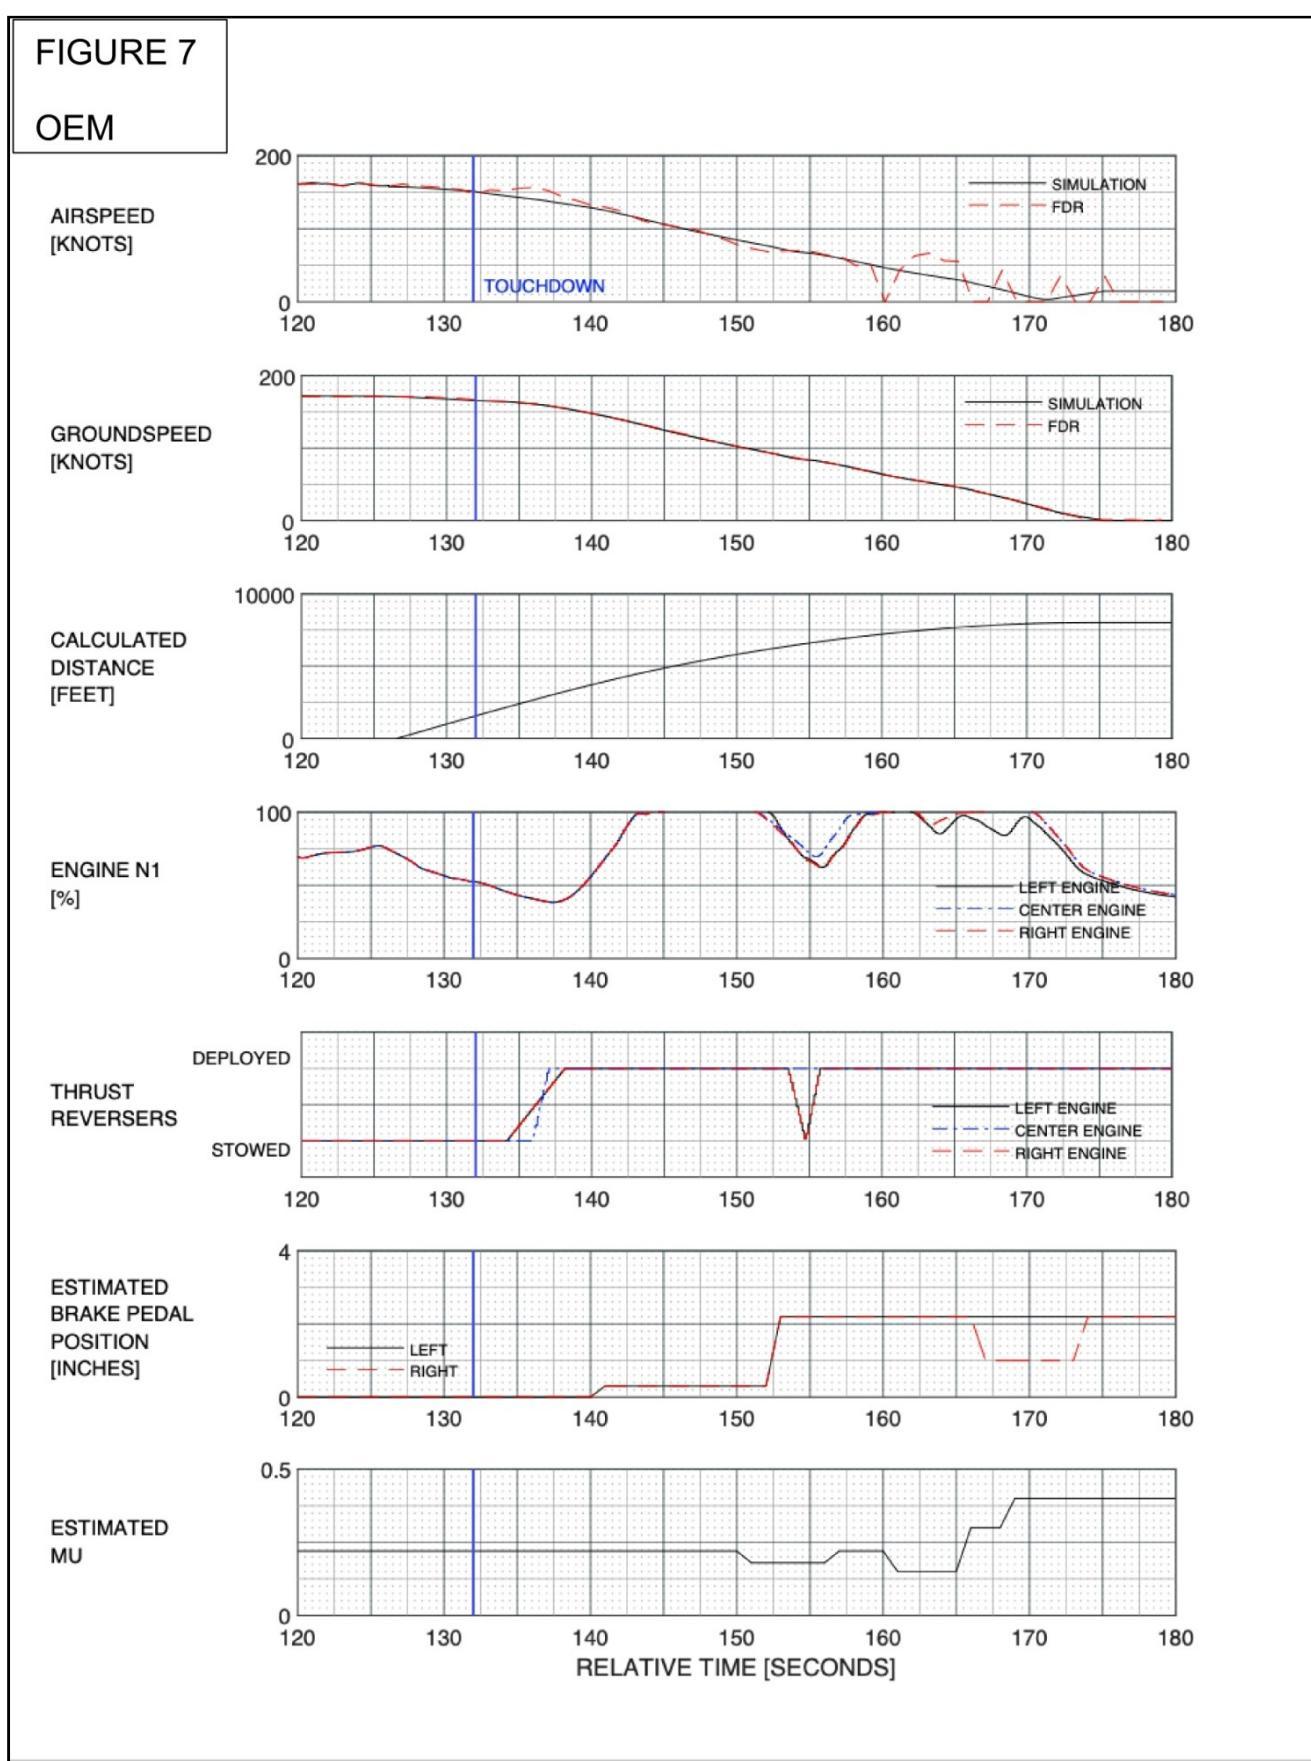
Touchdown likely occu<u>r</u>red at approximately 132 seconds, about 1,540 feet past the runway threshold of runway 14 as indicated by a slight decrease in longitudinal acceleration and an increase in normal load factor. At touchdown, normal load factor increased to approximately 1.3 g's, pitch attitude was approximately 5 degrees, bank angle was near wings-level, computed airspeed was approximately 150 knots, and ground speed was approximately 165 knots. The calculated tailwind component at touchdown, derived from the calculated wind speed was approximately 15 knots with a left crosswind component of approximately 17 knots (Figure 5).

reversers began transitioning to stow. In this segment of the landing rollout, the estimated $\mu_{airplane}$ fell from 0.22 to approximately 0.17. Three seconds later, a manual re-deployment back to full reverse thrust was initiated. This activity is characterized on Figures 1, 7, and 8. At approximately this time, manual braking is assumed to have been increased to max braking until a complete stop was achieved.

Analysis of the FDR data indicates that the approach to Runway 14 in turbulent atmosphere was stable. The airplane touched down within the touchdown zone at an acceptable closure rate of 5 fps, approximately 1,540 feet beyond the runway threshold at VREF. Following touchdown, ground spoilers and thrust reversers were deployed in full reverse thrust. However, the lack of FDR recorded braking parameters required significant assumptions to be made in the braking performance portion of the analysis. The initial portion of the landing rollout was consistent with medium auto- braking performance. As groundspeed approached 90 knots, the deceleration profile was consistent with application of maximum braking. The possibility of hydroplaning and/or degraded braking performance could not be confirmed or negated from the available data. The airplane braking coefficient $\mu_{airplane}$ representing braking capability as a function of the ratio of the deceleration force from the wheel brakes relative to the normal force acting on the wheels was in the 0.15 to 0.4 range which signifies a range from medium reported braking (RCC 3) on wet runway conditions to good braking. Performance data indicates that, using maximum braking and normal reverse thrust procedures combined with the reported wind and medium reported braking capability (RCC 3), the expected landing distance would have been 7,348 feet, giving a margin of about 750 feet on Runway 14. The higher than reported tailwind and the low runway friction in certain sections led to the airplane needing the entire length of the runway to stop. No airplane systems anomalies were noted.
