FINAL INVESTIGATION REPORT ON
SERIOUS INCIDENT TO M/S AIR INDIA LTD.
AIRBUS 321-211 AIRCRAFT
VT-PPU AT PUNE
ON 15TH FEBRUARY 2020

AIRCRAFT ACCIDENT INVESTIGATION BUREAU
MINISTRY OF CIVIL AVIATION
GOVERNMENT OF INDIA

**FINAL INVESTIGATION REPORT ON SERIOUS INCIDENT TO AIR
INDIA, AIRBUS A321 AIRCRAFT VT-PPU AT PUNE ON 15/02/2020**

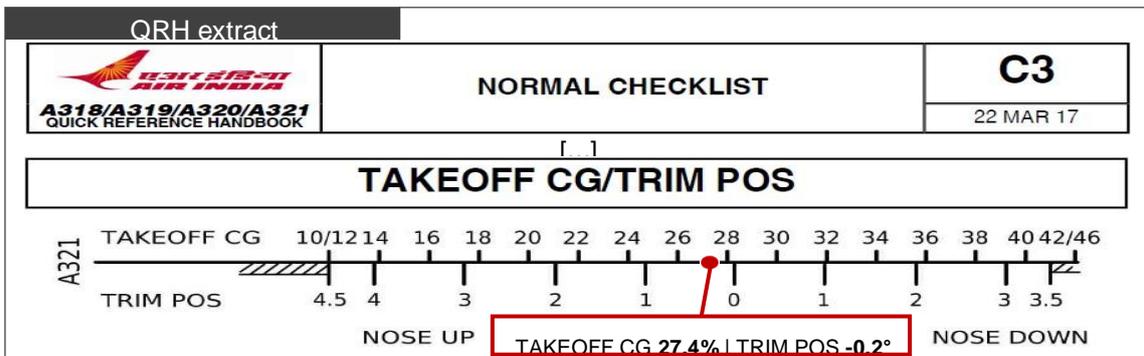
Fig 10: QRH Extract: QRH C3 Takeoff CG/Trim POS

(a) The DFDR recordings and analysis revealed that weight and CG of the aircraft were in accordance with the "Load and Trim" sheet provided by crew. Further, aircraft CG of 27.4% corresponding to a takeoff trim setting of -0.2° (nose up) by crew was in accordance with the QRH (extract as shown in Fig -10). The stabilizer trim value at take-off was thus consistent with the CG entered in MCDU.
