FOREWORD

SUMMARY

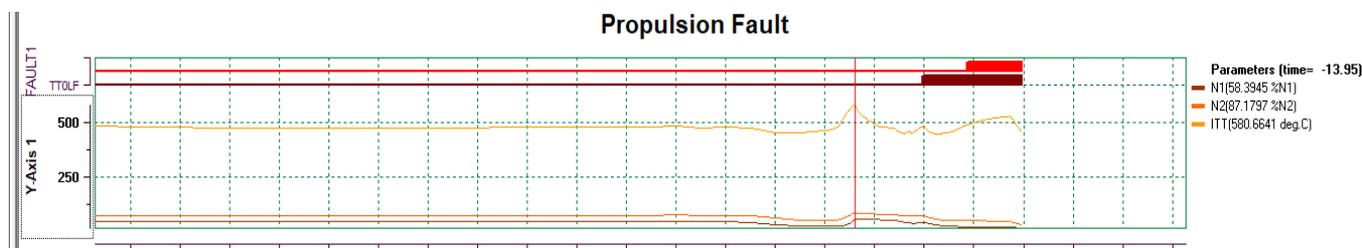
Fig 33: Plot 1

As per OEM, there was a trend monitoring carried out, and then 36.6 minutes later, two faults occurred. These two faults were a TTO inlet fault and a WOW cross-check fault.

On the following Plot 1, the TTO fault activates first as seen by the step change in the maroon line (green arrow), followed by the WOW fault (blue arrow) which is seen by the step change in the red line. The peak temperature (ITT) observed was approximately 581degC.

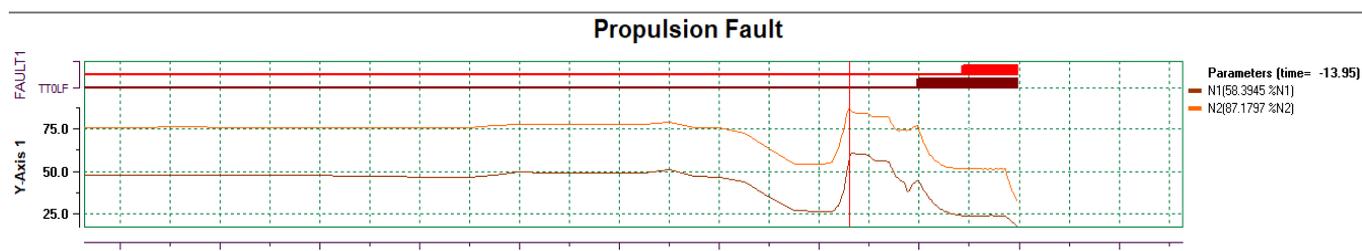
Fig 34: Plot 2

The following Plot 2 shows a closer up view of N1 and N2 where the peak N1 value and N2 value are seen to be approximately 59% and 87% respectively. These peaks occurred approximately 13s before the TTO fault appeared and 21s before the WOW fault appeared. It was reported to P&WC that during the runway excursion some foreign objects may have entered the engines inlet which, if these objects hit the inlet temperature probe causing damaged, could explain this fault. It was also reported to P&WC that the aircraft experienced landing gear damage during this event which could account for the weight on wheels cross-check fault which was observed.

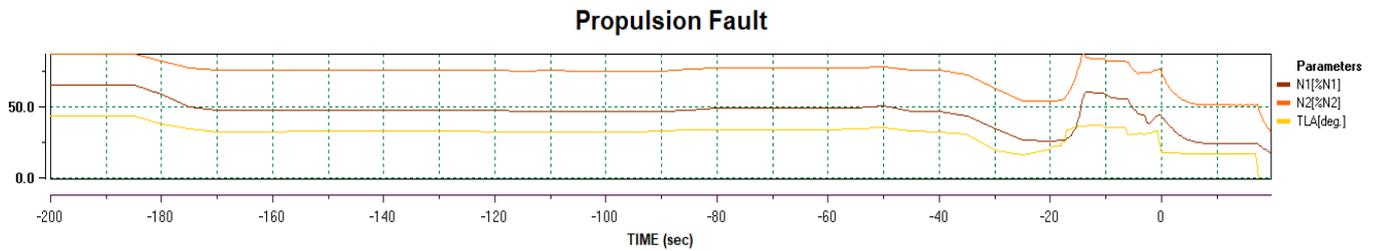
Fig 35: Plot 3

The following Plot 3 shows the two engine speeds as well as the TLA (yellow line). It shows that the engine was reacting and following the commands from the TLA. There were no speed nor temperature limit exceedences observed on this recording (Plot 3).

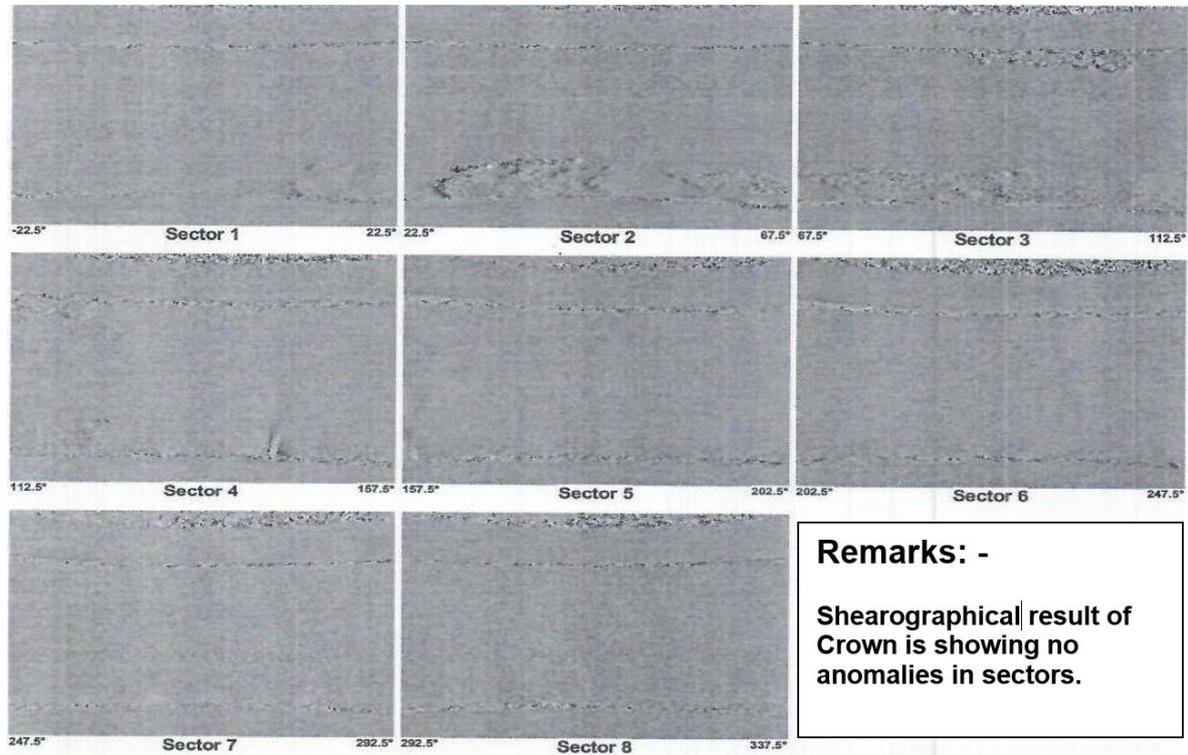
Figure 1: Crown (Tyre Sr.# 7355S236)

- 1) Testing confirmed that both MLG tyres had no anomalies
- 2) No significant difference was observed between both tyres

Shearographical Analysis results for both MLG Tyres after scanning Crown and both sidewalls except at the region of failure are shown in the figures given below:

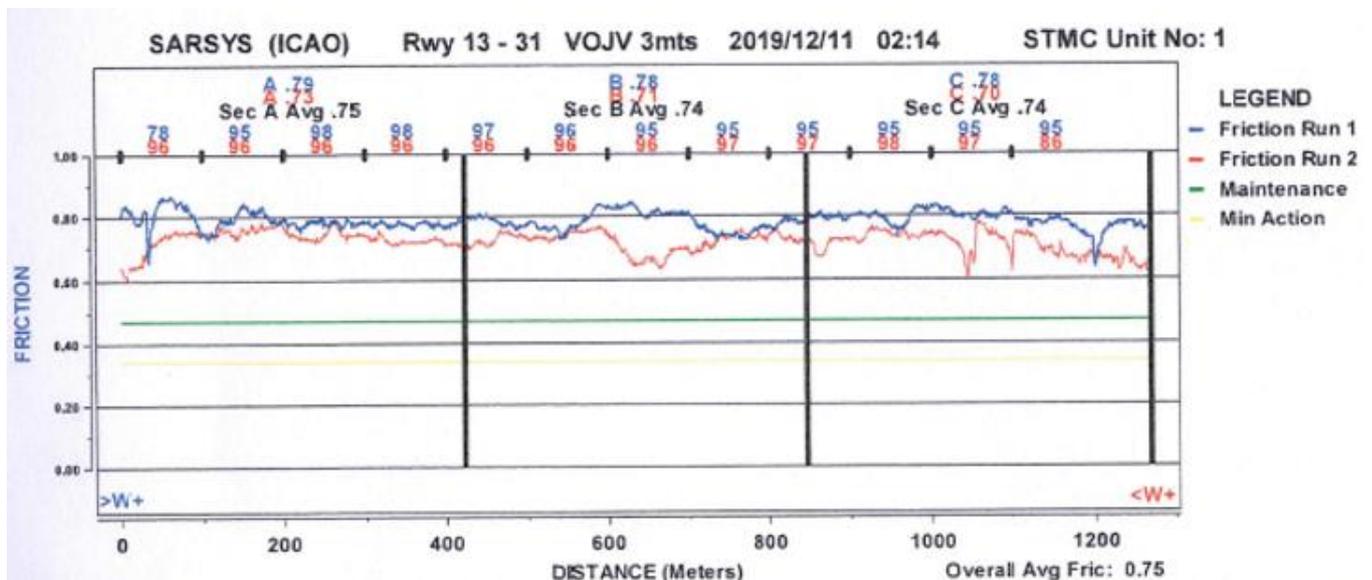
Graph 1: Friction measurement at 3 metres at 95 Kmph

- iii. At higher speeds, corresponding friction values dropped and least friction value for overall length of runway was found 0.74 μ at 95 Kmph.

Run 1	Run 2	Section Avg.
Section A	0.79	0.73	0.75
Section B	0.78	0.71	0.74
Section C	0.78	0.70	0.74

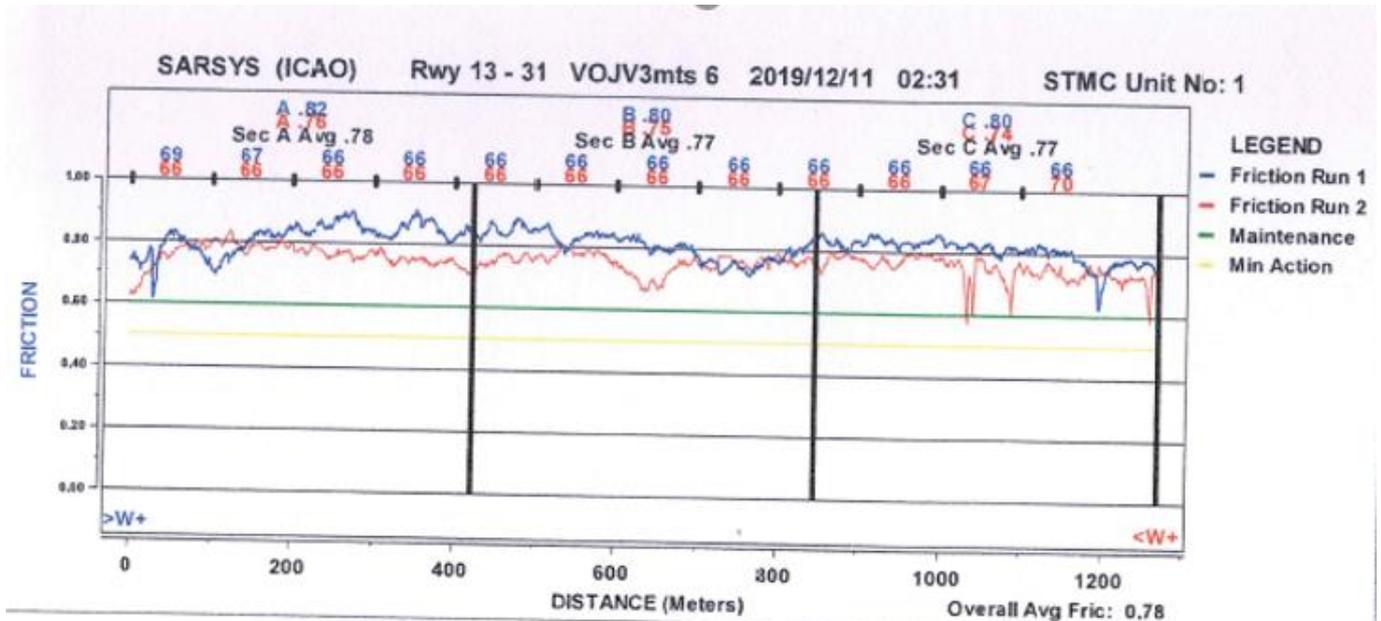
Graph 2: Friction measurement at 3 metres at 65 Km/h

Friction measurement at 3 metres (65 Km/h)				
	Run 1 Data		Run 2 Data	
Distance (m)	Avg. Speed	Avg. Friction	Avg. Speed	Avg. Friction
000-100	69	0.77	66	0.74
100-200	67	0.79	66	0.79
200-300	66	0.86	66	0.77
300-400	66	0.85	66	0.75
400-500	66	0.85	66	0.75
500-600	66	0.83	66	0.78
600-700	66	0.81	66	0.72
700-800	66	0.75	66	0.76
800-900	66	0.82	66	0.77
900-1000	66	0.84	66	0.78
1000-1100	66	0.82	67	0.74
1100-1200	66	0.79	70	0.64
Average	66	0.81	66	0.75
Overall Friction Average: 0.78

Section Friction Averages			
	Run 1	Run 2	Section Avg.
Section A	0.82	0.76	0.78
Section B	0.80	0.75	0.77
Section C	0.80	0.74	0.77

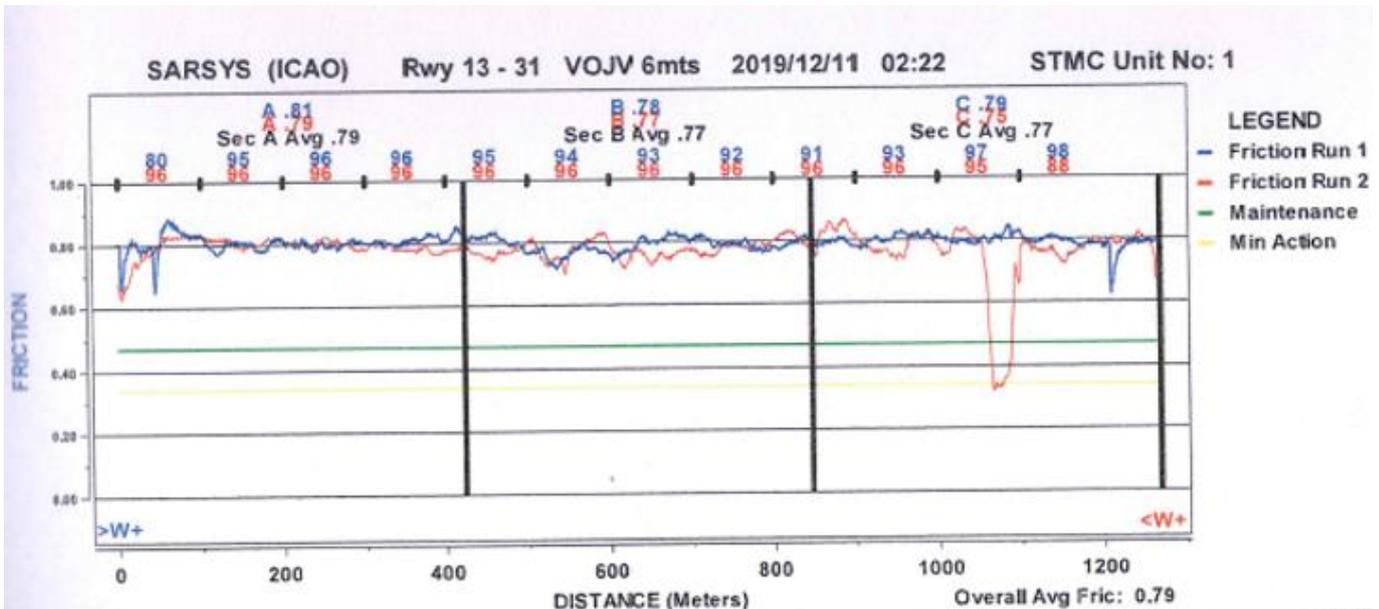
Graph 3: Friction measurement at 6 metres at 95 kmph

Friction measurement at 6 metres (95 Kmph)				
	Run 1 Data		Run 2 Data	
Distance (m)	Avg. Speed	Avg. Friction	Avg. Speed	Avg. Friction
000-100	80	0.81	96	0.78
100-200	95	0.80	96	0.81
200-300	96	0.80	96	0.80
300-400	96	0.81	96	0.79
400-500	95	0.82	96	0.77
500-600	94	0.77	96	0.78
600-700	93	0.80	96	0.76

Overall Friction Average: **0.79**

Section Friction Averages			
	Run 1	Run 2	Section Avg.
Section A	0.81	0.79	0.79
Section B	0.78	0.77	0.77
Section C	0.79	0.75	0.77

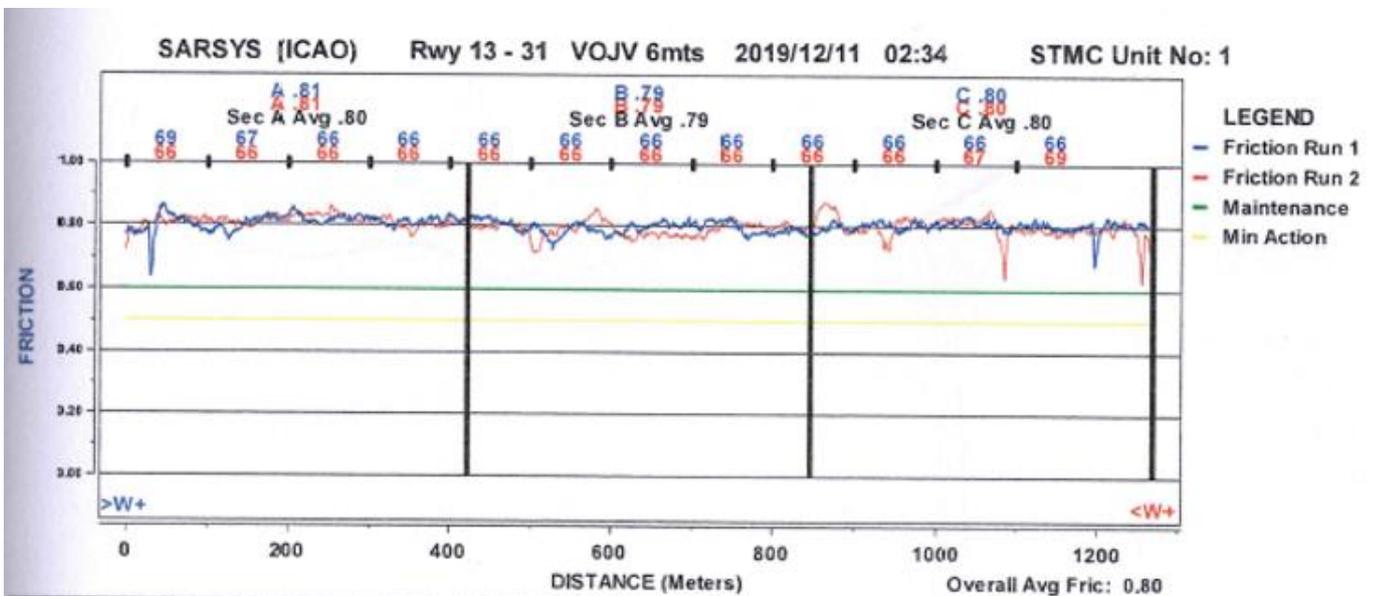
Graph 4: Friction measurement at 6 meters at 65 Km/h

Run 1	Run 2	Section Avg.
Section A	0.81	0.81	0.80
Section B	0.79	0.79	0.79
Section C	0.80	0.80	0.80

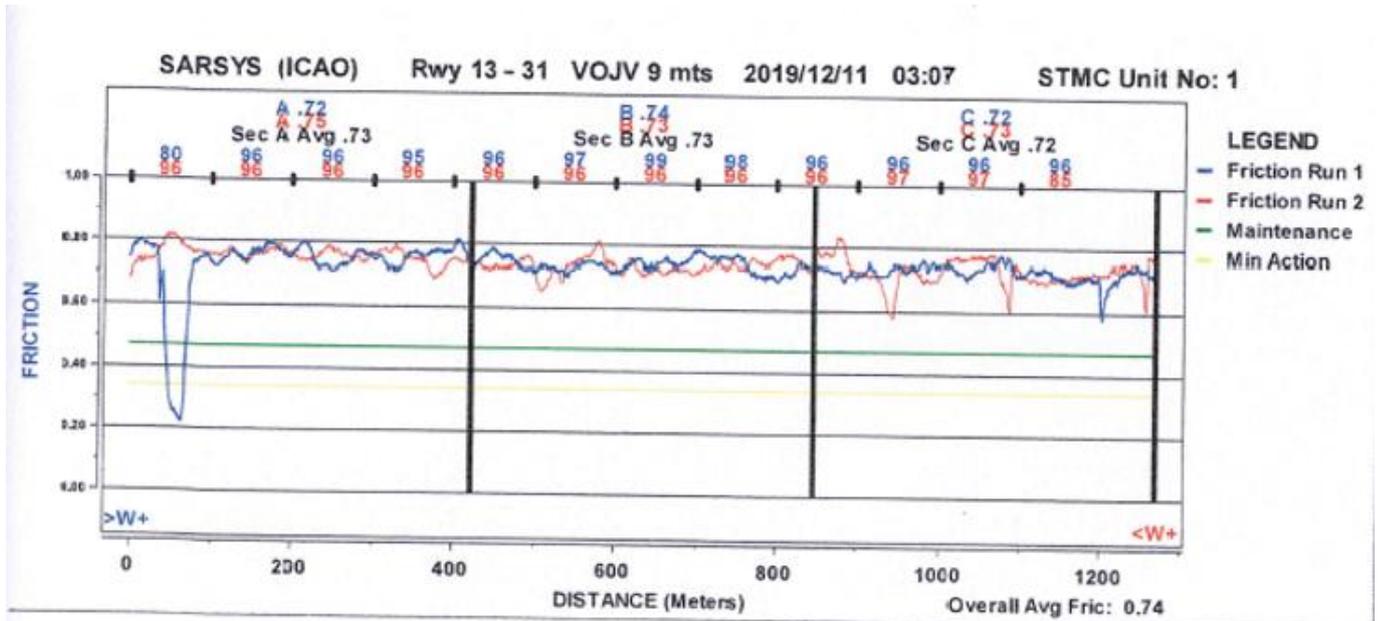
Graph 5: Friction measurement at 9 meters at 95 Km/h

Friction measurement at 9 metres (95 Km/h)				
	Run 1 Data		Run 2 Data	
Distance (m)	Avg. Speed	Avg. Friction	Avg. Speed	Avg. Friction
000-100	80	0.62	96	0.77
100-200	96	0.76	96	0.76
200-300	96	0.75	96	0.76
300-400	95	0.75	96	0.75
400-500	96	0.76	96	0.74
500-600	97	0.73	96	0.73
600-700	99	0.74	96	0.72
700-800	98	0.75	96	0.74
800-900	96	0.73	96	0.77
900-1000	96	0.73	97	0.70
1000-1100	96	0.74	97	0.75
1100-1200	96	0.72	85	0.71
Average	95	0.73	95	0.74
Overall Friction Average: 0.74
