FINAL INVESTIGATION REPORT ON ACCIDENT TO
DIRECTORATE OF AVIATION,
GOVERNMENT OF MADHYA PRADESH (DoA, GoMP)
SKA B200GT AIRCRAFT VT-MPQ
AT GWALIOR AIRPORT ON 06.05.2021

INVESTIGATION TEAM VT-MPQ

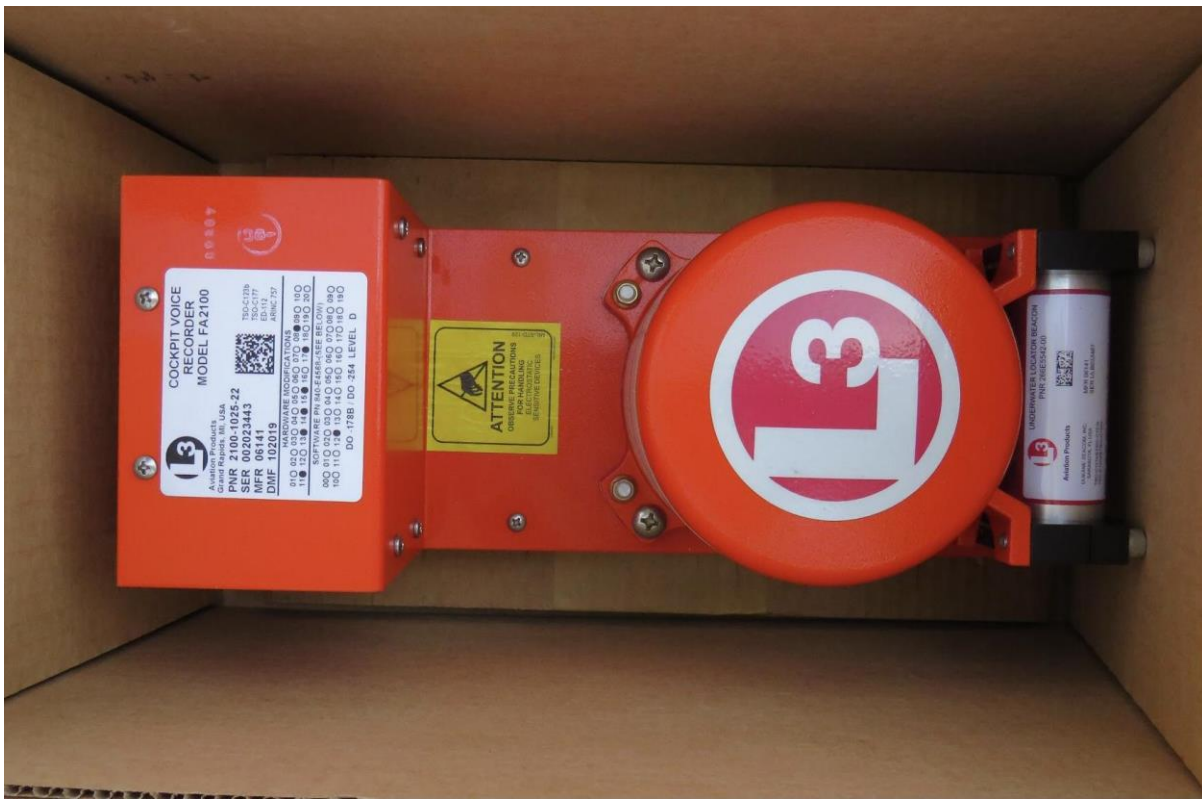
Fig 14: Photograph of actual recovered CVR

The CVR was removed from the accident site under the supervision of the DGCA officials by the DoA, GoMP Aviation engineering team and handed over to the DGCA officials. No damage was observed to the CVR. The unit was later handed over to the AAIB investigation team, by the DGCA Air Safety Directorate (WR). The CVR was downloaded at the DGCA CVR lab in New Delhi.

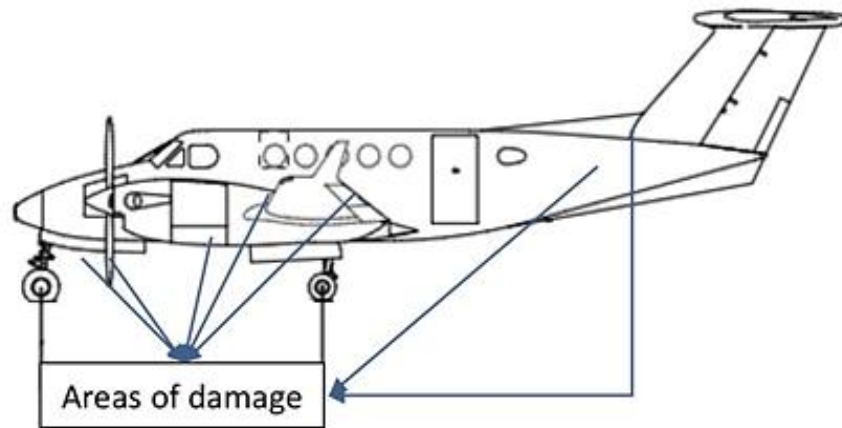
Figure 17

General Damage Locations on the King Air Model B200GT

The aircraft sustained significant multiple impact damage to the Nose, all landing gears, forward fuselage skin, both wings, both power plant and its cowling and nacelle structures, both flaps, dorsal fin, vertical stabilizer, rudder and empennage.

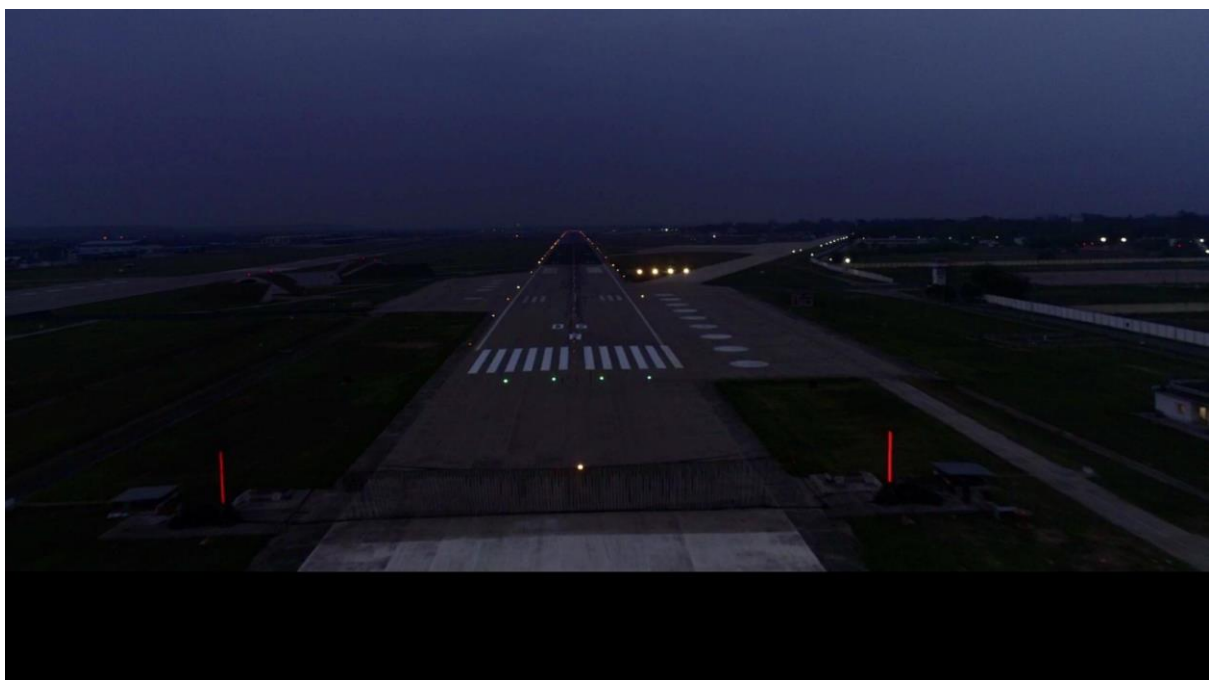
- The investigation team observed that with the "White LED" lights on the AB poles at the edge of RWY 06R along with the background lighting of the hangars and the lighting of the perimeter road, it would have been difficult for the DATCO to realise whether the AB was in a raised condition or not.

Figure 29: Indicative Arrester Barrier with Red Lights on the poles.

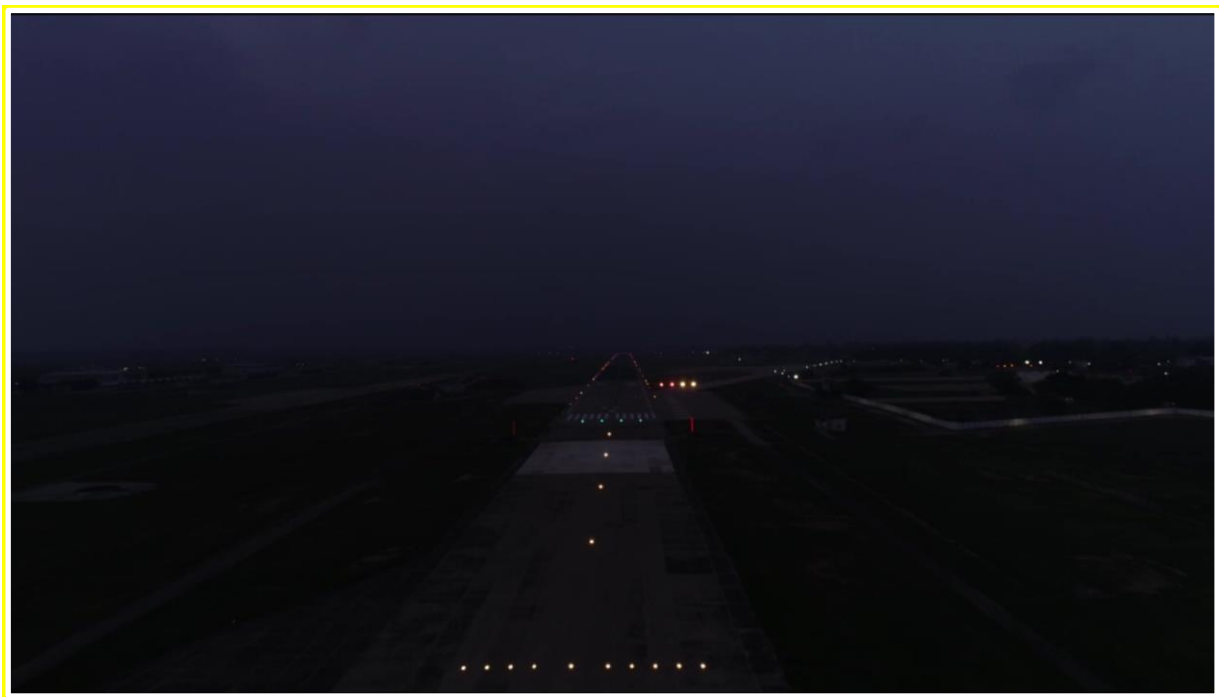
- **Visual Illusion: Black Hole Approach Effect** – For the Approach into Gwalior for RWY 06R, the PIC (PF) could have been possibly affected by the visual illusion of a “Black Hole Approach Effect”, which is applicable for night- time visual segment of the approach. However, to mitigate the risk of the Pilot Flying getting affected by the said visual illusion, PAPI (Landing aid) was made available. However, the PIC (Pilot Flying) in his interview stated that he disregarded the PAPI indications and went below the visual PAPI profile knowingly.

Figure 34: PAPI Indications and Displaced Threshold lights

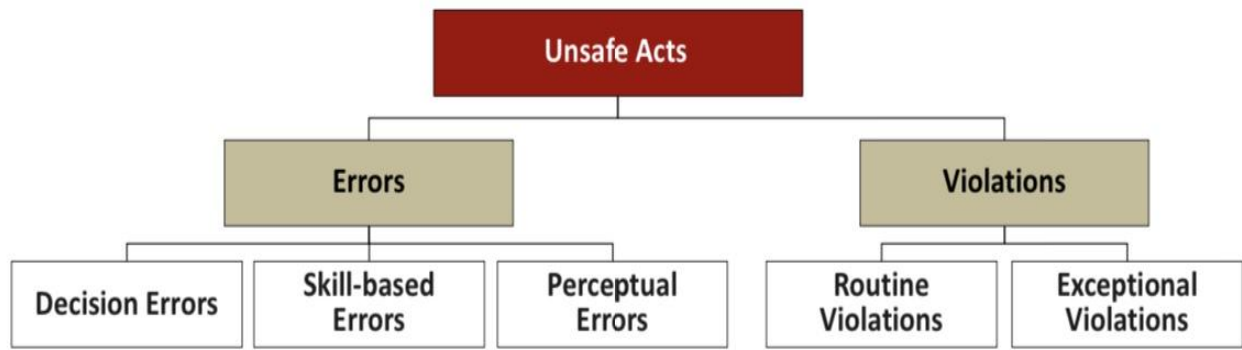
ERRORS			
	PIC	CO-PILOT	DATCO
DECISION ERROR	Flying a Visual Approach at Night while in violation of Company SOP Hurry up Syndrome Knowingly deviating from the Visual Flight Path (PAPI) Pointing to a Tower at a low height above ground / Deviating from the sterile cockpit requirement on final approach.	NIL	NIL
SKILL-BASED ERROR	NIL	NIL	Non-Adherence to Change of Runway Checklist
PERCEPTUAL ERROR	NIL	NIL	NIL

VIOLATIONS			
	PIC	CO-PILOT	DATCO
ROUTINE VIOLATIONS	Non-Compliance of SOP	Non-Compliance of SOP	NIL
EXCEPTIONAL VIOLATIONS	Carriage of Cargo in the Passenger cabin Distraction at a Low height above ground during final Approach	Distraction at a Low height above ground during final Approach	Non-Adherence to SOPs (Change of Runway Checklist not carried out)

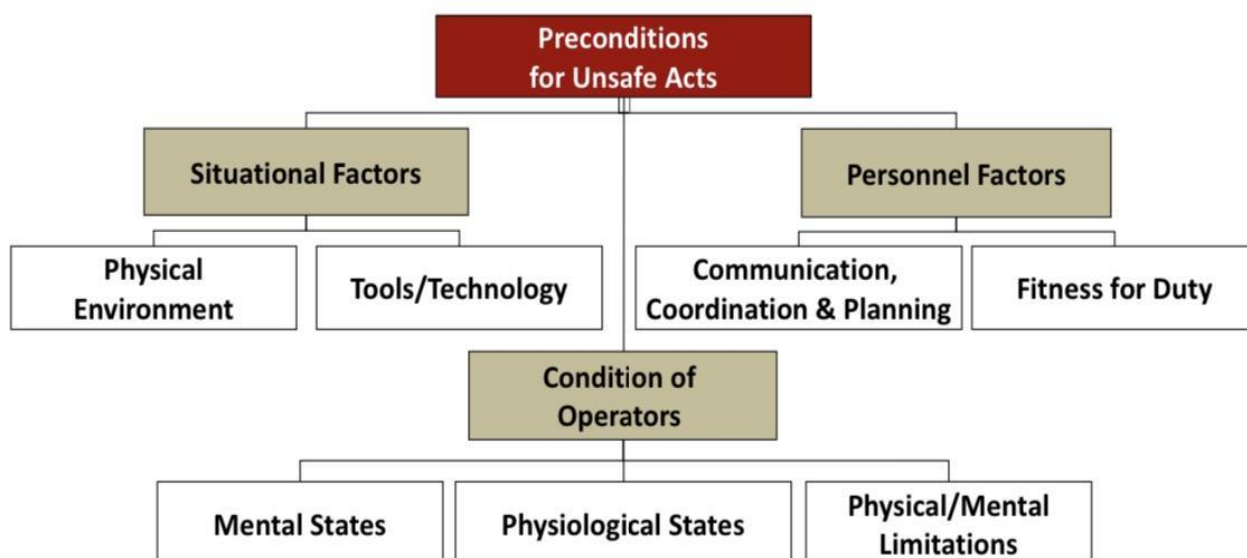
SITUATIONAL FACTORS			
	PIC	CO-PILOT	DATCO
PHYSICAL ENVIRONMENT	Night Flying	Night Flying	<p>Night time White LED lights on the Arrestor Barrier poles merging with the background lights.</p> <p>ATC design causing the vision of the Controller getting affected due to the pillars of the ATC building affecting the critical vision field of the "Approach of Runway 06R/24L"</p>
TOOLS/ TECHNOLOGY	<p>Not reporting and putting 'Off' ITAWS cautions and warning</p> <p>Not reporting ITAWS related technical issues in the "Tech Log"</p>	<p>Agreeing to switch the ITAWS warnings/cautions 'Off' on 'Command' of the PIC</p>	<p>Low intensity lighting inside the ATC at night time during (Approach for Landing, Take off and Landing.</p> <p>Arrestor Barrier Position Light unserviceable</p> <p>Arrestor Barrier Panel integral / background light unserviceable</p>

PERSONNEL FACTORS			
	PIC	CO-PILOT	DATCO
COMMUNICATION, COORDINATION AND PLANNING	Authoritarian (Subtle) type of Leadership	Non-Assertive behaviour	ATCO did not notify about the change of Runway from 24L to 06R to all concerned. Airman on Duty and Airman on Watch did not alert the DATCO of non-compliance to 'Change of Runway Checklist'
FITNESS FOR DUTY	Fit for Duty	Fit for Duty	Poor Management of Rest period by DATCO at a personal level.

CONDITION OF THE OPERATOR			
	PIC	CO-PILOT	DATCO
MENTAL STATES	Nil	Nil	Improper rest management by the DATCO leading to likelihood of Fatigue
PHYSIOLOGICAL STATES	Nil	Nil	Nil
PHYSICAL / MENTAL LIMITATIONS	Nil	Nil	Nil
