FINAL INVESTIGATION REPORT ON ACCIDENT TO
DIRECTORATE OF AVIATION,
GOVERNMENT OF MADHYA PRADESH (DoA, GoMP)
SKA B200GT AIRCRAFT VT-MPQ
AT GWALIOR AIRPORT ON 06.05.2021

INVESTIGATION TEAM VT-MPQ

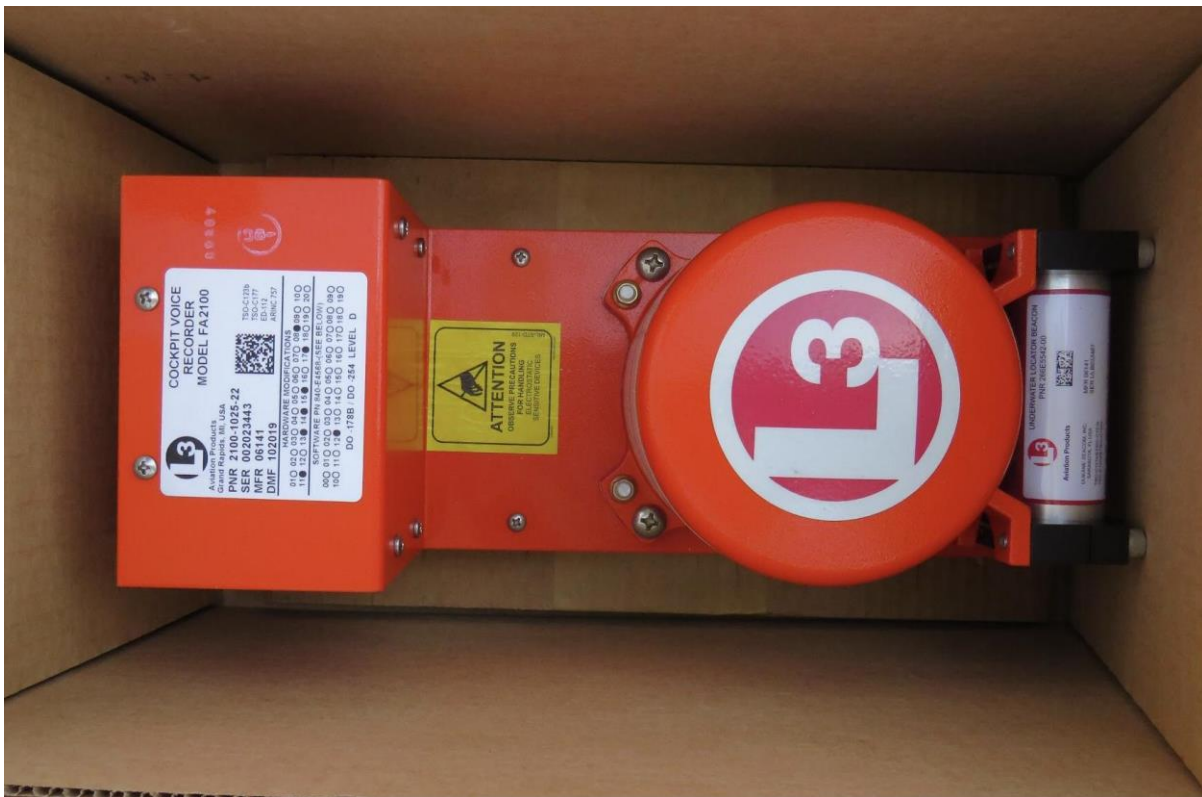
Fig 14: Photograph of actual recovered CVR

The CVR was removed from the accident site under the supervision of the DGCA officials by the DoA, GoMP Aviation engineering team and handed over to the DGCA officials. No damage was observed to the CVR. The unit was later handed over to the AAIB investigation team, by the DGCA Air Safety Directorate (WR). The CVR was downloaded at the DGCA CVR lab in New Delhi.

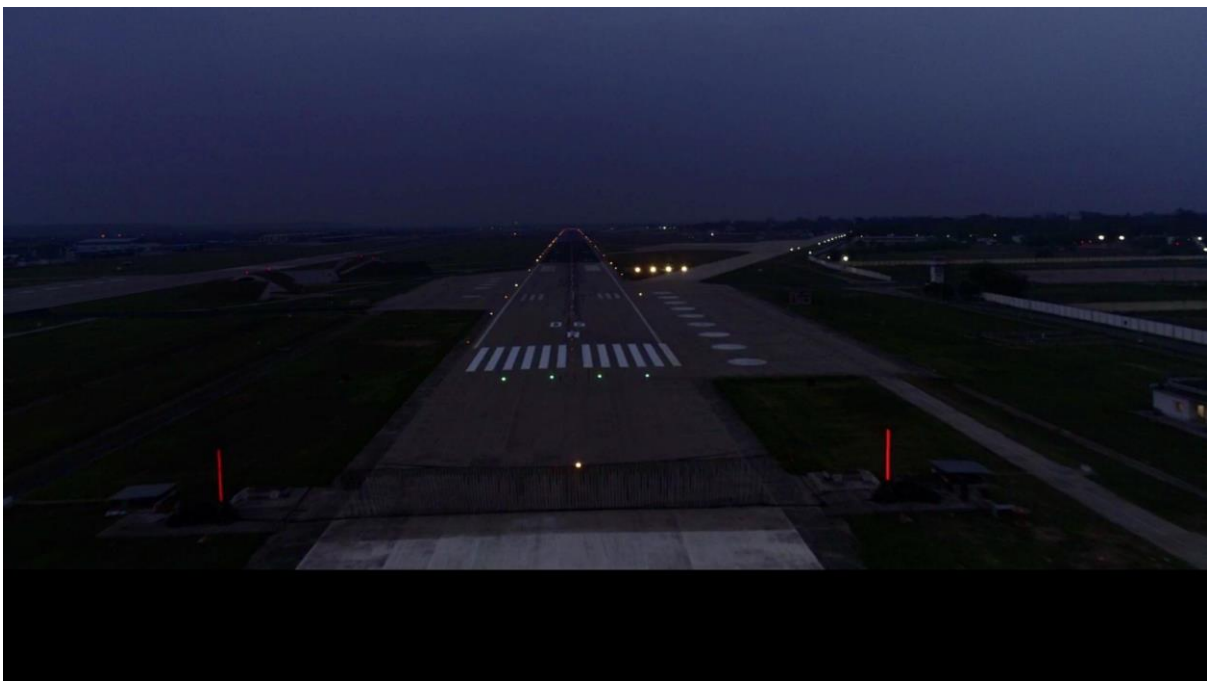
Figure 29: Indicative Arrester Barrier with Red Lights on the poles.

- The investigation team observed that with the "White LED" lights on the AB poles at the edge of RWY 06R along with the background lighting of the hangars and the lighting of the perimeter road, it would have been difficult for the DATCO to realise whether the AB was in a raised condition or not.

2.1.1.4 The Arrester Barrier remaining in the Raised Position

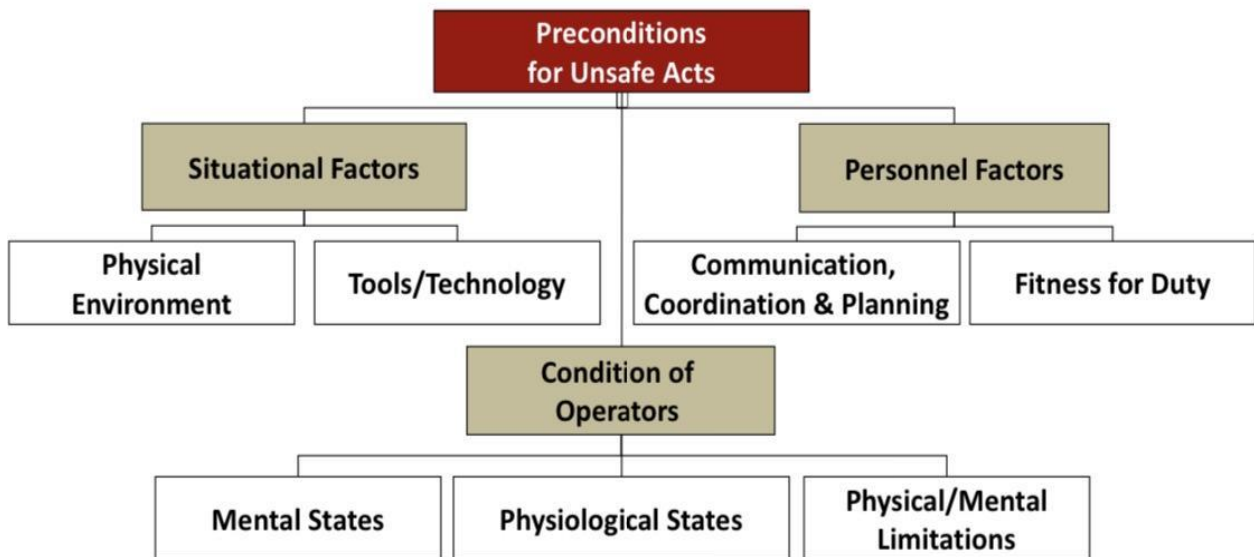
SITUATIONAL FACTORS			
	PIC	CO-PILOT	DATCO
PHYSICAL ENVIRONMENT	Night Flying	Night Flying	<p>Night time White LED lights on the Arrestor Barrier poles merging with the background lights.</p> <p>ATC design causing the vision of the Controller getting affected due to the pillars of the ATC building affecting the critical vision field of the "Approach of Runway 06R/24L"</p>
TOOLS/ TECHNOLOGY	<p>Not reporting and putting 'Off' ITAWS cautions and warning</p> <p>Not reporting ITAWS related technical issues in the "Tech Log"</p>	<p>Agreeing to switch the ITAWS warnings/cautions 'Off' on 'Command' of the PIC</p>	<p>Low intensity lighting inside the ATC at night time during (Approach for Landing, Take off and Landing.</p> <p>Arrestor Barrier Position Light unserviceable</p> <p>Arrestor Barrier Panel integral / background light unserviceable</p>

PERSONNEL FACTORS			
	PIC	CO-PILOT	DATCO
COMMUNICATION, COORDINATION AND PLANNING	Authoritarian (Subtle) type of Leadership	Non-Assertive behaviour	ATCO did not notify about the change of Runway from 24L to 06R to all concerned. Airman on Duty and Airman on Watch did not alert the DATCO of non-compliance to 'Change of Runway Checklist'
FITNESS FOR DUTY	Fit for Duty	Fit for Duty	Poor Management of Rest period by DATCO at a personal level.

CONDITION OF THE OPERATOR			
	PIC	CO-PILOT	DATCO
MENTAL STATES	Nil	Nil	Improper rest management by the DATCO leading to likelihood of Fatigue
PHYSIOLOGICAL STATES	Nil	Nil	Nil
PHYSICAL / MENTAL LIMITATIONS	Nil	Nil	Nil
