**FINAL INVESTIGATION REPORT ON ACCIDENT INVOLVING
TECNAM P2008JC AIRCRAFT, VT-BRP
OPERATED BY M/S NMIMS, ACADEMY OF AVIATION
ON 16 JULY 2021 NEAR VILLAGE VARDI, SHIRPUR**

AIRCRAFT ACCIDENT INVESTIGATION BUREAU

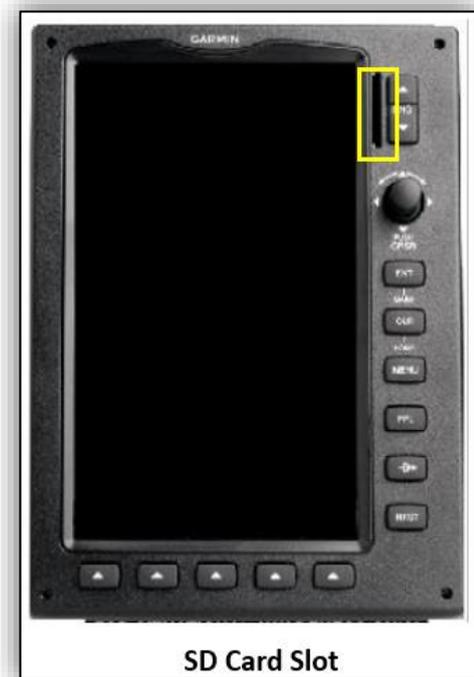
Fig 4: Garmin G3X system

The aircraft is equipped with Garmin G3X system. On Garmin G3X system, two SD card slots are provided on each display unit for capturing of aircraft parameters. The location of these slots are depicted in Figure 4.

The G3X Touch uses an SD Card for software updates, database updates, Map Source data, checklist files, Chart view, Flight Data Logging, exporting Track Logs/User Waypoints, importing/exporting Flight Plans, and user-downloaded vehicles. Garmin Guide also contains the guidelines for installation and removal of SD cards from the slots. After reaching the crash site, the SD cards installed in both the units were removed and it was found that only dummy cards were installed in SD card slot on both display units.

Later, during the course of investigation, Operator's Engineering team informed that aircraft was without SD Card/ Memory Card, when it was received from OEM. As per the operator, at the time of aircraft delivery, a loader card (Software update Card) which is used for aircraft's software updation, was initially supplied by the OEM. Consequent upon induction into the fleet, loader card was never used for updating the software and thereon, the aircraft was

flying with the pre-installed software till it met with the accident. The Engineering Head of the organization stated that their Engineering team was unaware about the utility of these slots, hence, SD Cards were never installed on the device.

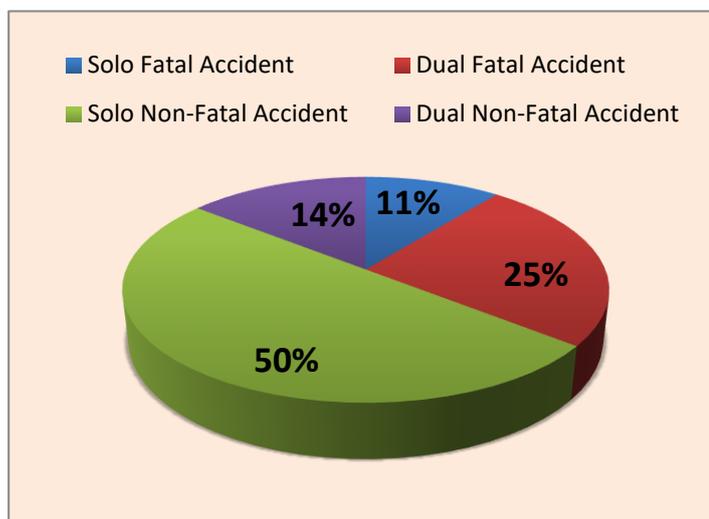
Fig 11: Fatal/Non-Fatal accidents involving Solo/Dual flying

The analysis of the data further revealed that out of the total 28 accidents, about 61% accidents occurred during solo flying training exercise and 39% accidents occurred during dual flying training exercise. However, while analyzing the data of fatal accidents, it was observed that 70% of the fatal accidents occurred during dual flying exercise i.e., while student pilots were flying under the supervision of an instructor on board.

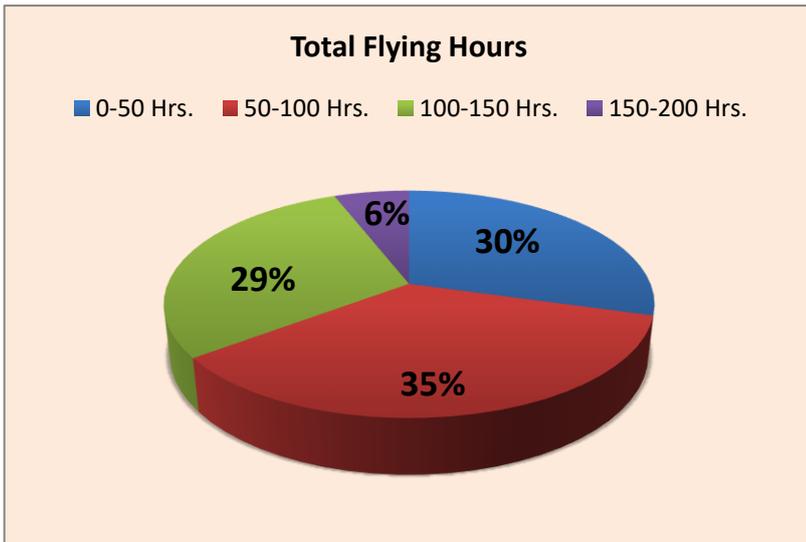
Fig 12: Total flying hours experience of student pilots involved in Solo flying accidents.

Out of the total 28 accidents, 61% of accidents were during solo flying training. Most of the solo flying accidents were non-fatal in nature and only 11% of solo flying accidents were fatal. The analysis of flying experience of student pilots involved in solo flying accidents revealed that student pilots with flying experience between 50-150 hrs were more prone to accidents (64%) than other student pilots having lesser flying hours experience (0 to 50 hrs) (30%).

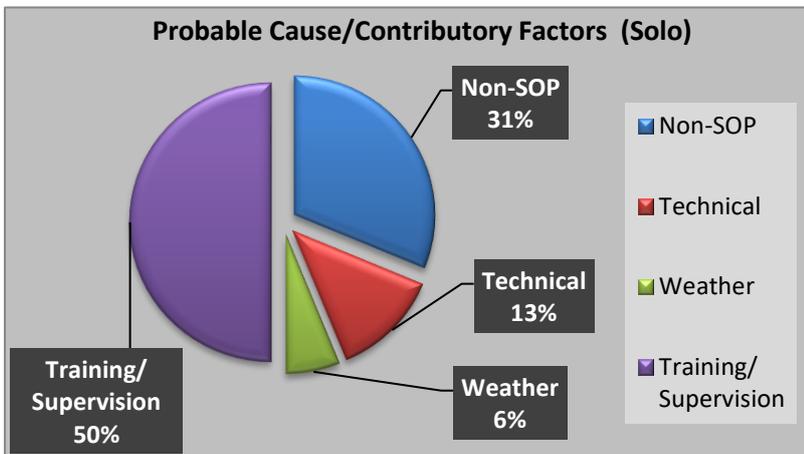
Fig 13: Probable Cause/Contributory Factors of Solo flying training exercise accidents

Probable cause/contributory factor(s) of these accidents were analyzed for both involving dual flying exercise and solo flying exercise separately to understand the nature of these accidents. It was observed that for solo flying training exercise, 50% of the accidents occurred due to lack of training/ supervision (Refer Fig. 13). However, for dual flying training exercise

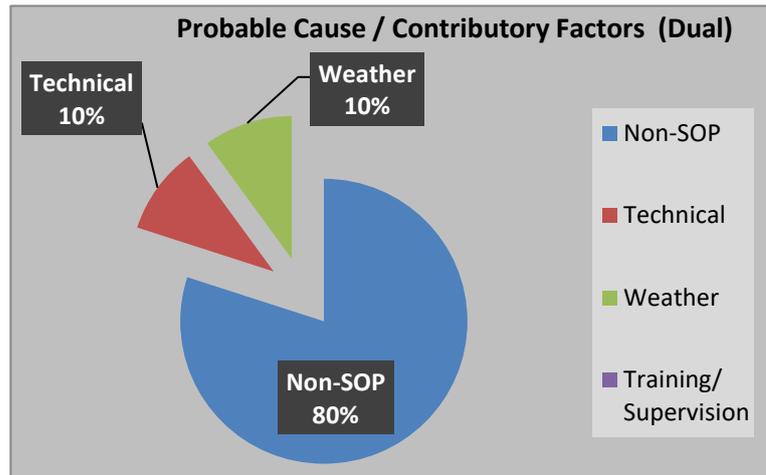
Fig 14: Probable Cause/Contributory Factors of Dual flying training exercise accidents

80% of the accidents occurred due to non-adherence to SOP (Refer Fig. 14).

The investigation team further analyzed the probable cause/contributory factors of fatal accidents involving dual flying training exercise which revealed that all these accidents occurred due to non-adherence of SOP, wherein the aircraft was involved in unauthorized activities such as low flying, deviating from authorized flight path, acrobatic manoeuvres, carrying out flying training in low visibility below VMC, not performing the correct pattern for landing/take-off, etc. Most of these accidents occurred in an uncontrolled airfield/region.
