**FINAL REPORT ON ACCIDENT INVOLVING BOEING**  
**737-800 AIRCRAFT VT-GHE OPERATED BY M/s AIR**  
**INDIA EXPRESS AT VIJAYAWADA AIRPORT ON**  
**20TH FEB 2021.**

**FINAL REPORT ON ACCIDENT INVOLVING BOEING 737-800 AIRCRAFT VT-GHE OPERATED BY M/S AIR INDIA EXPRESS AT VIJAYAWADA AIRPORT ON 20TH FEB 2021.**

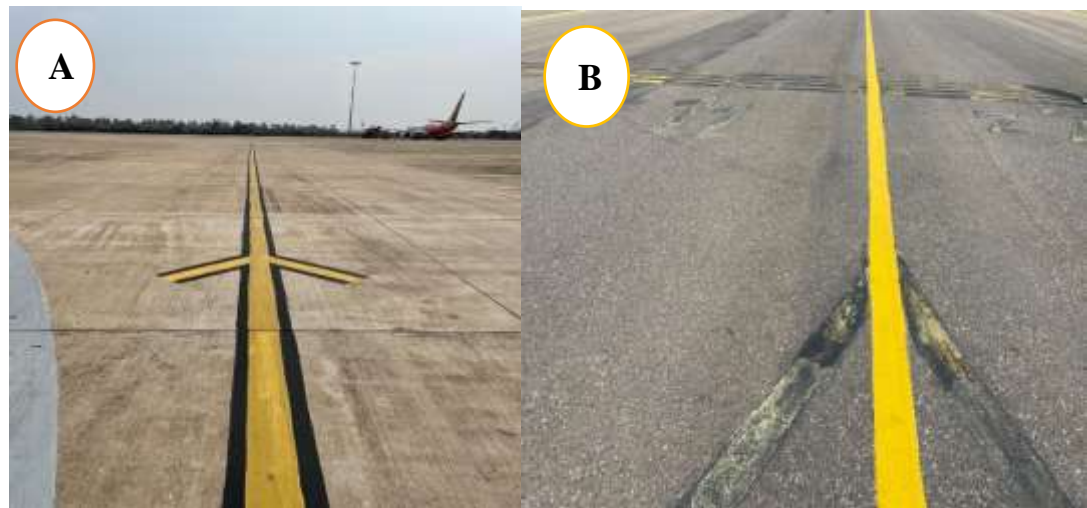
At Airport, markings are done as per International Standards. Yellow color center line markings (yellow covered with black strip on either side) are used at apron to guide the crew of the aircraft. It helps the pilot in maneuvering the aircraft like, how to take turn, where to stop etc. An arrow is also marked in yellow color to indicate the direction of movement.

**FIGURE (A) SHOWS MARKING AT APRON**

**(B) MARKING AT TAXIWAY A**

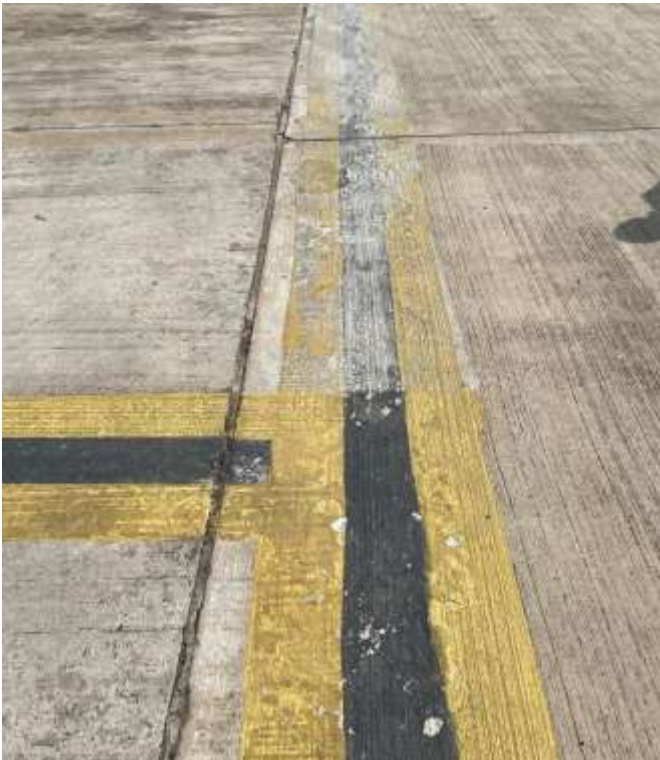
Shoulder edge markings are in the form of yellow strips (black line covered with yellow on either side), exact reverse of taxiway markings.

**FIGURE: SHOWING SHOULDER EDGE MARKING AT VIJAYAWADA AIRPORT**

As per ICAO DOC 9157 (Aerodrome Design Manual), if any portion of marking needs to be erased on tarmac, it shall be completely erased by applying paint of color matching with the tarmac or grey color, so that it is not visible. At Vijayawada Airport, Taxiway marking were found faded and were not as per standards laid down in DOC 9157. At few places, taxiway marking were erased permanently but they were not in the color matching the tarmac. They were in white color paint. However, the markings erased were visible. It might create doubt in mind of the Crew.

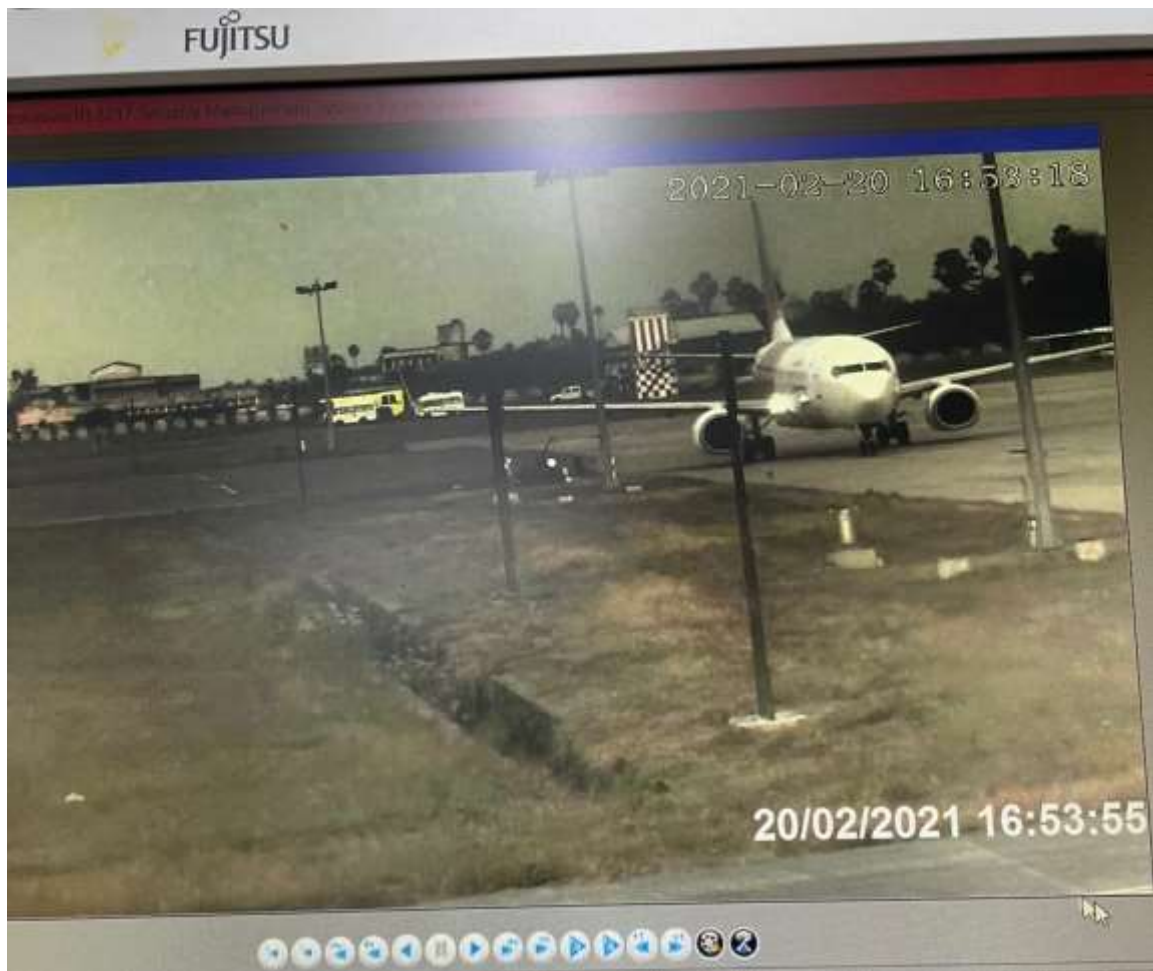
Aircraft continued taxi till the aircraft hit the flood light mast installed at edge of Apron, and crew heard a THUD sound. Immediately, at 11:22:52 UTC, crew gave a call to ATC controller. At that time the ATC Controller was busy in giving take off clearance to one of the departing aircraft on Runway 08. At 11:23:20 UTC, Tower replied back to flight crew, to which PF said *"WE ARE ON WRONG TAXIWAY I THINK WE HAVE HIT THE ONE OF THE TAXILIGHTS WE WANT TO HOLD THE PRESENT POSITION"*.

**FIGURE: SCREEN SHOT OF CCTV CAMERA INSTALLED NEAR TAXIWAY B**
