Final Investigation Report
on
Accident to Interglobe Aviation Ltd.
Aircraft ATR 72-212A (600 version), VT-IYM
Enroute Trichirapalli, Tamilnadu to Bengaluru, Karnataka
on 04 Sep 2021

Aircraft and Accident details of Interglobe Aviation Aircraft VT-IYM on 04 September 2021			
1.	Aircraft	Type	ATR 72-212A (600 version), MSN1512
		Nationality	Indian
		Registration	VT-IYM
2.	Owner	M/S Truenoord Yamuna Limited	
3.	Operator	M/S InterGlobe Aviation Limited	
4.	Country of Manufacture	France and Italy	
5.	Pilot	ATPL and CPL	
6.	No. of Persons on board	52 passengers+02 Flight crew+02Cabin crew	
7.	Date & Time of Accident	04 Sept 2021	
8.	Place of Accident	During Cruise	
9.	Co-ordinates of Accident Site, AMSL	N11 44.504'N/78 18.590 E	
10.	Last point of Departure	Tiruchirapalli, Tamil Nadu, India	
11.	Intended landing place	Bangalore, Karnataka, India	
12.	Type of Operation	Scheduled Operation	
13.	Phase of operation	Cruise	
14.	Type of Occurrence	TURBULENCE	
15.	Extent of Injuries	Nil

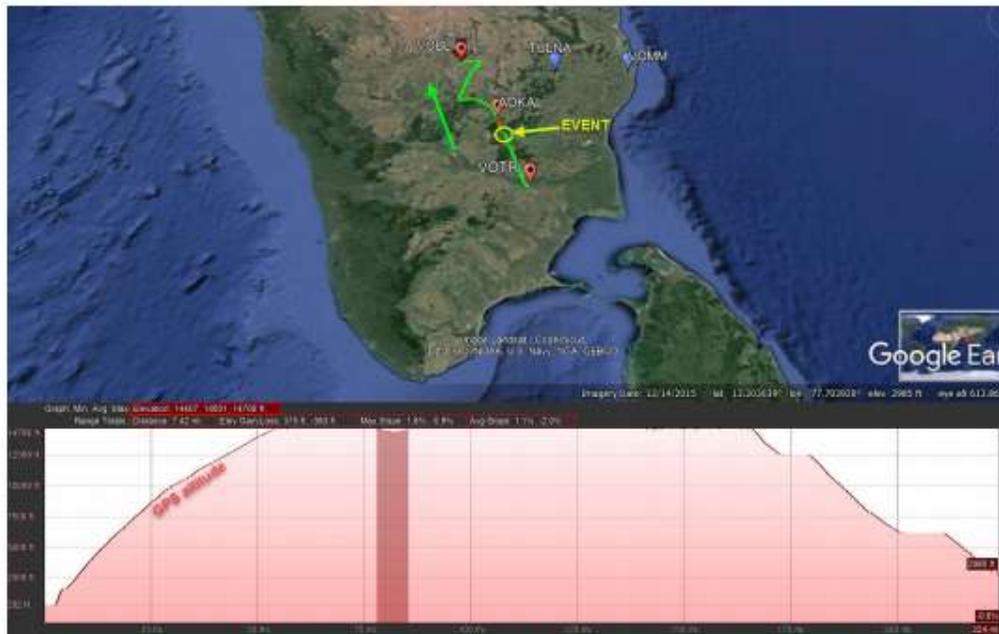
Figure 1: Overall Flight Trajectory based on GPS Position

On 04 Sept 2021, ATR 72-212(600), Reg. VT IYM, operated by M/S InterGlobe Aviation Ltd, flew into turbulent weather and experienced high vertical loads in flight during cruise. The Aircraft with call sign IGO 7739 was a scheduled flight from Tiruchirapalli airport (VOTR, INDIA) to Bengaluru airport (VOBL, INDIA). There were 52 passengers and four Crew members (Two Cockpit crew and Two Cabin crew) on-board. The aircraft was commanded by a PIC, an ATPL holder and he was assisted by a Co-pilot who was a CPL Holder. The Co-pilot was the PF and the PIC was the PM for this sector. The aircraft flew into turbulent weather and one of the Cabin crew (L1) had a fall and fractured her left leg.

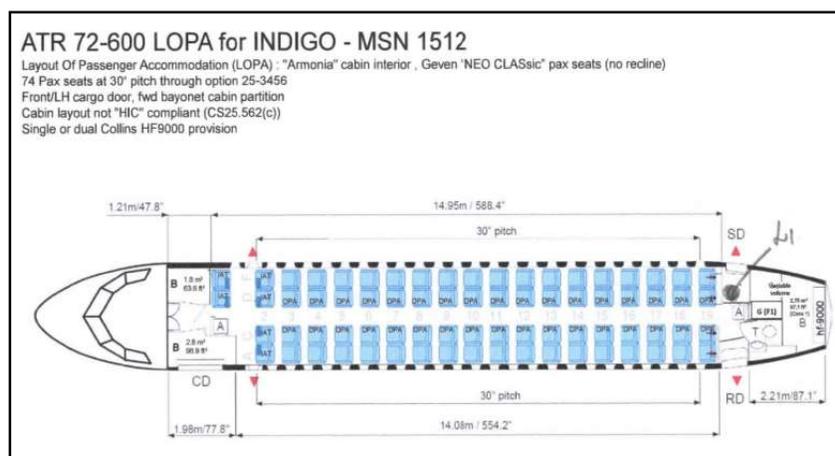
Figure 7: LOPA ATR 72-600

The L1 was serving food to some staff travelling on duty (For location of L1 at the time of turbulence refer **Figure 7**). She too had noticed that the seat belt signs were 'ON' but continued with her service. She could have enquired from L2 if it was safe to move around in that situation. She did not follow the stipulated SOPs.
